KIRSTEN MOFFITT
PAINT ANALYSIS REPORT

**‘DUDLEY DIGGES HOUSE’
524 PRINCE GEORGE STREET
WILLIAMSBURG, VIRGINIA**

NOVEMBER 19, 2017

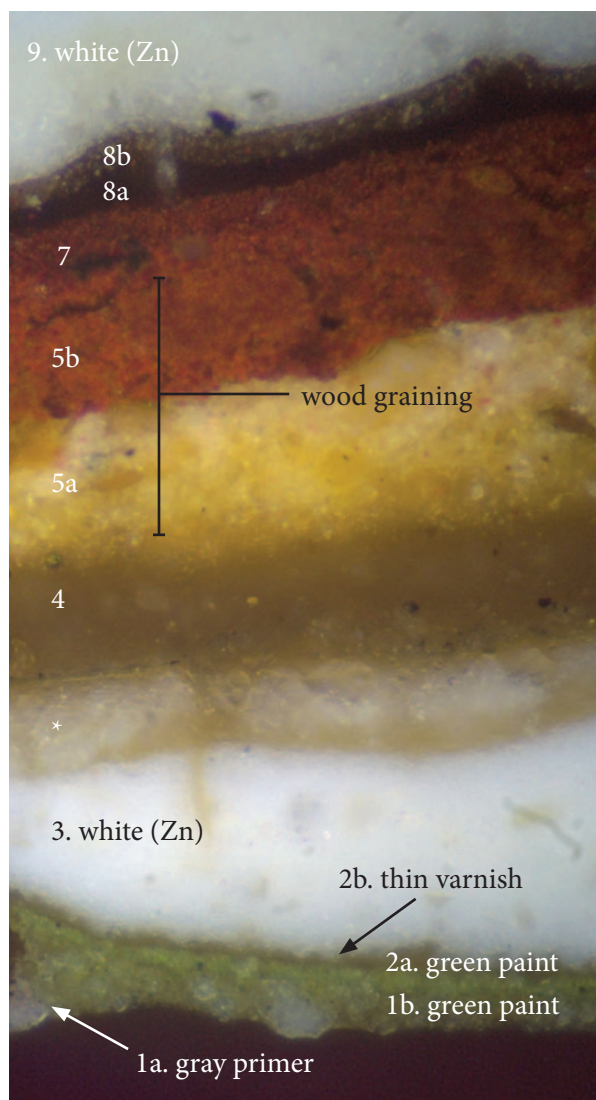
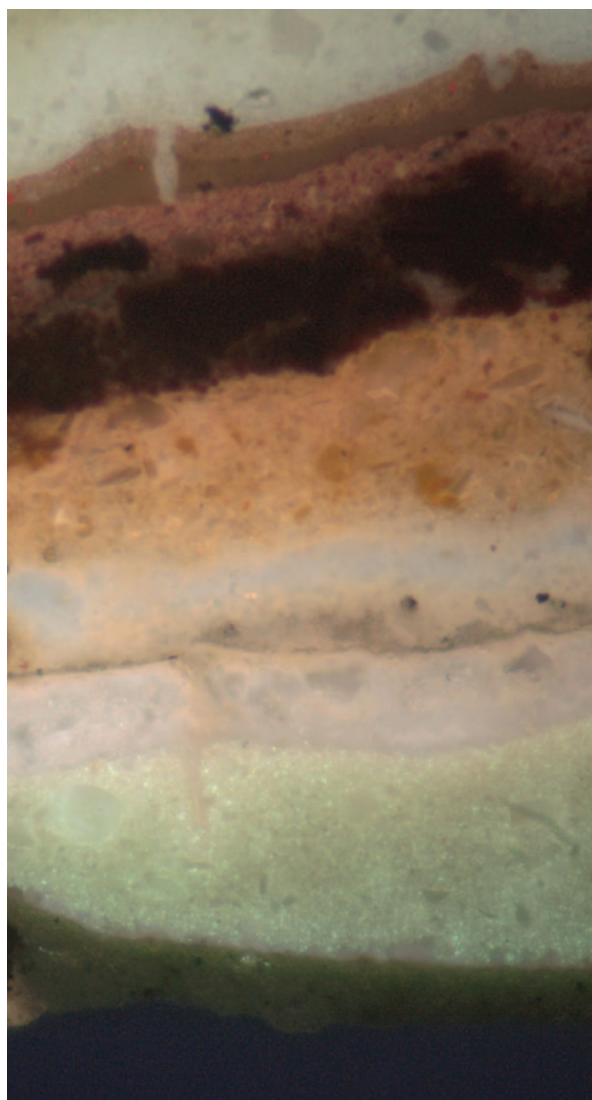
CROSS-SECTION MICROSCOPY RESULTS**SAMPLE DD 17: TALL SECOND POST, EAST (FRONT) FACE AT THE OUTER CORNER, 3'6" ABOVE THE LOWER FLOOR**

This sample from the stair newel post aligns with the earliest paint layers in the house. The earliest layers are shown in detail here, including the first generation gray primer (1a) and green paint (1b). The second generation green paint (2a) and varnish (2b) follow, although they are not as obvious here as they are in other samples. Generation three is a zinc-based paint, which SEM-EDS found to contain lithopone, which could date this layer to the late 19th c. The following tannish, translucent layer (*) was present only in this sample and not elsewhere, so it was not annotated. Generations 5-8 are imitation wood graining and/or dark brownish layers.

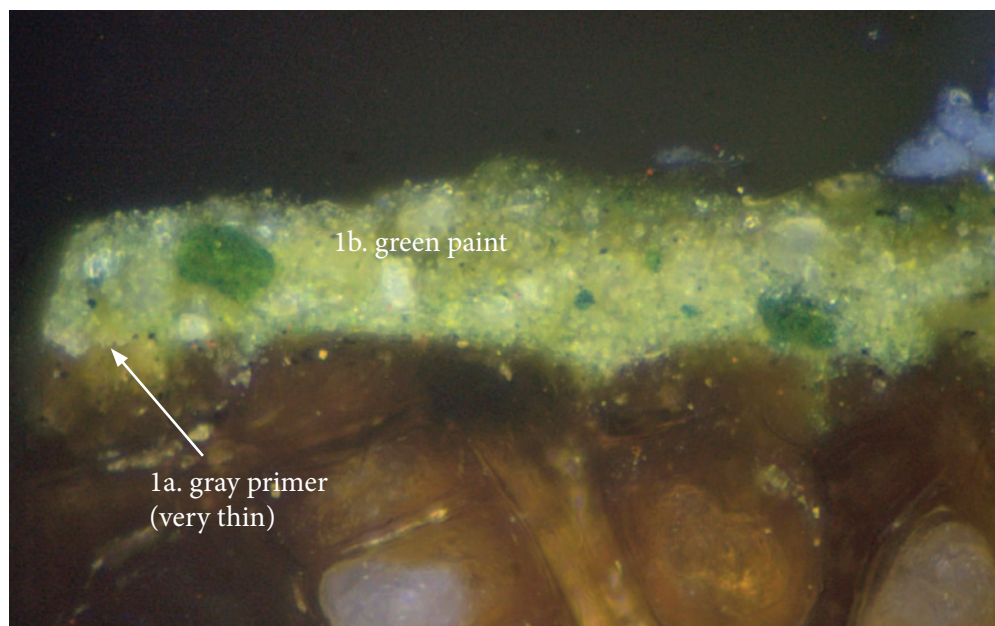
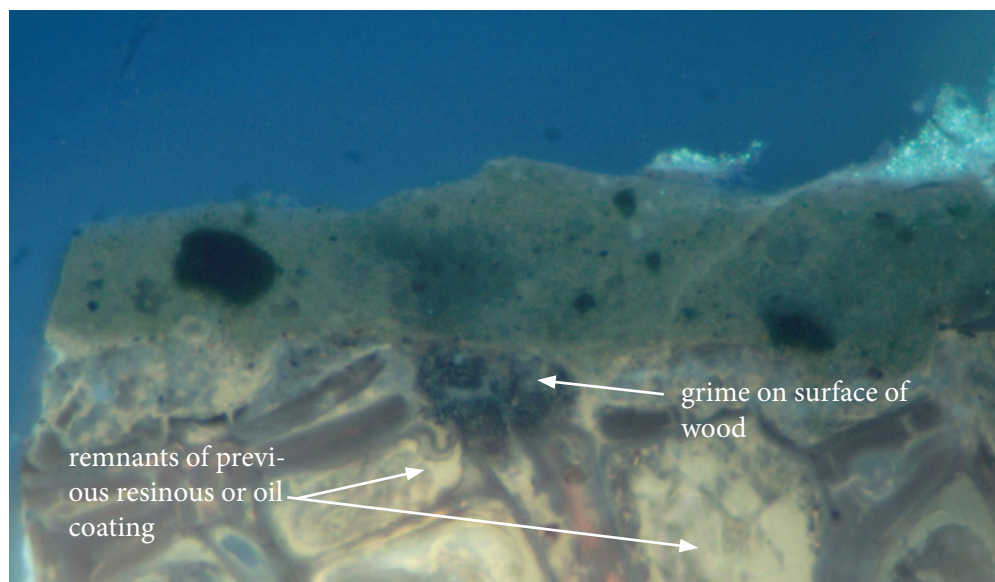
CROSS-SECTION MICROSCOPY RESULTS**SAMPLE DD 17: CONTINUED FROM PREVIOUS PAGE**

This fragment from sample DD17 is significant in that it shows what appears to be remnants of an earlier resinous or oil-based finish embedded into the wood cells, covered with a layer of grime. This suggests that an earlier clear coating (which could include an oil, resin (varnish), or wax (which is notoriously difficult to identify in a thin layer on wood in cross-section)), was applied to the wood and allowed to wear and become soiled before being painted over with the first generation green paint.

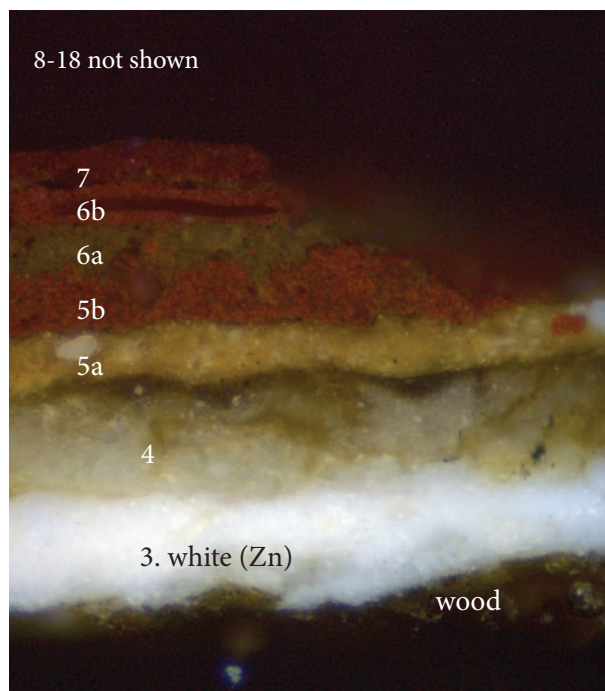
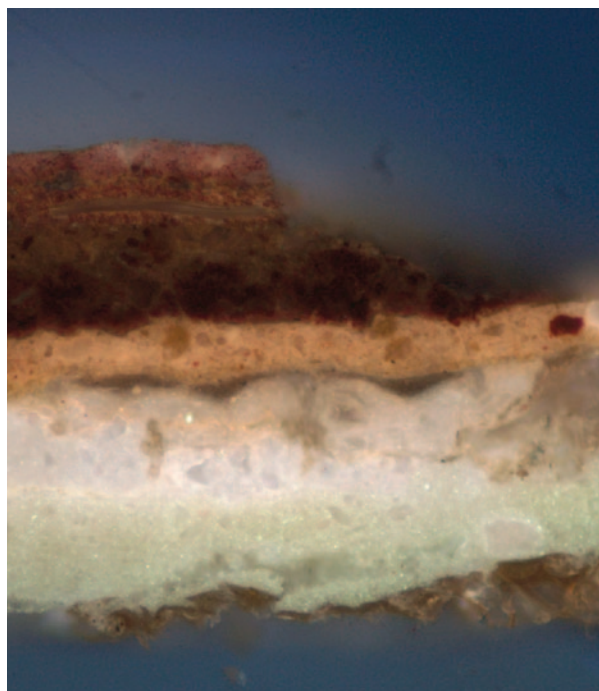
CROSS-SECTION MICROSCOPY RESULTS**SAMPLE DD 19: NINETEENTH BALUSTER, SOUTH FACE, IMMEDIATELY BELOW THE HANDRAIL**

Only the earliest paints from the baluster are shown here. The earliest paint on the wood is the white paint that aligns with the third generation throughout the house. This confirms that the balusters are later than the first period woodwork. The presence of a zinc-based pigment in the earliest paint dates the balusters to c.1845 or later. In addition, SEM-EDS suggests that this paint could contain the zinc-based pigment lithophone, which was introduced in 1874.

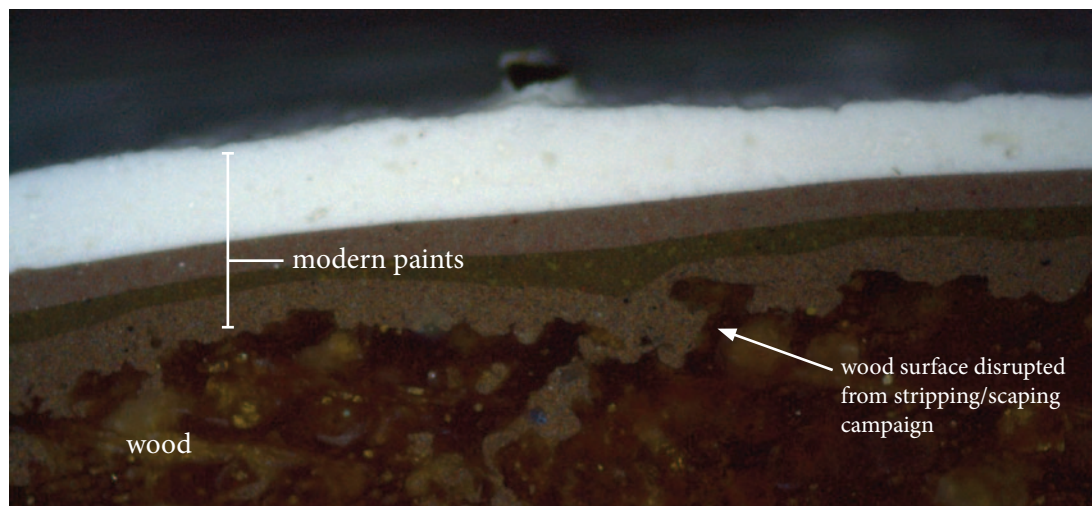
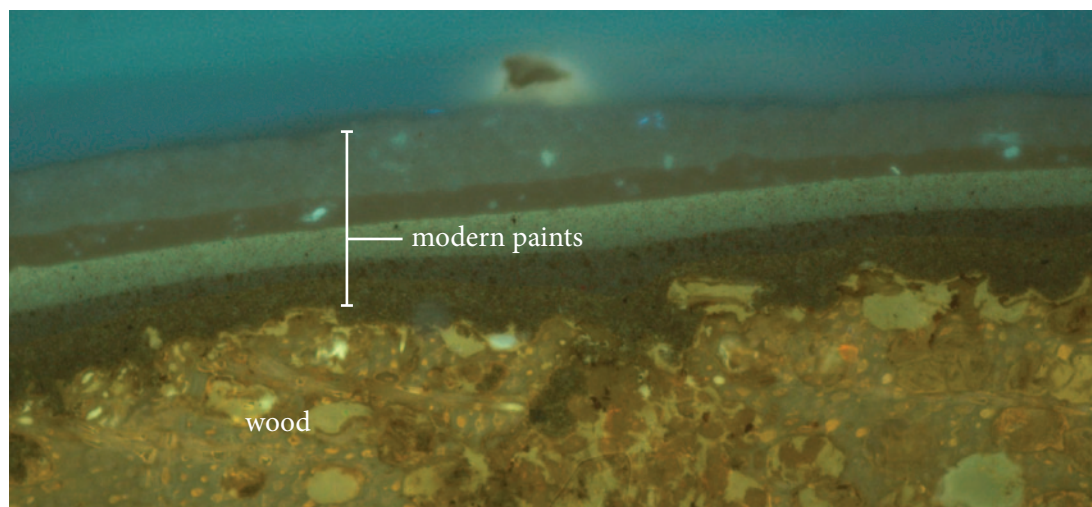
SAMPLE DD 20: THIRD SECTION OF HANDRAIL, NORTH FASCIA JUST BELOW TORUS, WHERE IT MEETS THE 4TH POST

The extant coatings on the handrail are all finely ground, dimly autofluorescent modern (20th c.) paints that align with generations 21-15 in the rest of the house. Any earlier finishes appear to have been stripped or scraped from the handrail, evidenced by the rough, disrupted surface of the wood substrate underneath.

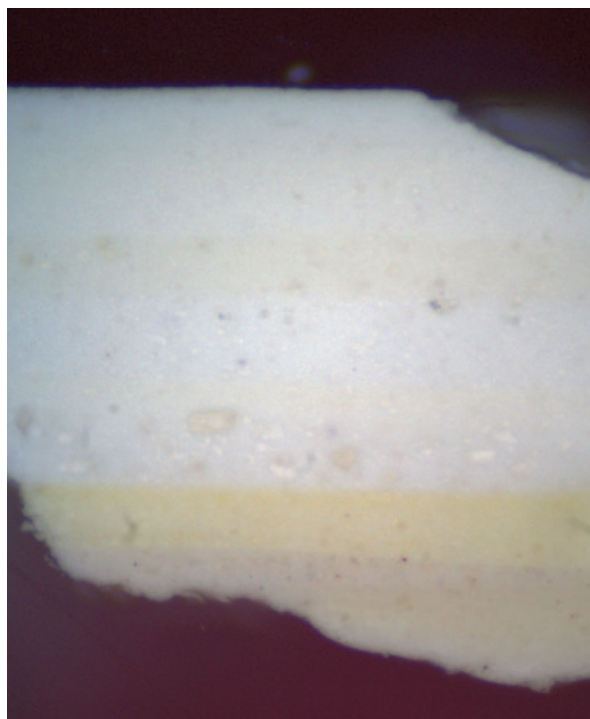
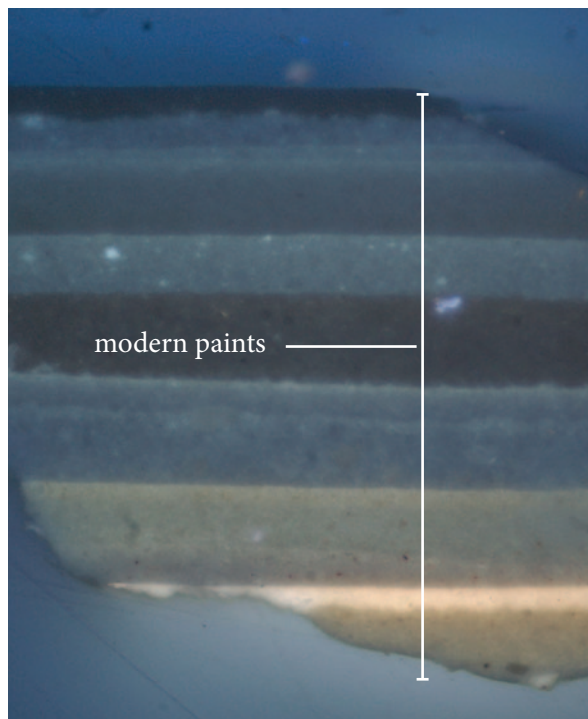
SAMPLE DD 3: GHOST OF AN UPPER HL HINGE AT THE JOINT BETWEEN THE HORIZONTAL AND VERTICAL ARM.

Following removal of the hinge, the door was painted with ten layers of finely ground, dimly autofluorescent modern paints (20th c.). This suggests the hinge was removed in the mid-late 20th c.

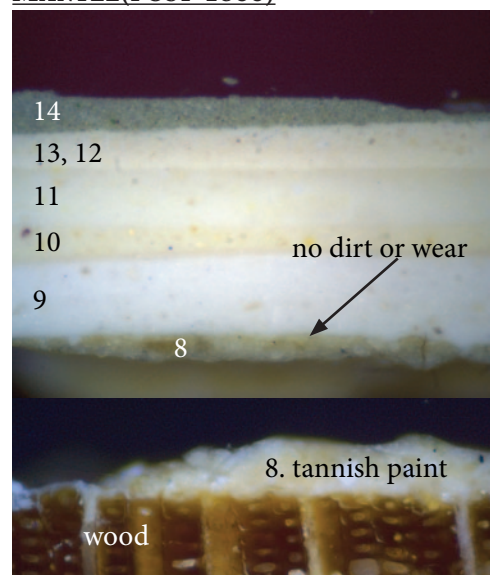
MANTEL (POST-1800)

The sample from the mantel contained mostly modern (late 19th - 20th c.) paints that align with generations 9-22 on the rest of the woodwork (see comparison below). However, the earliest generation on the mantel appears to be a hand-ground tan-colored paint not seen elsewhere. This is not unusual, since mantels were often painted differently from the rest of the woodwork. The alignment suggests it could date to generation eight, although it could be even earlier. However, the lack of dirt or wear on its surface suggests the tan paint was not exposed for a significant amount of time. While the paint stratigraphy confirms the mantel is later (which was expected), there is not enough evidence to confidently place its installation within the context of the house.

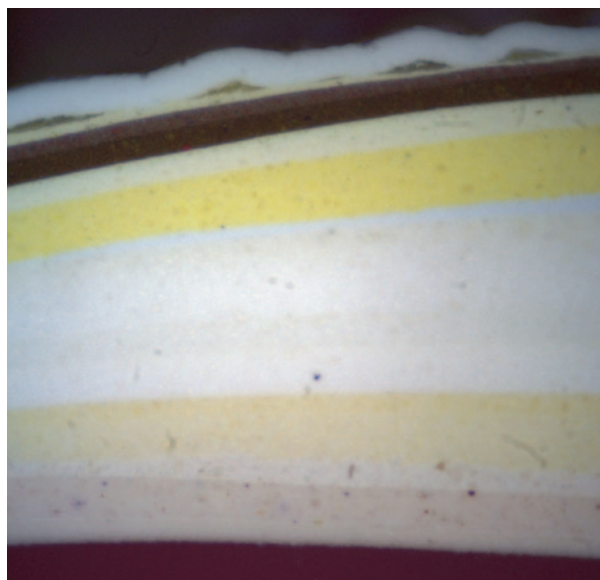
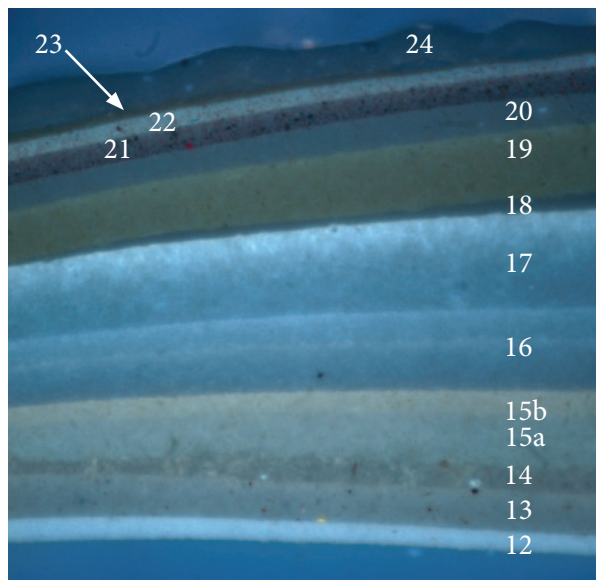
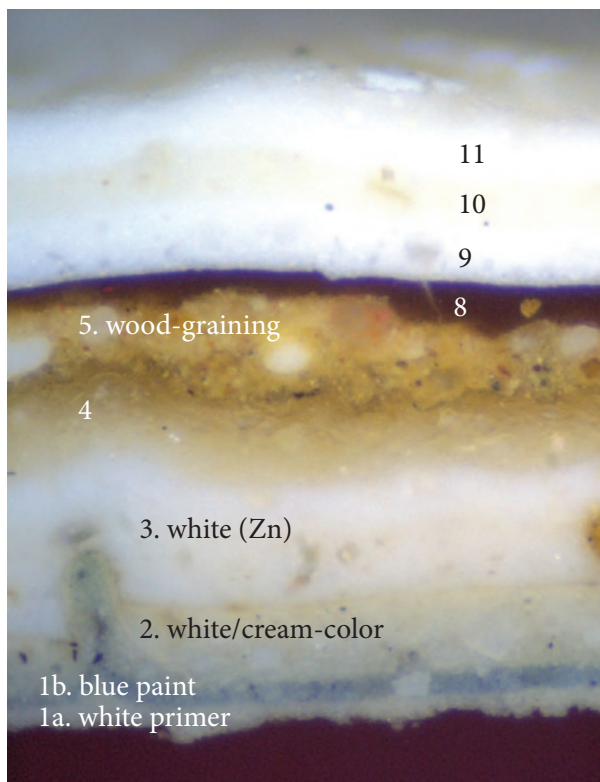
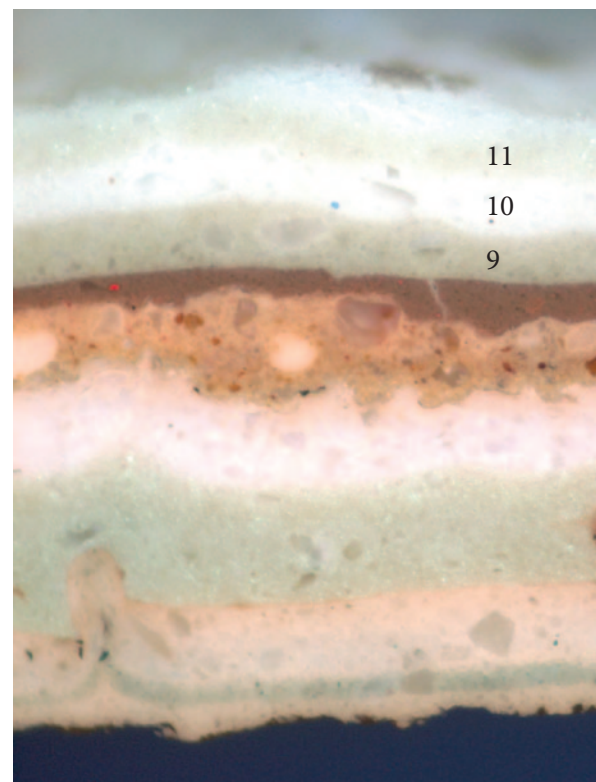
SAMPLE DD 15: EAST WINDOW, FACE OF ARCHITRAVE AGAINST BACKBAND, 1'1" BELOW HEAD

This sample from the east window architrave contains a first generation white primer (1a) and blue paint (1b), not seen elsewhere in the house. This could be contemporary with the first generation green paint found elsewhere. Generation two is a white/ cream-colored paint. Generation three is the same white zinc-based paint used on the rest of the woodwork.

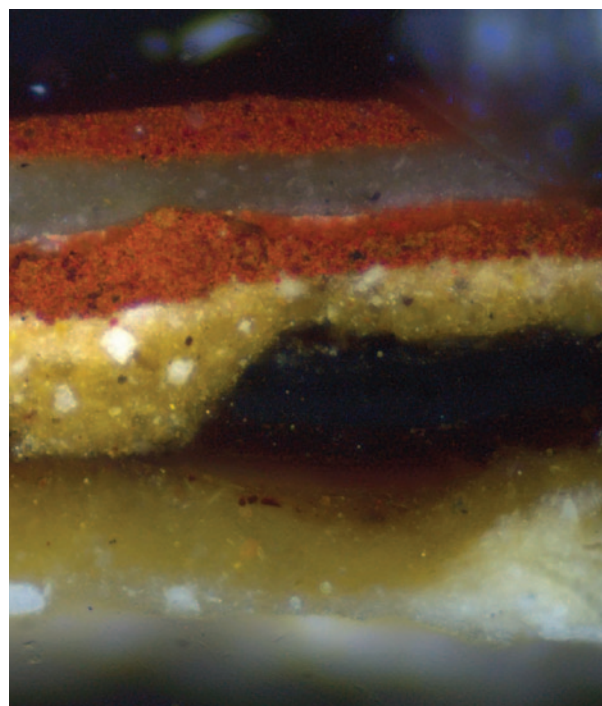
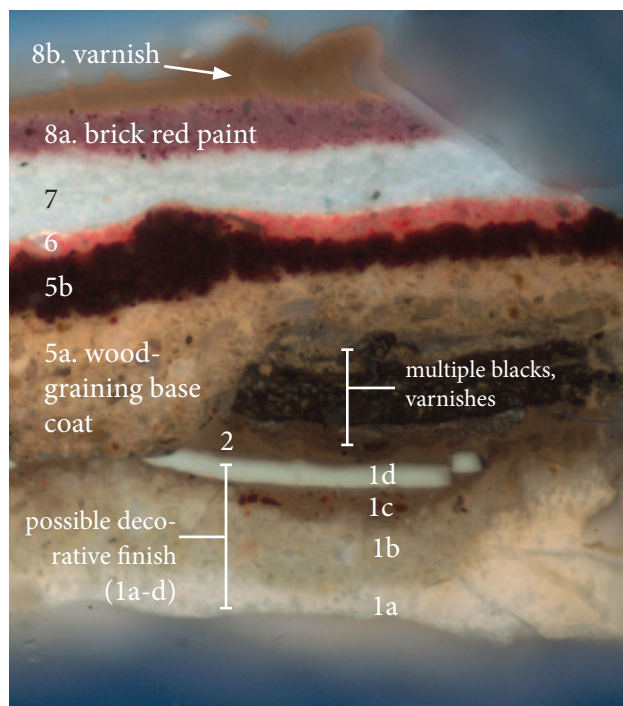
SAMPLE DD 14: MANTEL, RECESSED FACE OF EAST (LEFT) PILASTER AT UPPER-LEFT CORNER

This mantel contains a number of early paints that are unique to this element. The first generation could be a multi-layered decorative finish, consisting of a white, opaque base coat (1a), a tannish, translucent layer (1b), a dark brown ish-red layer with some deep red pigments (1c), and a resinous varnish (1d). This varnish is deeply cracked and disrupted suggesting a long period of exposure.

Generation five is the same wood-graining finish found on many elements in the house.

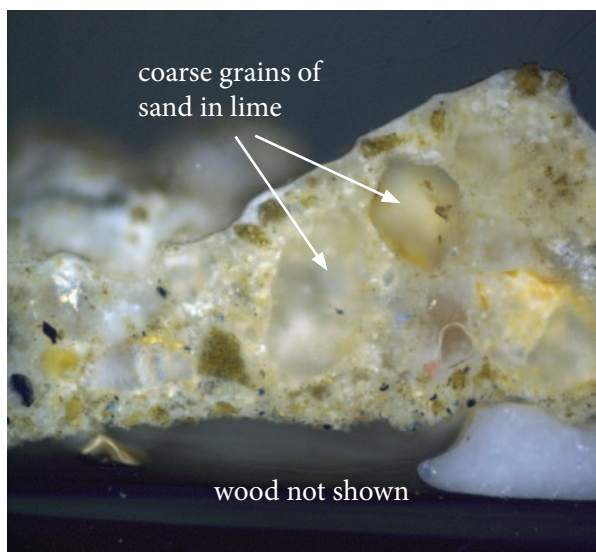
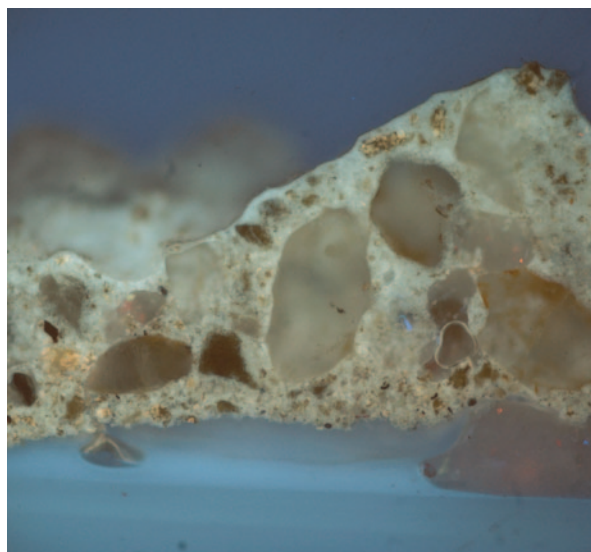
SAMPLE DD 21: SAMPLE FROM UNDERSIDE OF BOARD BETWEEN 10TH AND 11TH RAFTERS, COUNTING FROM THE NORTH END, TOP BOARD ON WEST SLOPE, TAKEN FROM THE EDGES

The results found that the material on the attic boards does appear to be a mortar, rather than a limewash. There is a thick, single layer of what appears to be a lime-based coating that contains a good deal of sandy aggregate. This is very unlike a limewash, which is typically very thin and contains no aggregate. The purpose of this mortar-like material on the surface seems to confirm that these boards were re-used from a construction site, possibly as a scaffolding platform.

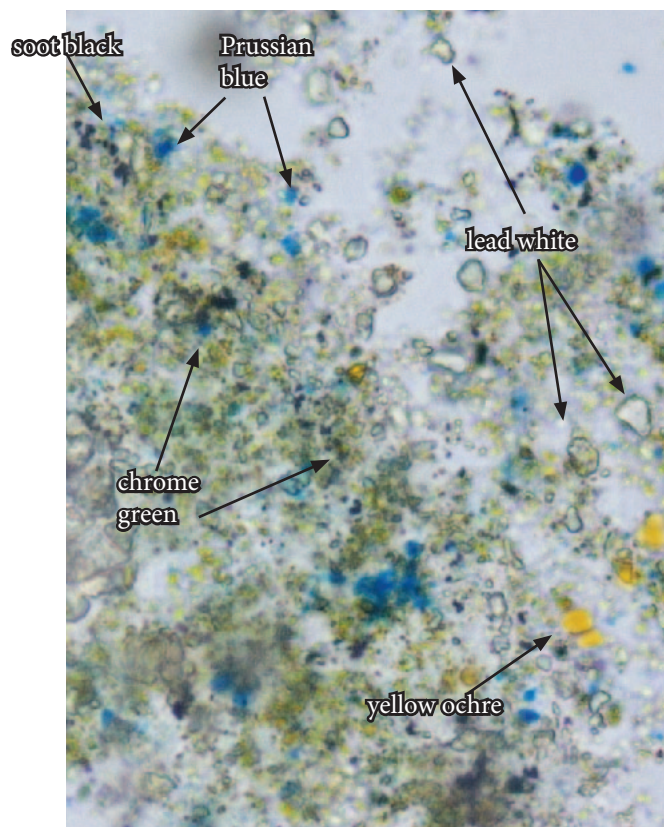
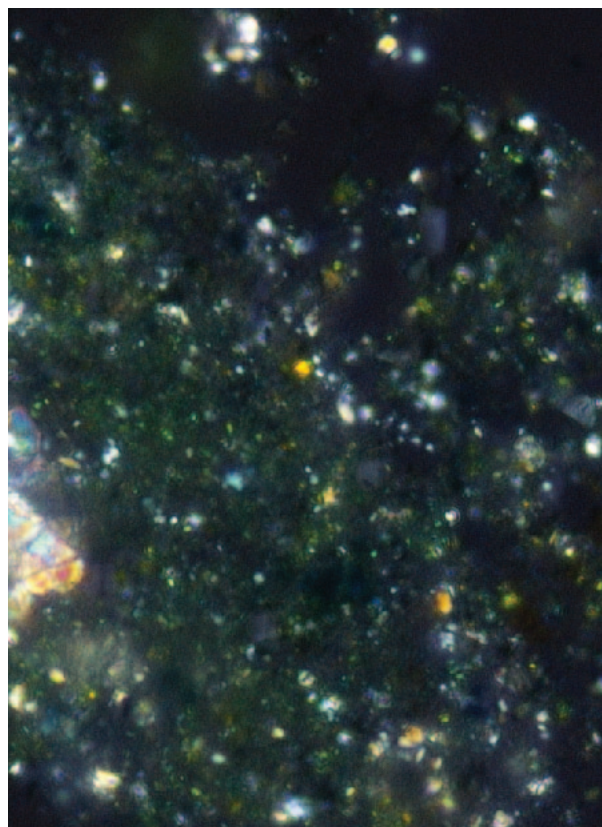
SAMPLE DD 1: GENERATION 1 GREEN PAINT (MAY ALSO CONTAIN SOME PIGMENTS FROM GRAY PRIMER).

Pigment particles from the first generation green paint were collected with a clean scalpel blade, dispersed on a glass slide, and mounted in Cargille meltmount ($RI=1.662$). Examination under plane and cross-polarized light identified the presence of lead white ($2PbCO_3 \cdot Pb(OH)_2$), Prussian blue ($Fe_4[Fe(CN)_6]_3$), chrome green (mixture of Prussian blue and chrome yellow ($PbCrO_4$)), yellow ochre ($Fe_2O_3 \cdot nH_2O$), and soot black (C) pigment particles.

Lead white particles were observed to be rounded, colorless grains, ranging in size from 1-3 μm , with high relief and $RI > 1.662$. Birefringence was strong with second and third order jewel tones observed. Extinction was complete.

Chrome green is a mixture of Prussian blue and chrome yellow pigment. Prussian blue particles were observed to have a deep blue color, an amorphous shape with low relief (no strong boundaries), and $RI < 1.662$. This pigment is isotropic (dark) in crossed polars. The chrome yellow pigment appears mostly green in color, suggesting an intimate mixture of the two pigments. Particle size was very small, $\sim 1\mu m$, with high relief and $RI > 1.662$. Birefringence was strong with greenish polarization colors.

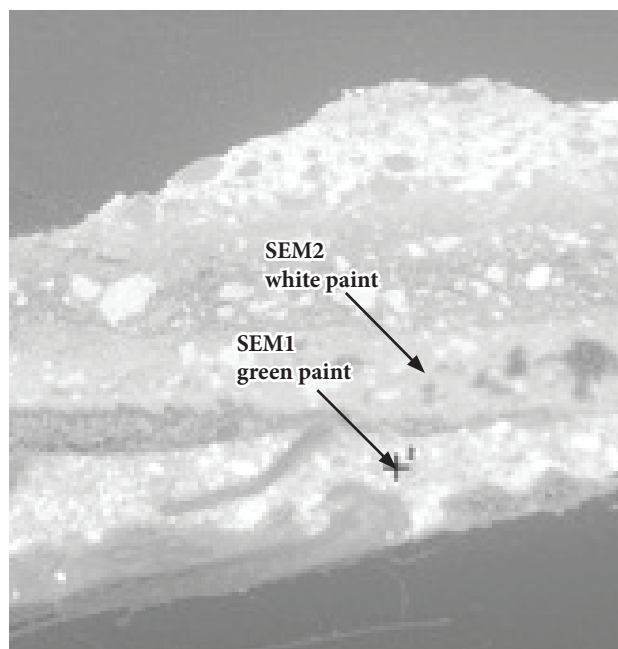
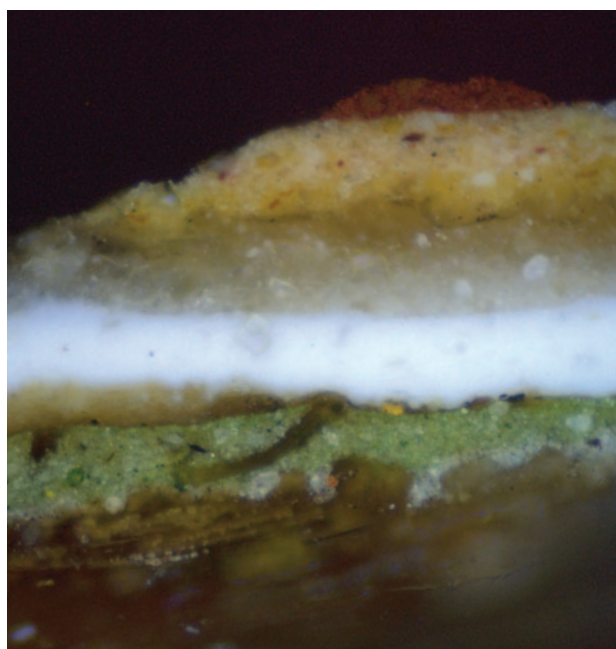
SAMPLE DD 17: GENERATION 1 GREEN PAINT

SEM 1 - gen. 1 green paint	
Element	Wt. Conc.
Carbon (C)	26.06
Oxygen (O)	15.65
Lead (Pb)	54.96
Zinc (Zn)	1.23
Calcium (Ca)	1.56
Chromium (Cr)	0.55

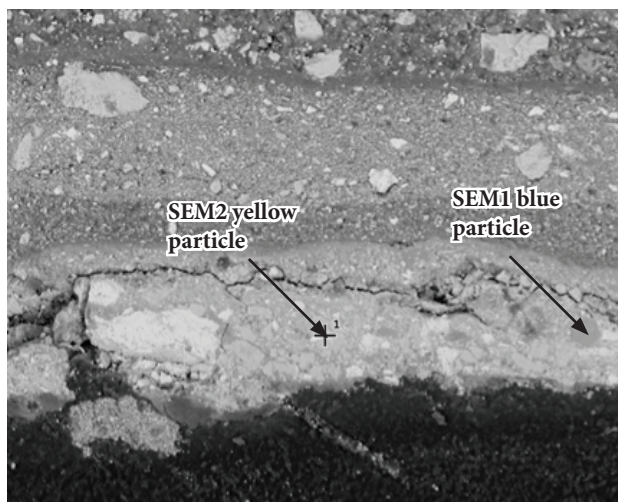
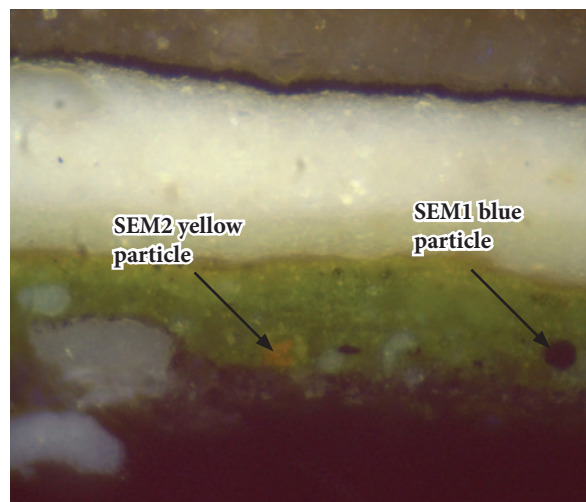
SAMPLE DD 1: GENERATION 1 GREEN PAINT

SEM 1 - dark blue pigment particle	
Element	Wt. Conc.
Carbon (C)	26.68
Oxygen (O)	12.57
Nitrogen (N)	8.71
Lead (Pb)	38.50
Iron (Fe)	8.65
Aluminum (Al)	1.01
Potassium (K)	0.72
Zinc (Zn)	0.97
Barium (Ba)	1.99
Silicon (Si)	0.21

The elemental analysis of the green paint in sample DD 1 gave similar results as sample DD 17 (previous page). The complete analysis is found in the attached appendix. The dark blue particle was confirmed as Prussian blue ($\text{Fe}_4[\text{Fe}(\text{CN})_6]_3$) based on the presence of iron and nitrogen. This confirms the PLM findings. A small amount of zinc was again detected in this layer.
