**A PRESERVATION PLAN FOR THE
MATTHEW JONES HOUSE
FORT EUSTIS, VIRGINIA**

Technical Report Series No. 3

January 17, 1991

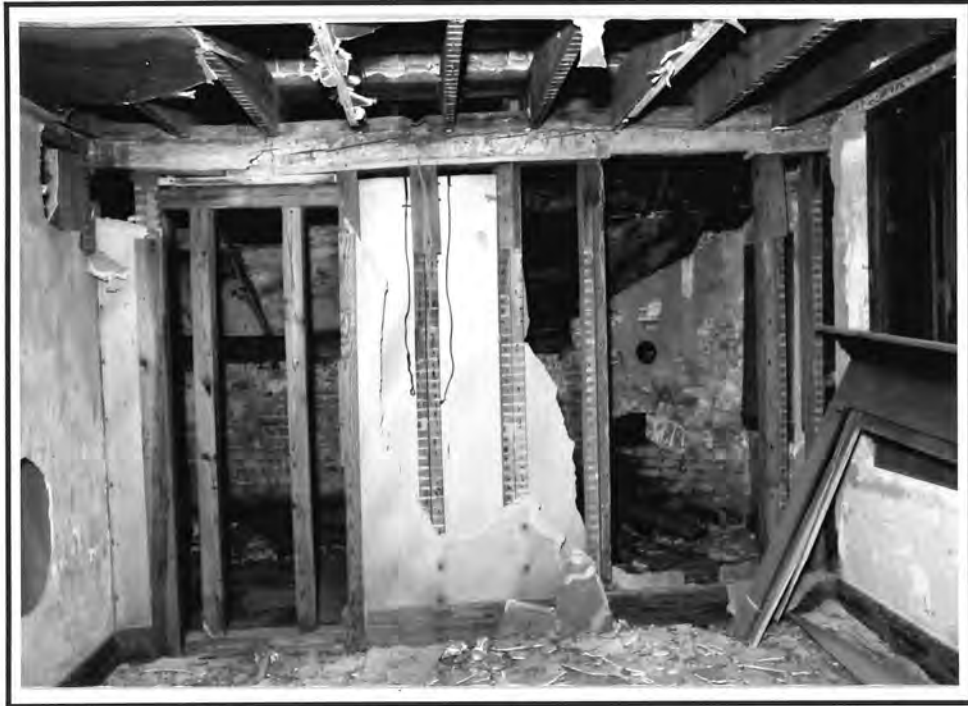
The rear plate, located along the north wall of the main block, extends the length of the house (Figure 18). Measuring $8\frac{1}{4} \times 6$ in., it is decorated with a chamfer and lamb's tongue stops on its lower, interior edge. Mortises robbed of their tenons (but retaining their pegs) indicate the bay system utilized in the construction of the Period I frame. The now-missing posts were flanked by well-executed stops on the plate (Figure 19). The north end of the plate has been defaced due to subsequent alterations.

Figure 18. Matthew Jones House, original rear plate of house, now supported by modern framing and carrying 1893 joists.

The size of the original posts can be determined once the modern framing below the plate is removed. The use of chamfer stops on the plate above the posts and decorative framing schemes used in other early Virginia houses indicates that the posts were meant to be seen and thus were approximately 5½ in. deep, the depth of the plates above. A plaster ghost on the underside of the plate illustrates that the studs were merely 3½ in. deep. These latter members were bevel lapped to the outside of the plate and on the top and bottom of the end joists. Up braces rose from the corner posts and were half-dovetail lapped and nailed to the plate as well. Thus the space between the posts and between the corner posts and the sides of the chimneys were plastered, leaving the principal framing exposed inside the room.

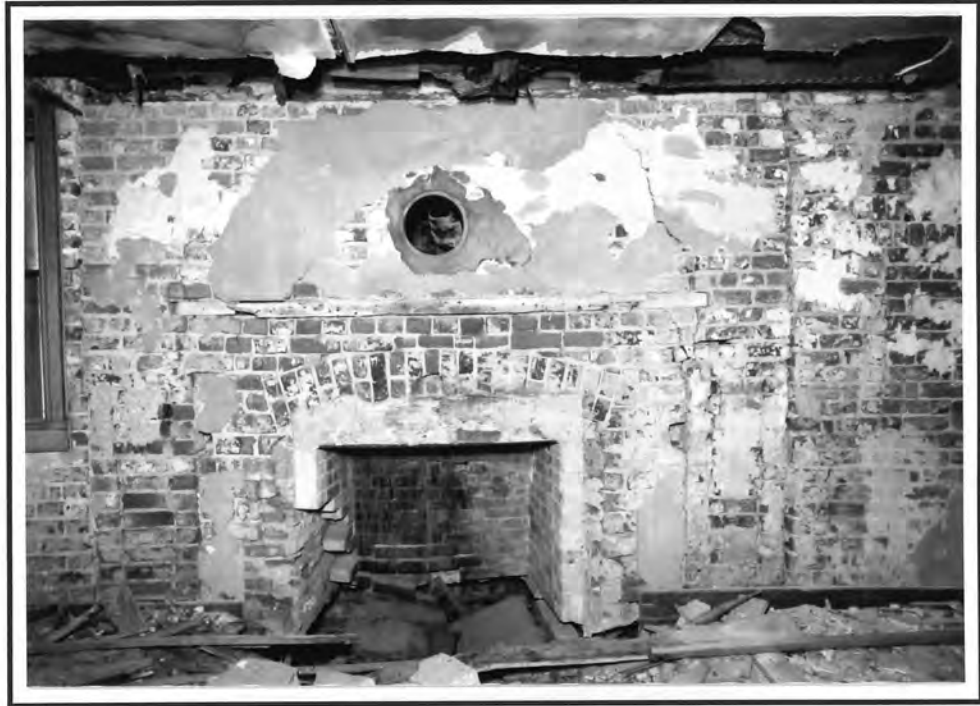
Figure 28. Matthew Jones House, hall fireplace with two generations of infill.

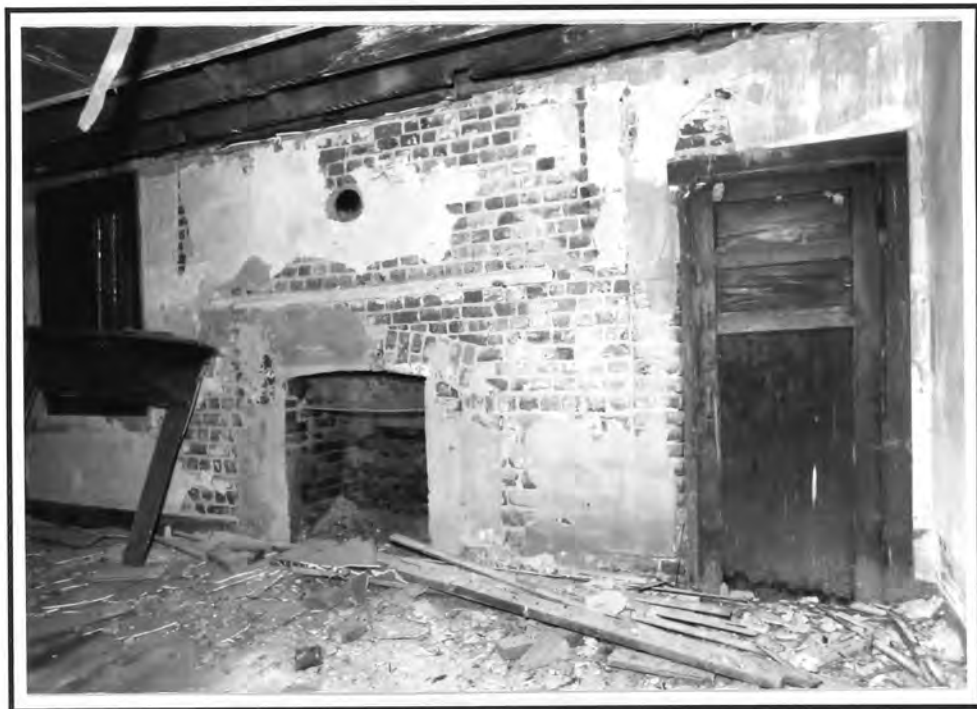
Figure 29. Matthew Jones House, chamber fireplace. New cheeks were added to both sides of the firebox probably in the late nineteenth century.

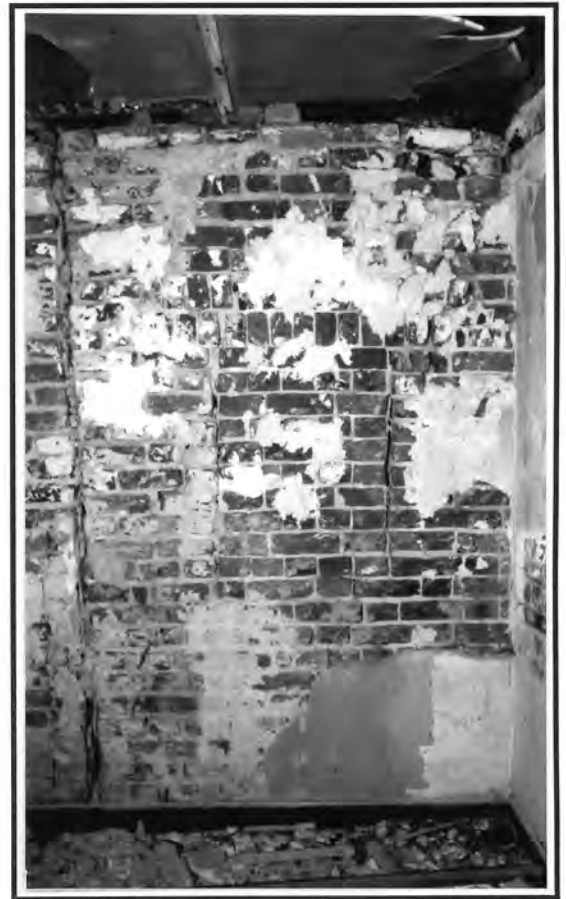
To the rear of the west chimney on the gable wall is a window opening blocked early in the life of the house. The window was clearly 1 ft. 11½ in. wide × 2 ft. 10 in. tall and was therefore considerably more narrow than all of its contemporary first-floor openings, including those in the shed. The latter brick opening measures 1 ft. 11 in. wide × 4 ft. tall. In the opening of this window on the outside of the house, brick has been infilled that is distinctive from that which

Figure 40. Matthew Jones House, detail of blocked window on west gable.

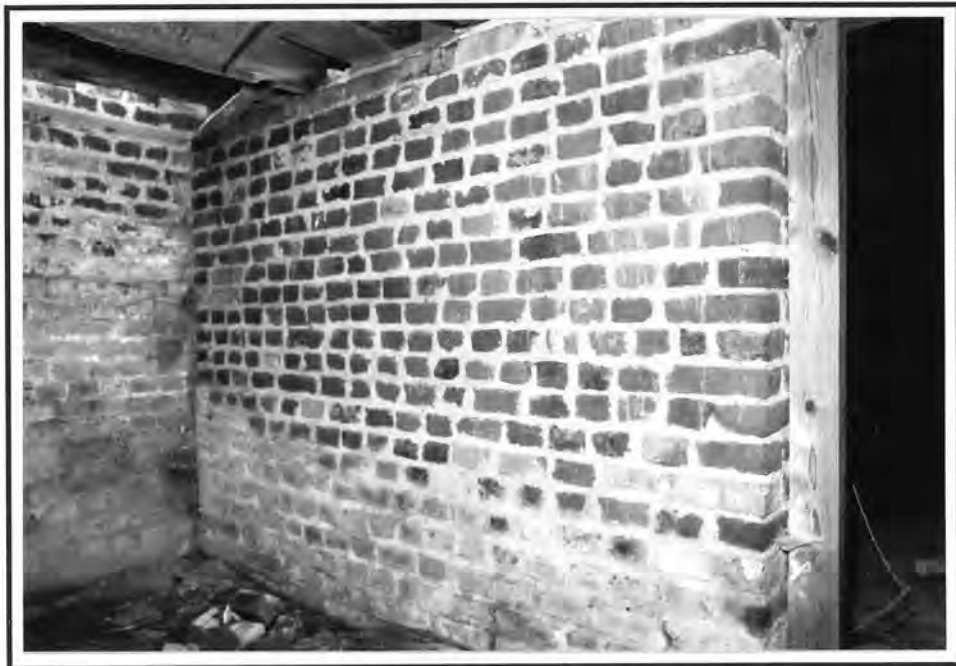
Figure 44. Matthew Jones House, foundation wall built under wall between the shed and main block of the house. This feature was added in 1893, likely when the floor joists were cut and new ones installed in the main block.

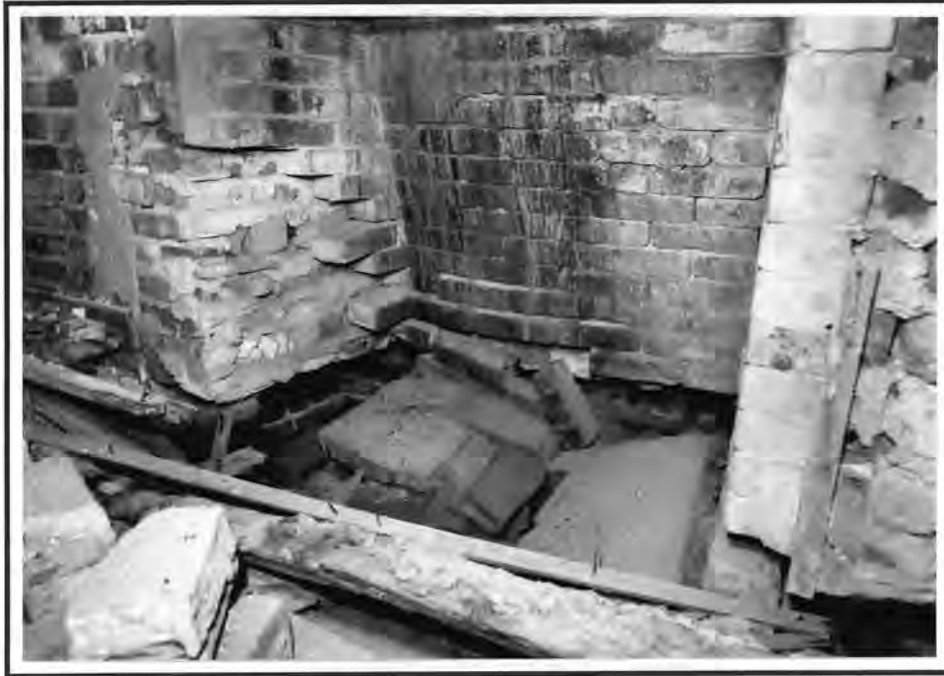
Significant differential settlement in the masonry was not observed in any portion of the house except the infilled brick walls in the cellar. Some cracks are occurring, but they are of a different origin.

Figure 47. Matthew Jones House, detail showing deterioration in west fireplace.
