# Geomorphology along an incised channel

Catherine Noll  
advised by Greg Hancock  
with Becca Lawrence and Chris Bowles

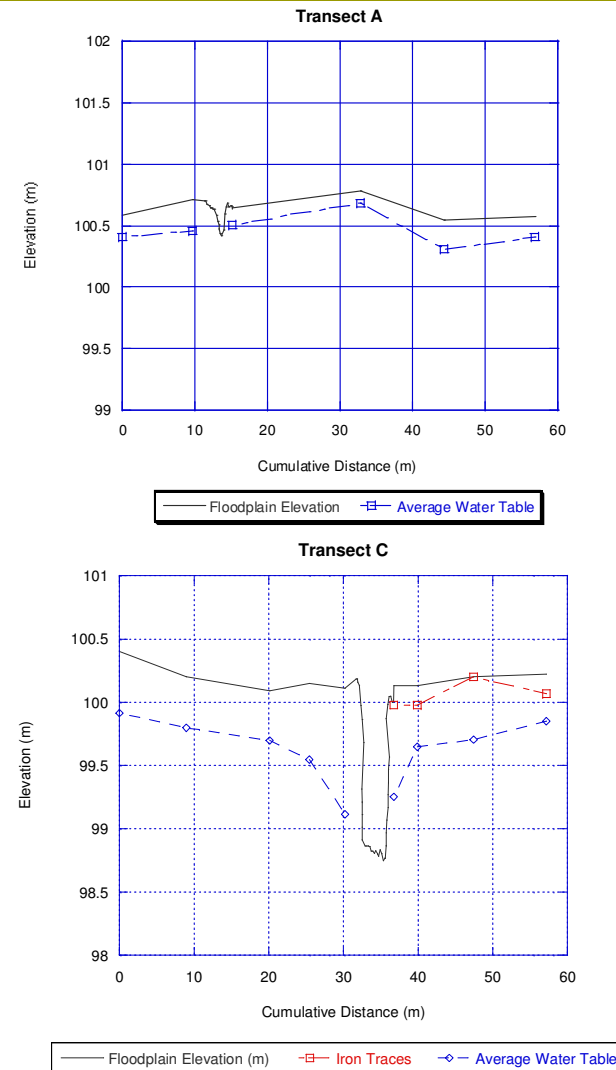
# Incision

- ❑ Occurs as runoff from urbanization increases flows through a channel
- ❑ Cuts into the streambed, deepening the channel and altering its shape and the bank shape
- ❑ Changes the flow patterns of the water table
  - Water table drops at knickpoint
  - Groundwater flow direction changes to flow into the stream
  - Increase in hydraulic head can lead to bank failure

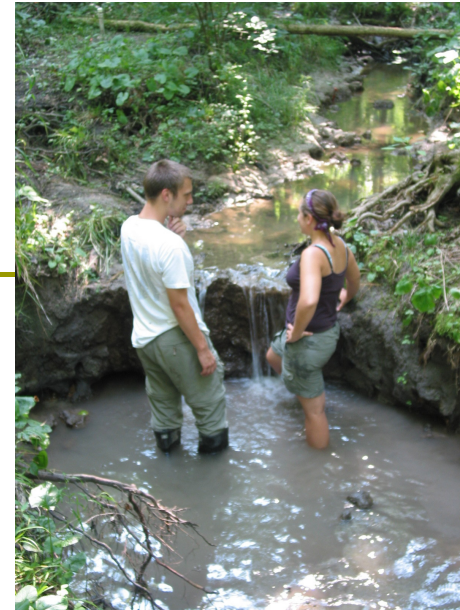
# The Knickpoint

- A point upstream of which the channel and floodplain maintain natural condition
  - Large, well developed floodplain
  - Storm recovery
  - Fine grained, highly organic floodplain and streambed
- Downstream the channel is incised
  - Small or no floodplain
  - High erosion rates, little recovery after storms
  - Coarser grained, often soil has been eroded away entirely

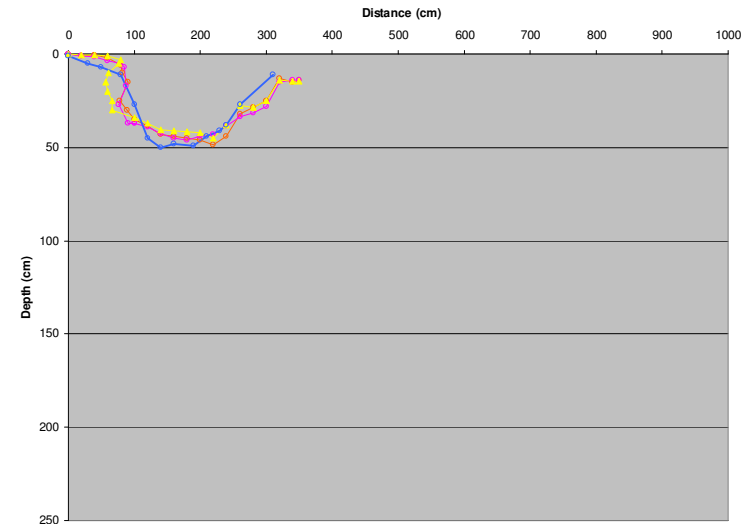
**Upstream of Knickpoint: B transect**

Average size from summer 2005 x-sections	Average change between measurements	% change total 2005	% Growth since 2001
Transect A	4082 cm	145 cm	7%	
B	9471	72	2	8%
K	12099	851	14	
Just above k.p.	15707	407	5	
Just below k.p	41457	109	1	
C	47167	185	1	49
D	40828	492	2	-3
E	32340	235	1	
F	70468	1502	4	32

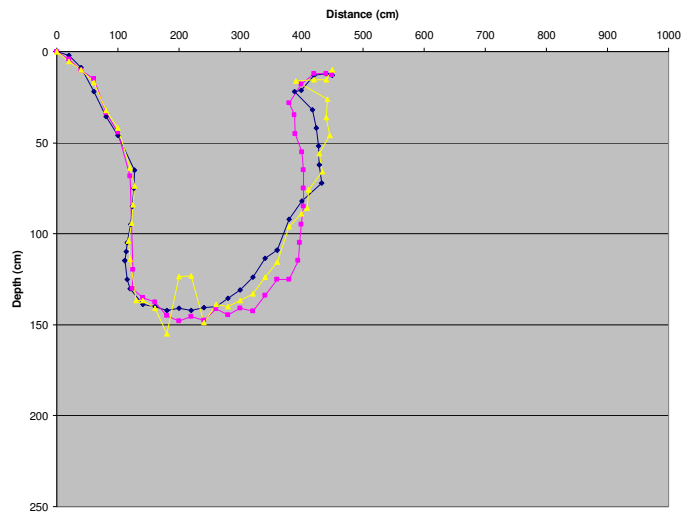
Just Below Knickpoint
