ARCHAEOLOGICAL DATA RECOVERY OF SITE 44HT0125, ASSOCIATED WITH THE I-64 HAMPTON ROADS BRIDGE TUNNEL EXPANSION PROJECT, CITY OF HAMPTON, VIRGINIA

VDOT Project: 0064-M06-033; UPC: 115009, 115011; Activity Code: 612

W&MCAR Technical Report Series No. 37

DECEMBER 13, 2022

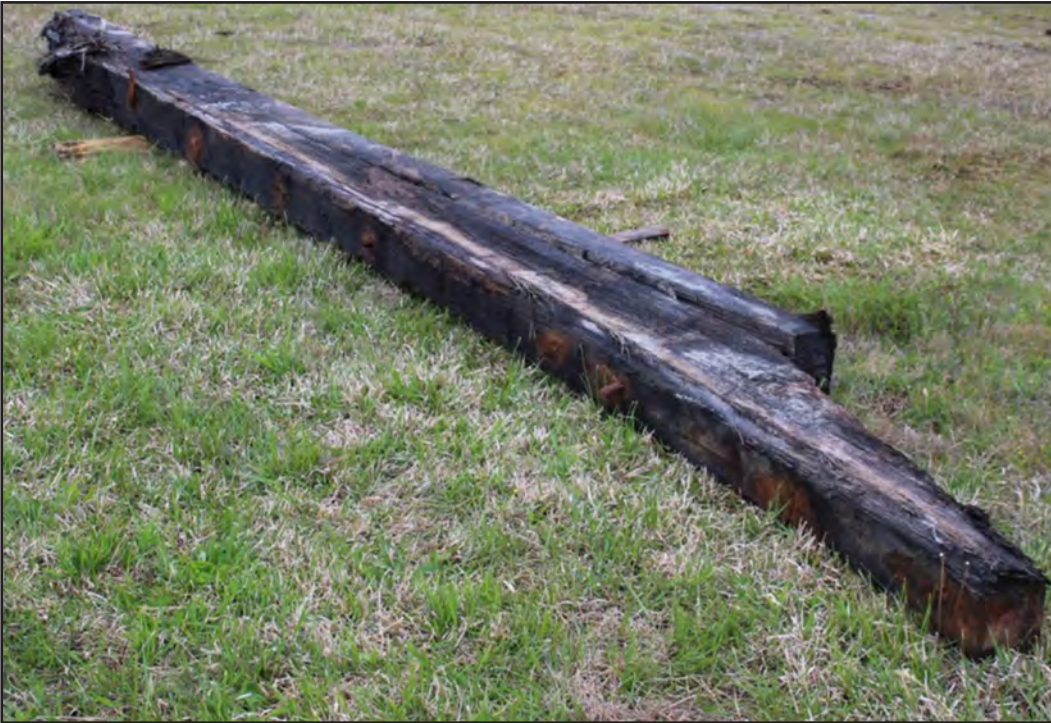
Figure 1.4. Keel from Site 44HT0125, 23 ft. in length.

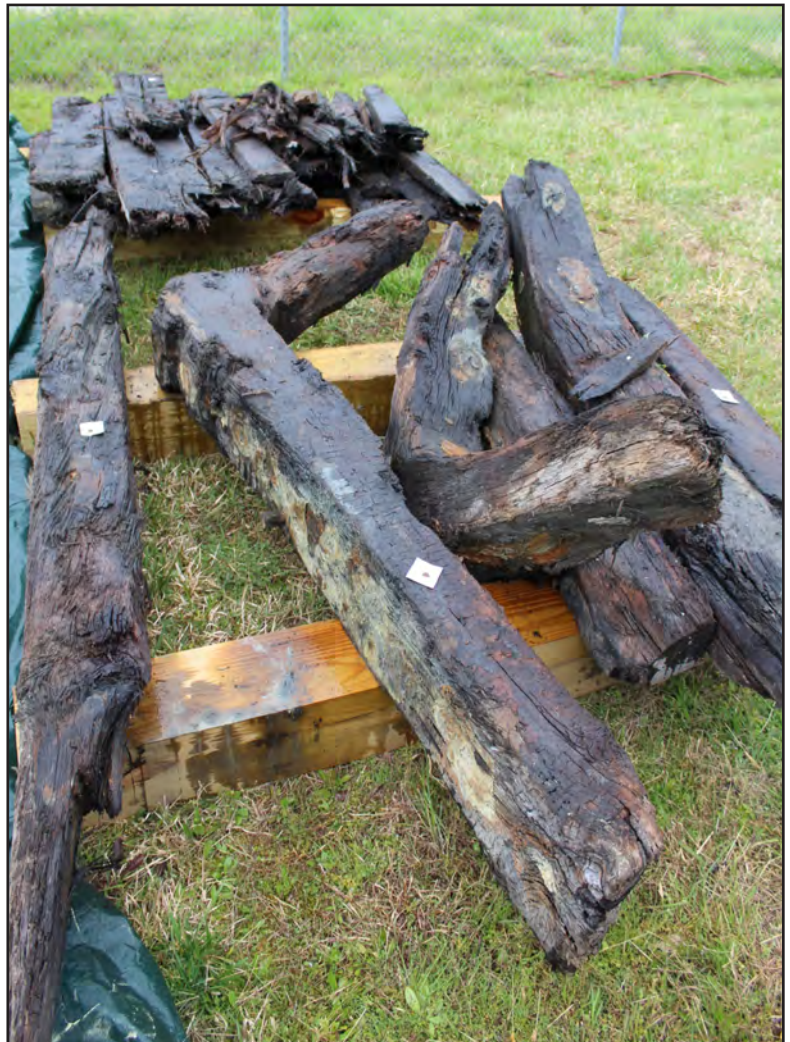
Figure 1.5. Standing knee and other ship timber components from Site 44HT0125.

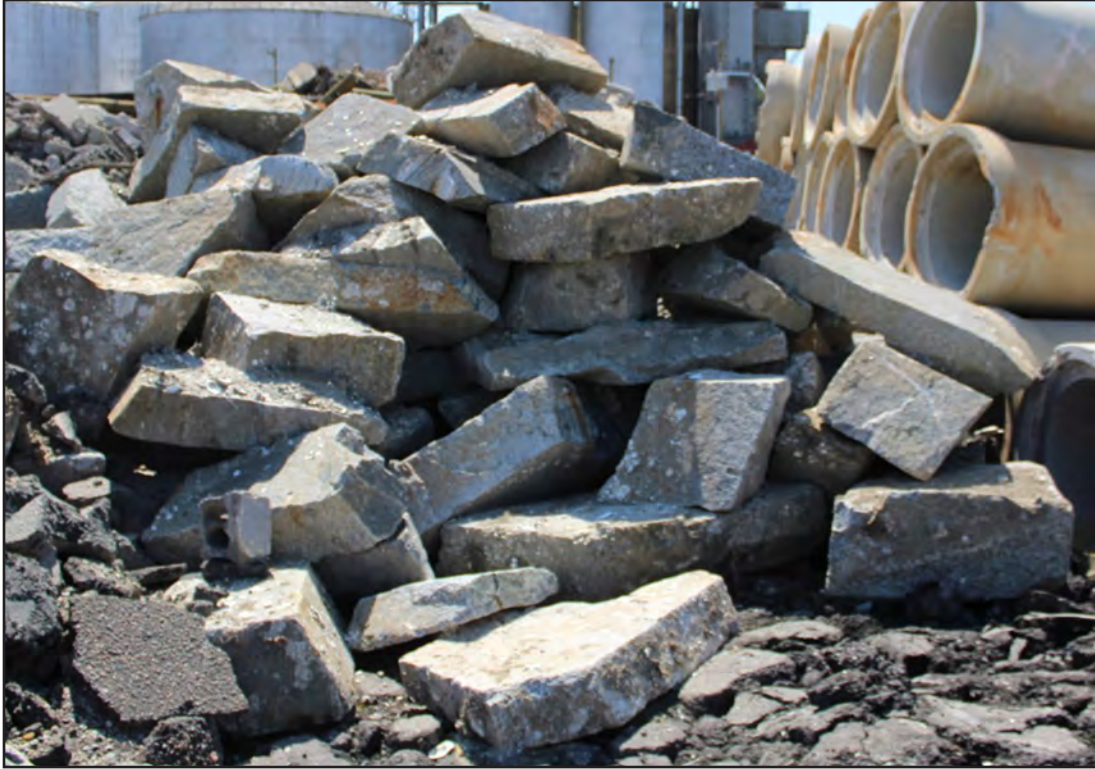
Figure 1.6. Quarried gneiss blocks from Site 44HT0125.

The dredging activity also brought to the surface blocks of building stone and a number of smaller artifacts. Goodwin estimated that the pile of stone stored at the Bainbridge Recycling Center comprised over 80 blocks of quarried rock that the Goodwin team assumed to be granite (Wright 2021:14). The largest piece of rock observed in the sub-assembly measures 4.98 x 2.0 x 4.0 ft. (1.52 x 0.61 x 1.22 m). The specific identification and source of the rock was unconfirmed. There were granite quarries in Virginia (e.g., vicinity of Petersburg and falls of the James) and Maryland during the early nineteenth century with access

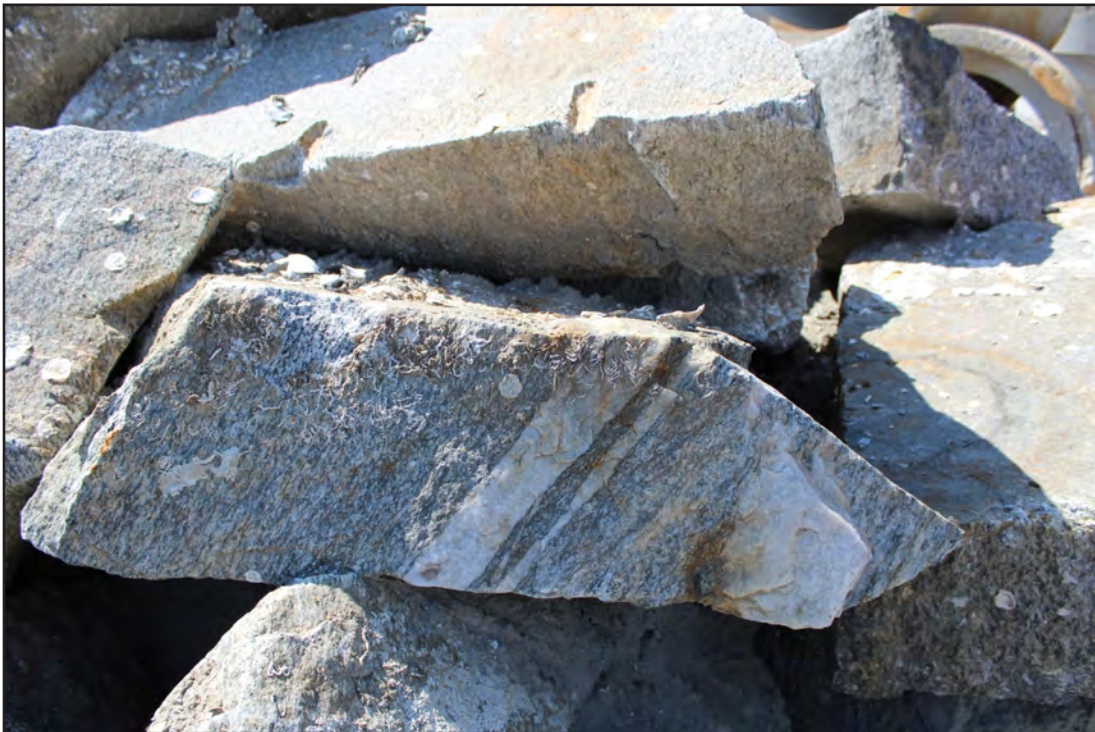
Figure 1.7. Detail of quarried gneiss blocks from Site 44HT0125.

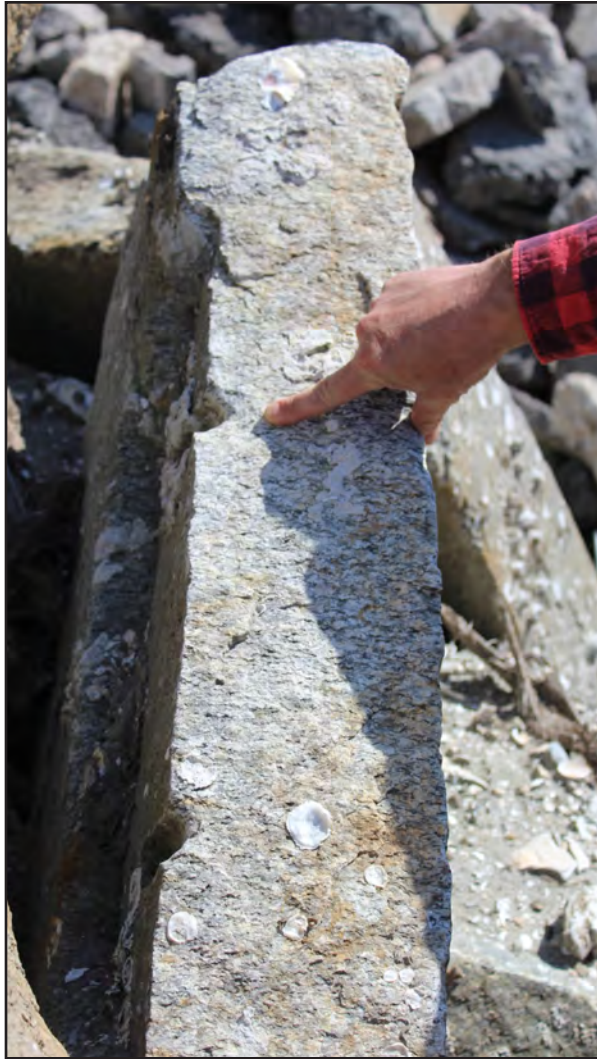
Figure 1.8. Drill holes in quarried gneiss blocks from Site 44HT0125.

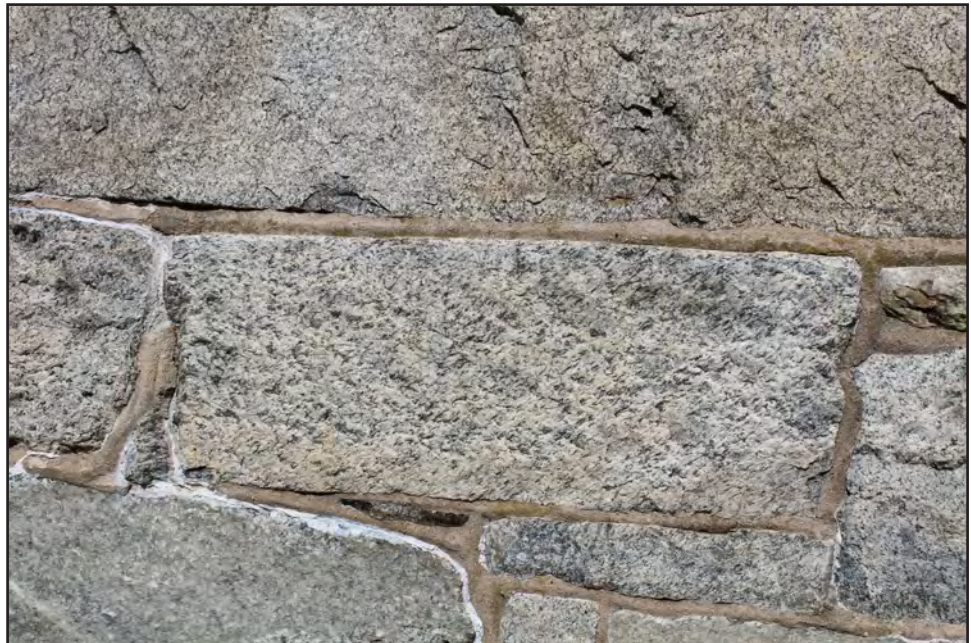
Figure 2.2. Detail of masonry in the Flagstaff Bastion of Fort Monroe.

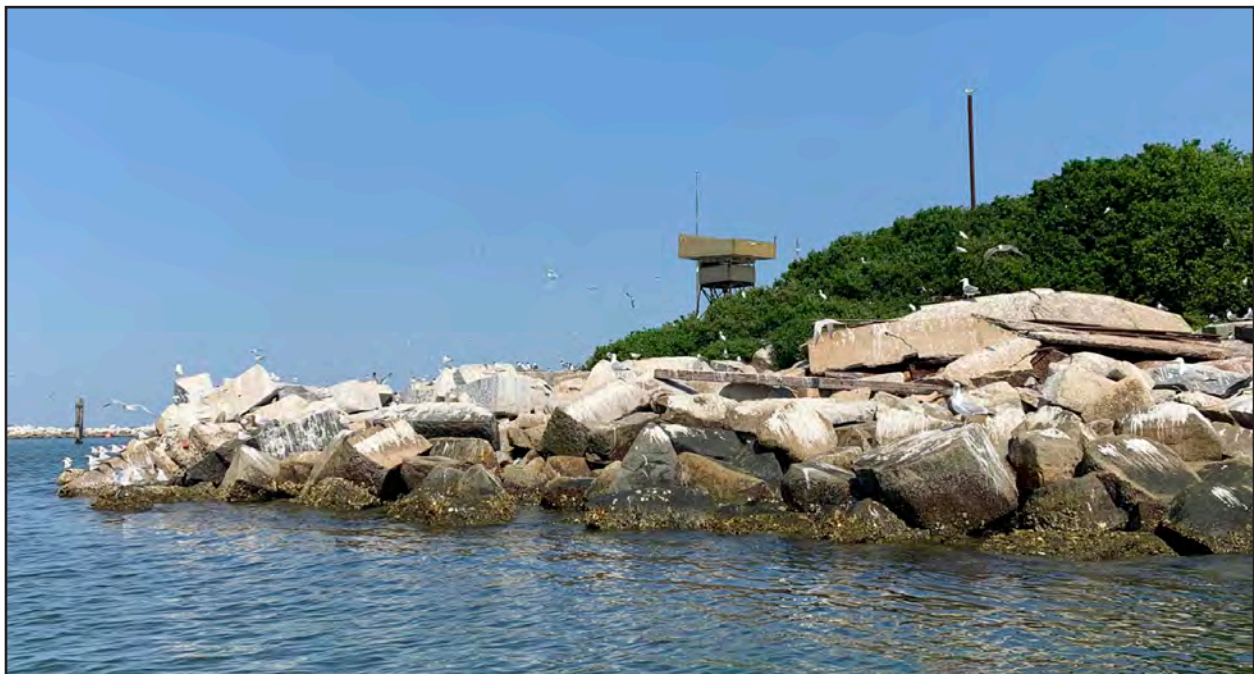
Figure 2.4. Stone block forming southeast portion of artificial island built up from underlying Willoughby Shoal for the construction of Fort Calhoun/Fort Wool.

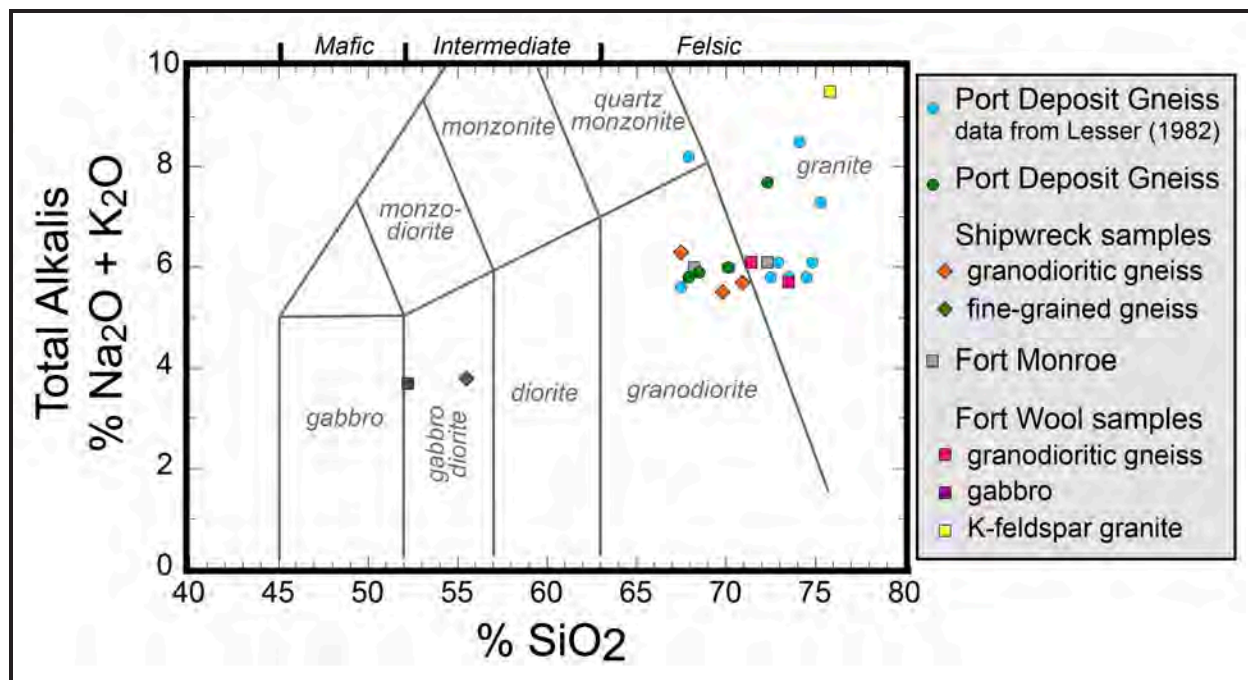
Figure 4.8. Total Alkali-Silica diagram for shipwreck samples, Port Deposit Gneiss, as well as Fort Monroe and Fort Wool samples.

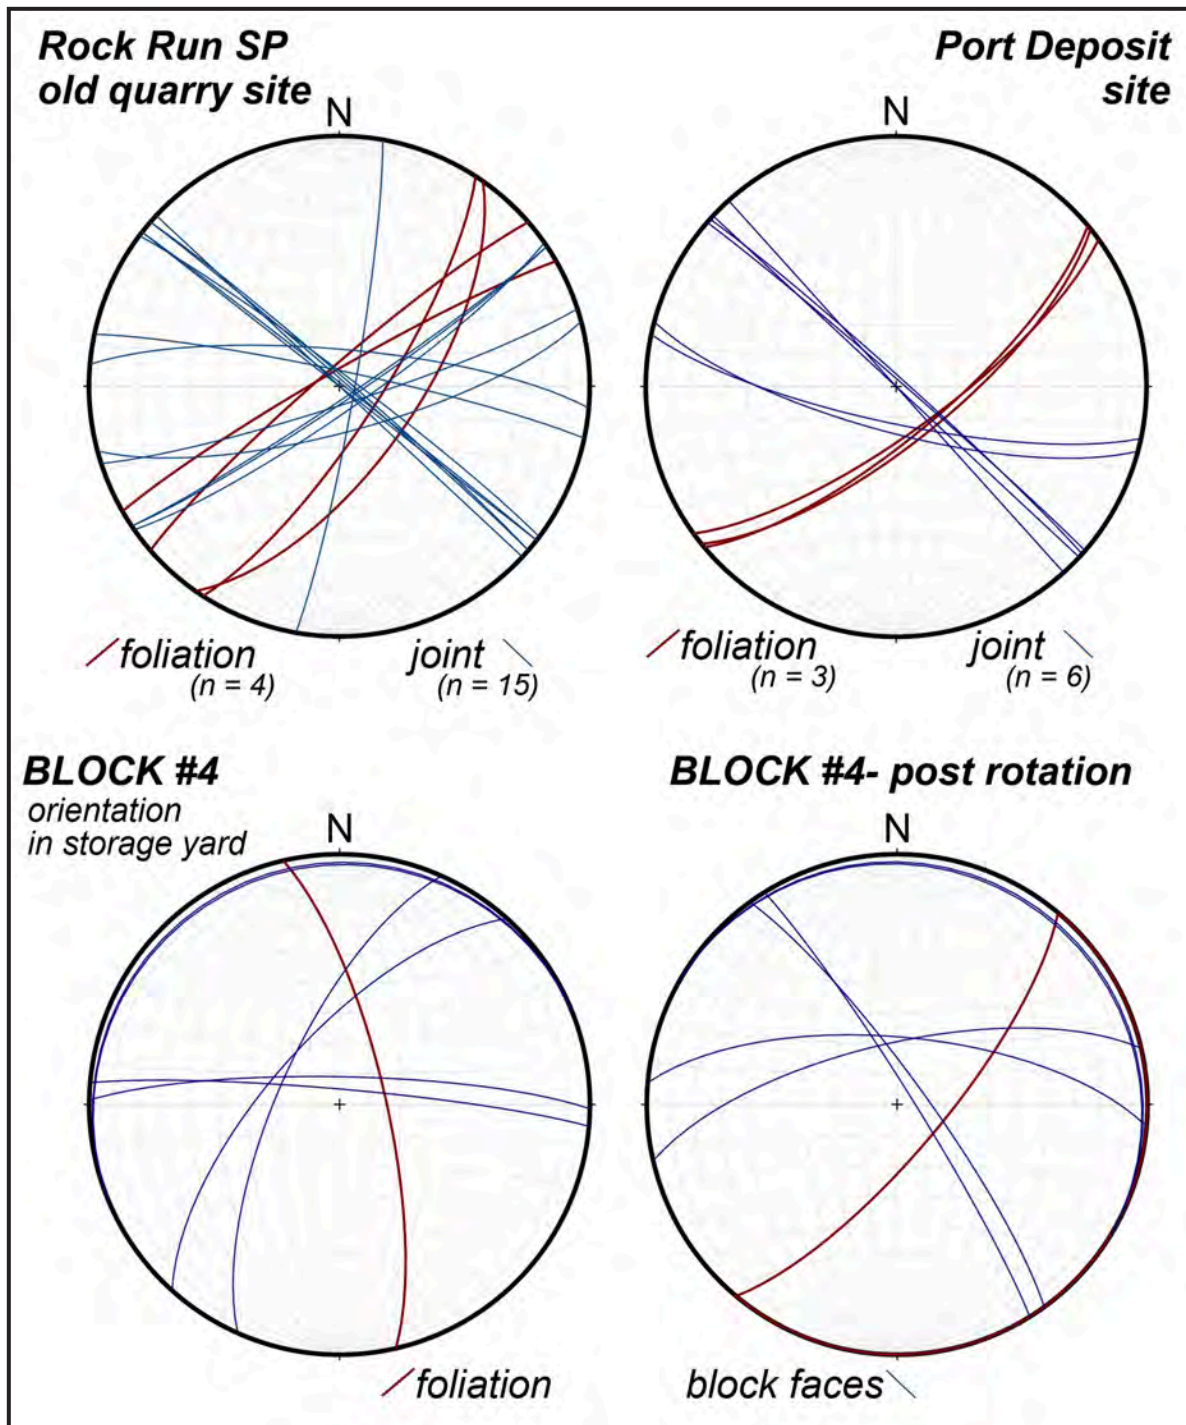
Figure 4.10. Top - stereograms of foliation and joints from two sites in the Port Deposit area. Bottom - stereograms of fabric elements in the storage yard (left) and the orientation of those structures after rotating the foliation back to its orientation in the Port Deposit area. Note the joints align with those in the Port Deposit area.

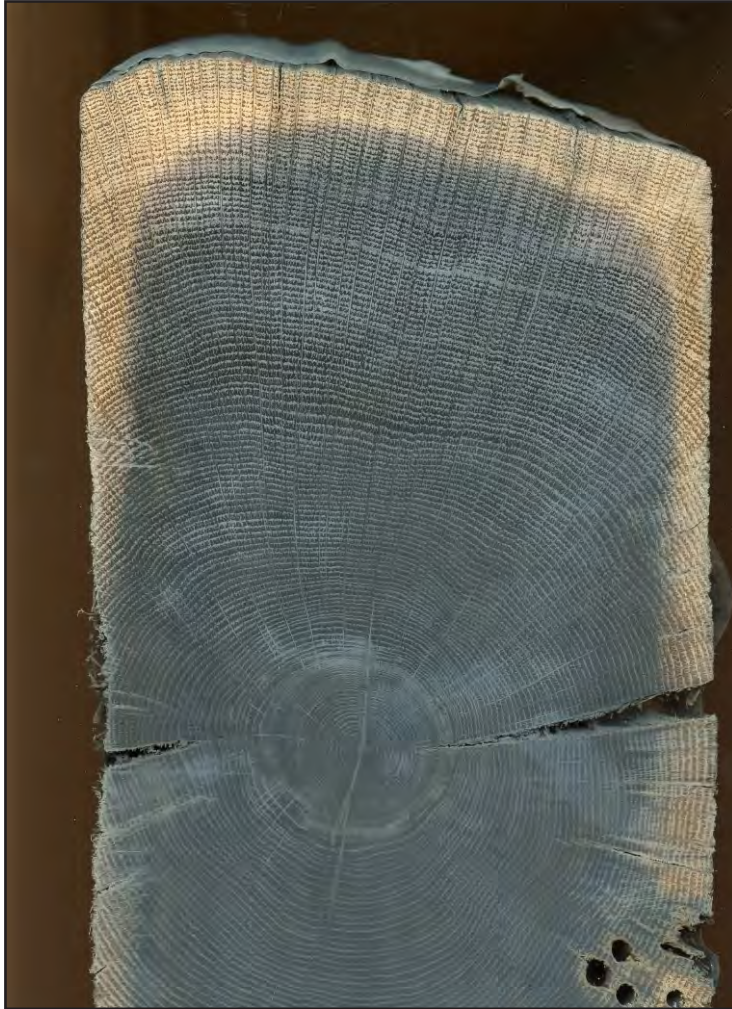
Figure 5.1. Cross-section of the keel timber 1 sample. The dimensions of the portion shown here are 26 x 18.5 cm; the whole sample is 41.5 x 18.5 cm. Note the same rings running along the upper edge, and suggestion of a slightly different ring color of the outer seven rings. The outermost incomplete ring on this sample dates to 1814, but all rings contain tyloses so at least the outer four to six rings are missing. Note the overall increase in rings widths from pith to outer rings, a normal phenomenon of closed-forest tree growth, where rings become larger as the tree is increasingly exposed to sunlight. The darker color in most of the sample is due to age and use in a vessel but may be caused partially by any substance used to waterproof the wood.

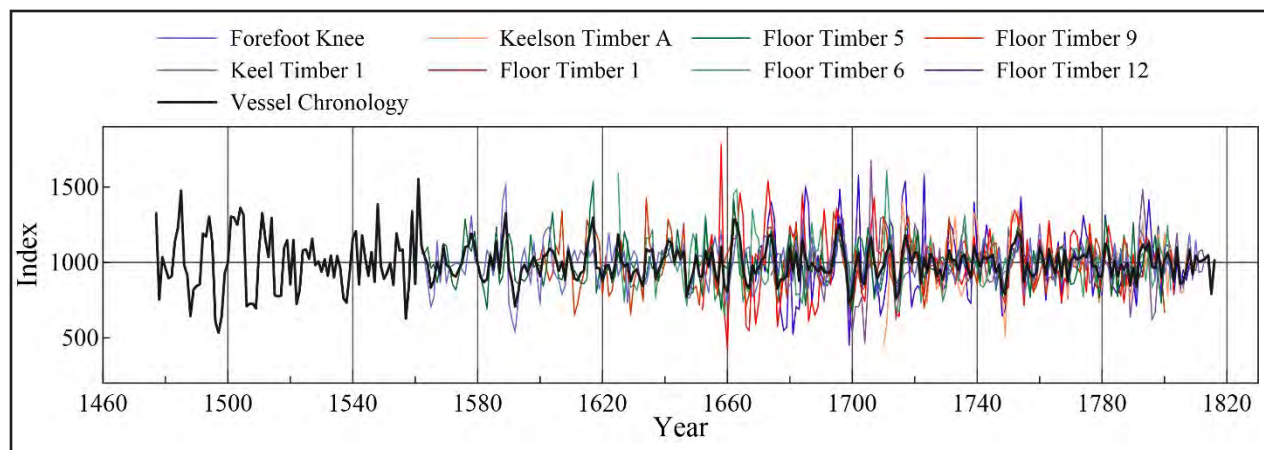
Figure 5.2. The eight relatively dated tree-ring sequences and their average in the Site 44HT0125 vessel chronology. Intercorrelation for the sequences is 0.364 and, while low for that statistic ($-0.45 - 0.55$ is normal), the low values are not uncommon in oaks, especially for different species. The calendar dates of the sequences are explained in the text and Figure 5.3.
