# Tracking Nutrient Pollution Downstream from BMPs

Ashley Heaton  
Department of Geography  
University of Tennessee

Dr. Randy Chambers, Faculty Mentor  
College of William and Mary  
National Science Foundation  
Research Experience for Undergraduates

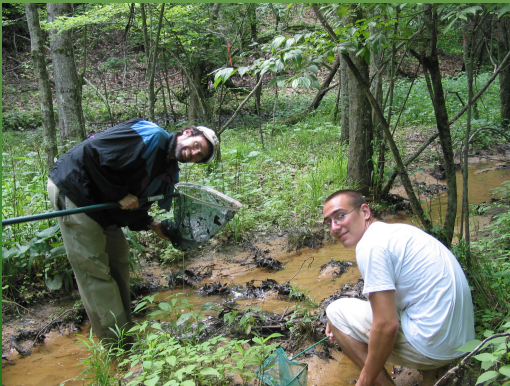
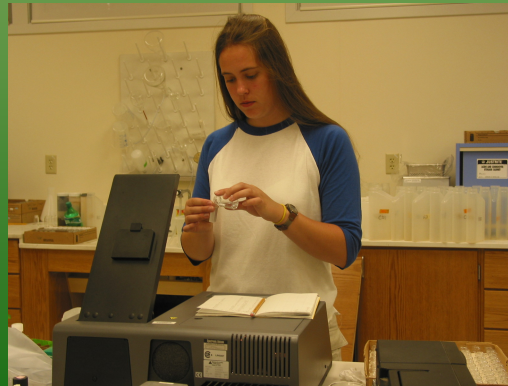
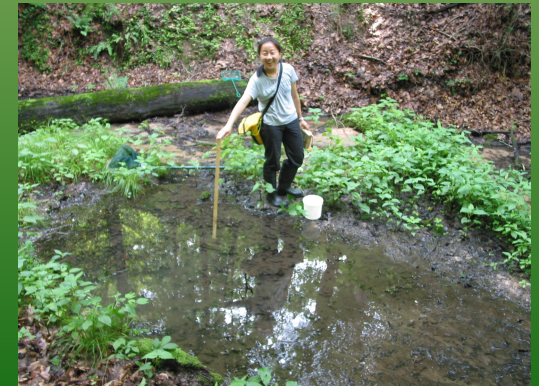
# Sample Sites

- 1. Casey Property Site:** A newly developed watershed with nonfunctional BMP.
- 2. Eastern State Site:** A watershed that has been developed for an extended period of time. Also, there are no significant BMPs within the Eastern State watershed.
- 3. Lowe's Site:** This watershed has been developed for a short amount of time with a functional BMP.
- 4. Paschal's Site:** An undeveloped watershed with a BMP at the headwaters.
