# VEE Geology Research Summer 2002

Sara Bottenfield, Sharon Cardinal,  
Mike Pistorio, John Turcotte

# Purpose of Proposed Studies

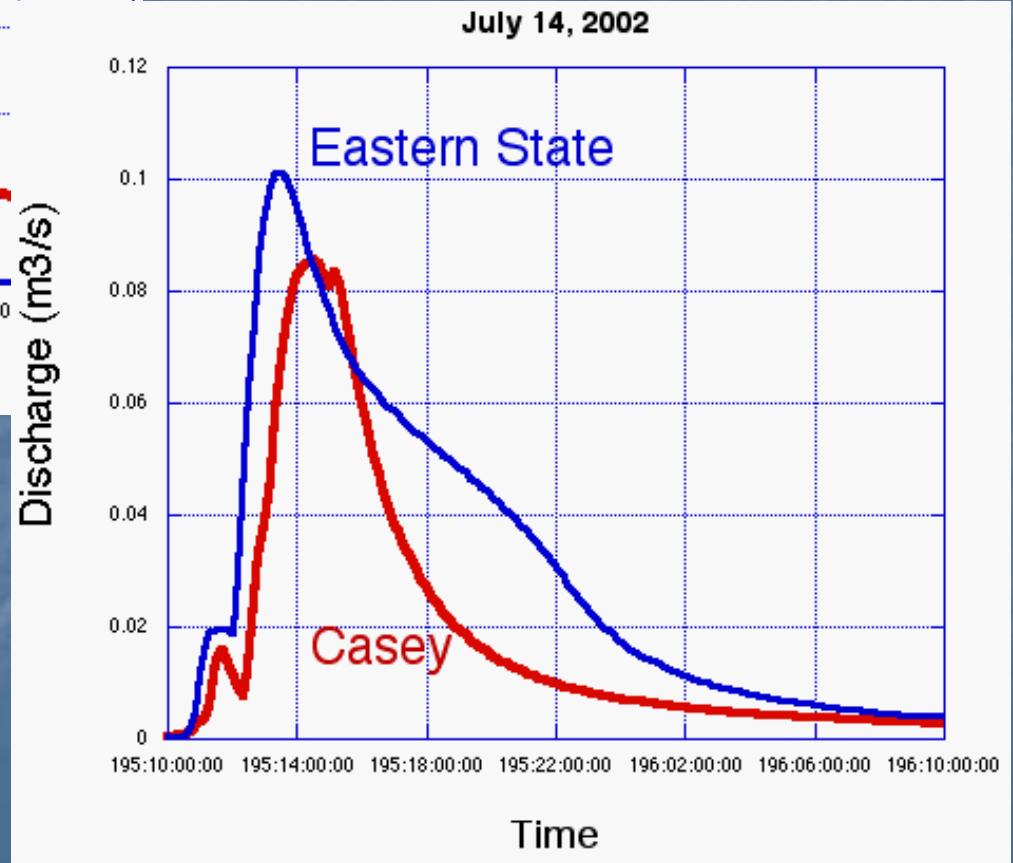
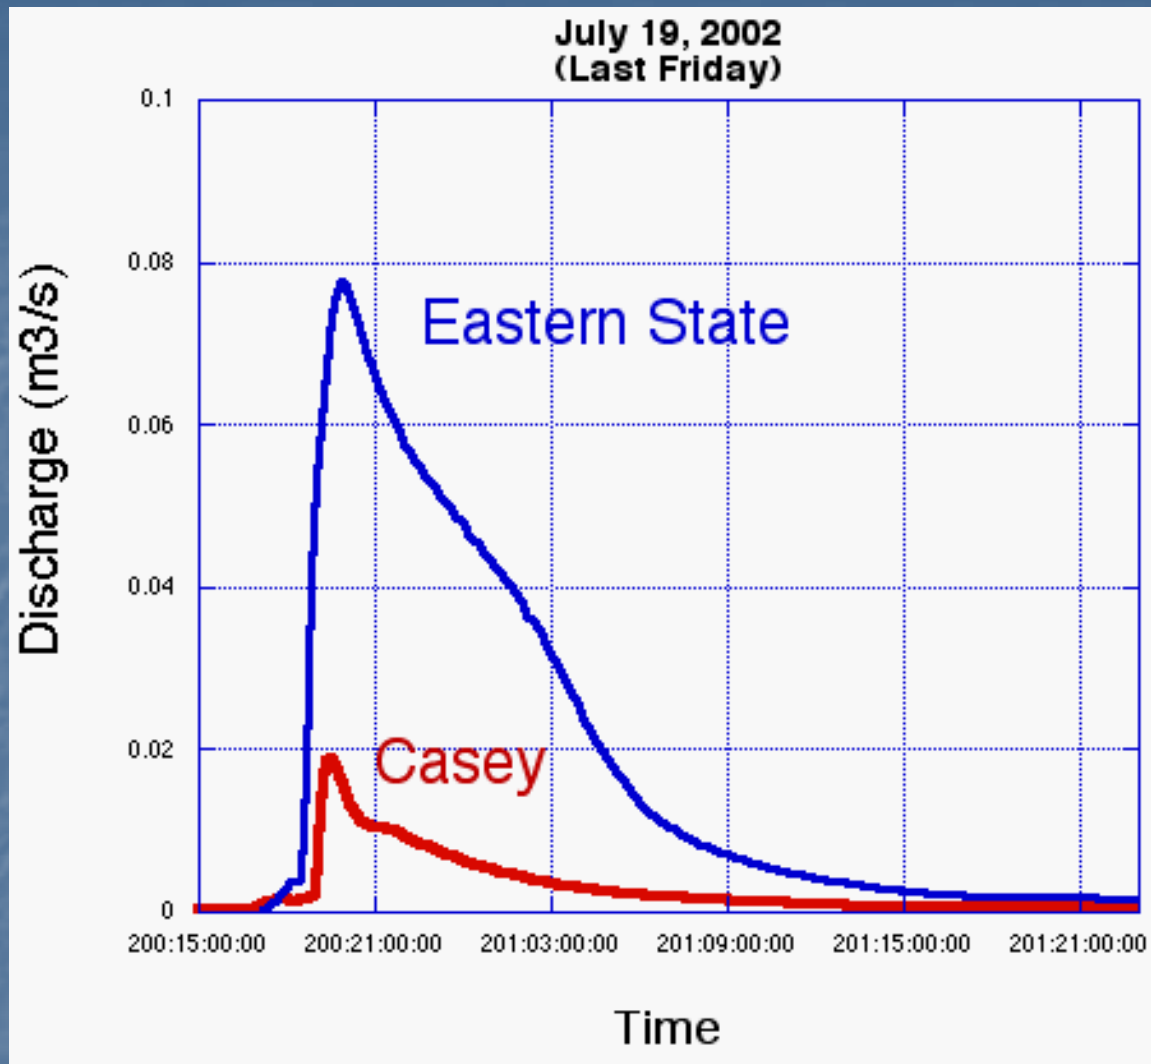
# Discharge Hydrographs

Powhatan  
Watershed

Although equal in watershed area, the more developed Eastern State drainage basin exhibits a larger stormwater discharge hydrograph, relative to Casey.
