KIRSTEN MOFFITT
PAINT ANALYSIS REPORT

**‘DUDLEY DIGGES HOUSE’
524 PRINCE GEORGE STREET
WILLIAMSBURG, VIRGINIA**

NOVEMBER 19, 2017

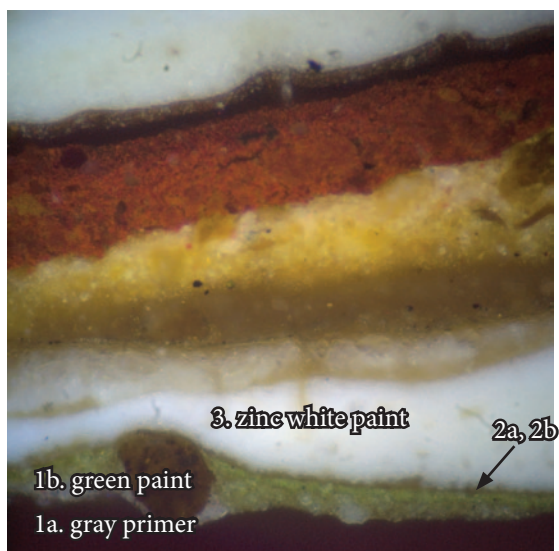
COMPARISON OF SELECT EARLY WOODWORK:**Stair Newel (DD 17), 200x**

This sample from the stair newel post aligns with the earliest paint layers in the house. The earliest layers are shown in detail here, including the first generation gray primer (1a) and green paint (1b). The second generation green paint (2a) and varnish (2b) follow, although they are not as obvious here as they are in other samples. Generation three is a zinc-based paint, which SEM-EDS found to contain lithopone, which could date this layer to the late 19th c. The following tannish, translucent layer (*) was present only in this sample and not elsewhere, so it was not annotated. Generations 5-8 are imitation wood graining and/or dark brownish layers.

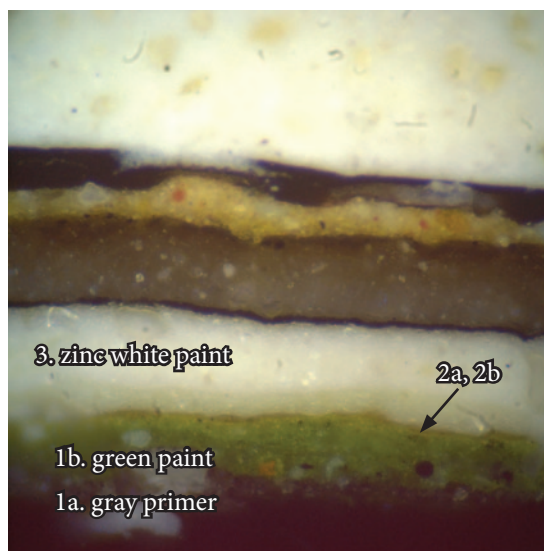
**Door leaf (DD 1), 200x**

The first paint generation on the door leaf is a thin gray primer (1a) and a coarsely ground green paint. This finish was found on several early elements throughout the house (stair tall post, north room east and west window architraves). PLM and SEM-EDS determined that this green paint contains chrome yellow pigment, dating this paint to the early 19th century. In generation two, this green paint was re-applied (2a), and followed by what appears to be a thin layer of varnish (2b). This varnish is dim in UV, suggesting it is an oil-based varnish. This layer is not always visible in all samples.

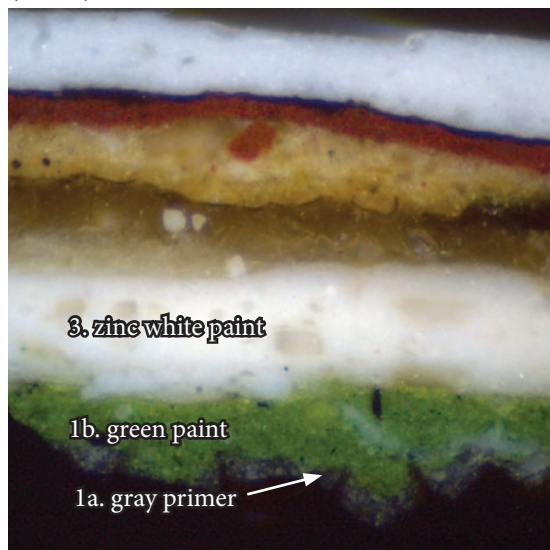
**North room, East window architrave (DD 8), 200x**

The findings suggest that the earliest elements are the east and west window architraves and the upper sash in the east window only. On the architraves, the first paint generation is the thin gray primer (1a) and coarsely ground green paint that was found on several early elements throughout the house (stair tall post,

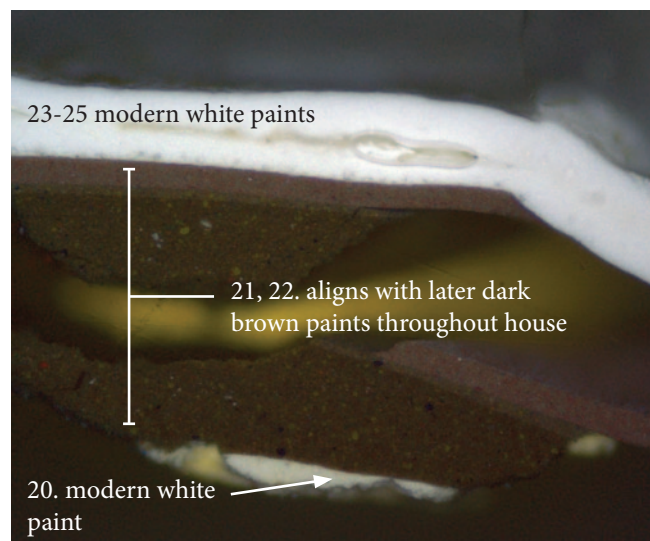
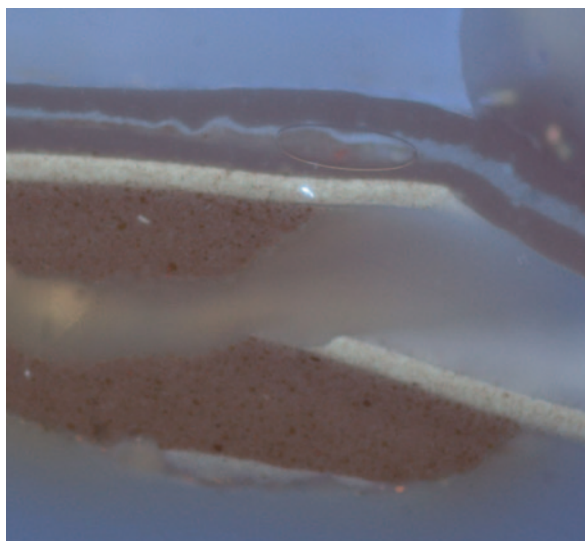
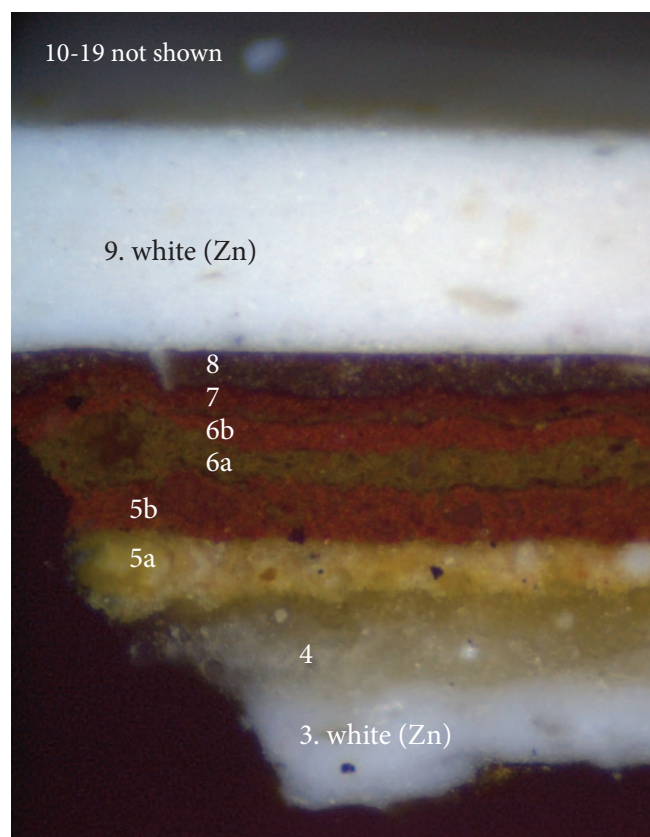
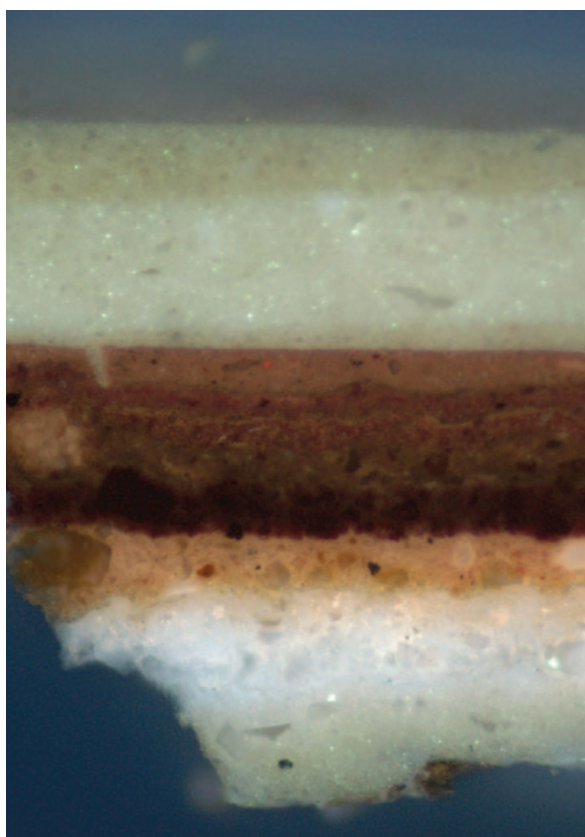
SAMPLE DD 18: STRINGER CAP, LONG FIRST RUN, NORTH FACE 4'2" ABOVE THE FLOOR

DD 18a (bottom, 200x), 18b (top, 100x), visible light

DD 18a (bottom, 200x), 18b (top, 100x), UV light

The extant coatings on the handrail are all finely ground, dimly autofluorescent modern (20th c.) paints that align with generations 21-15 in the rest of the house. Any earlier finishes appear to have been stripped or scraped from the handrail, evidenced by the rough, disrupted surface of the wood substrate underneath.

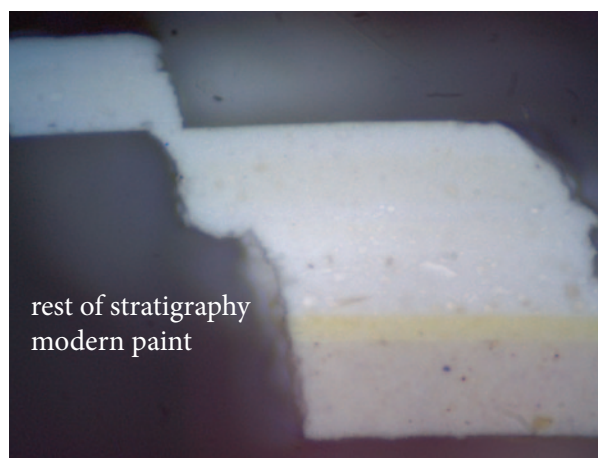
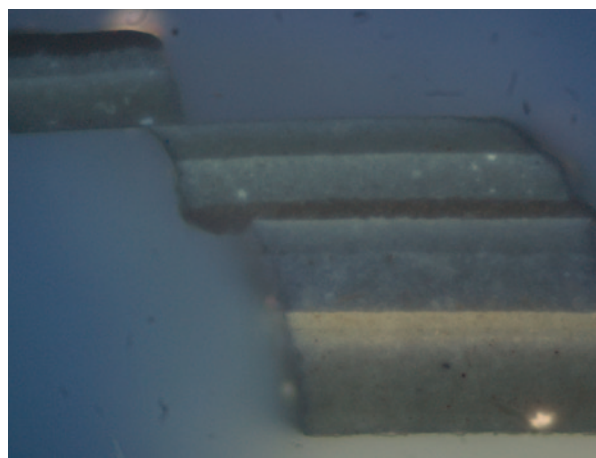
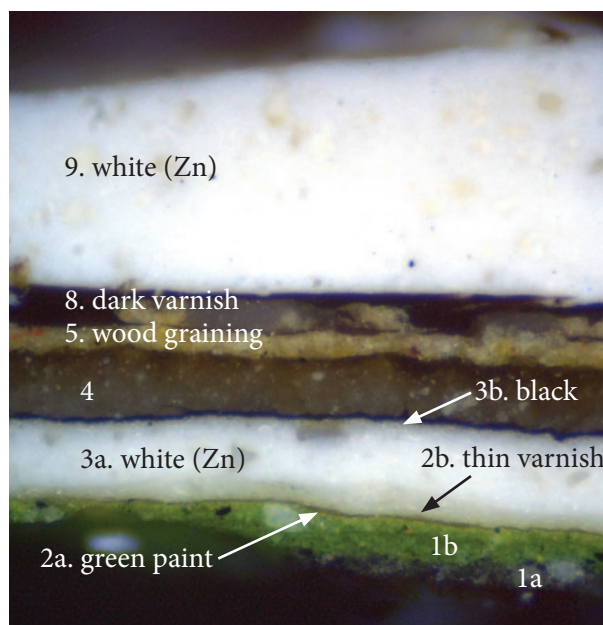
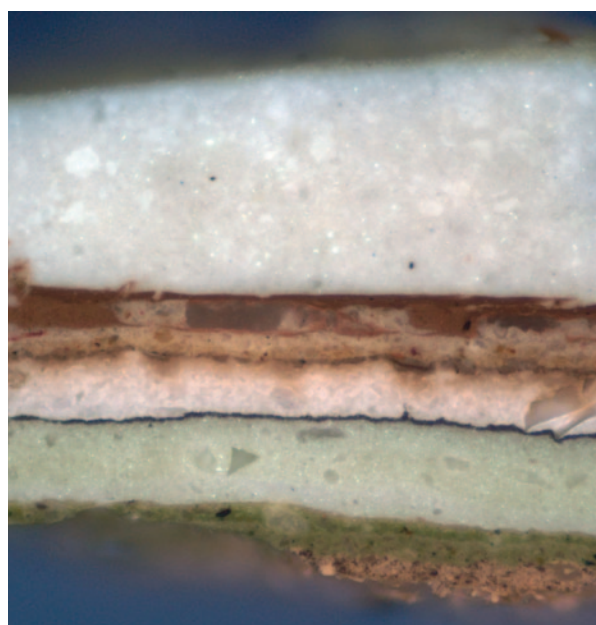
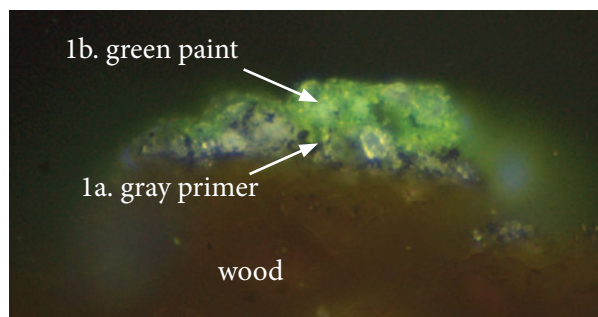
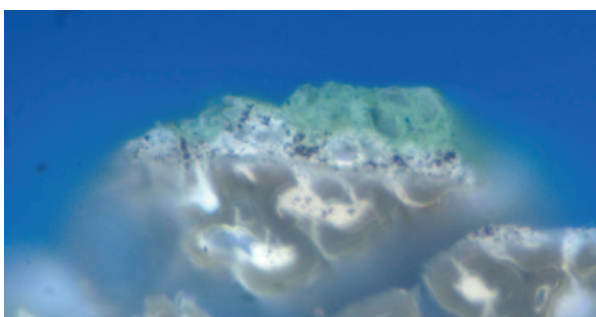
SAMPLE DD 1: FACE OF RE-USED PANEL DOOR, TOP OVOLO OF LOWER-LEFT PANEL, 1" FROM THE UPPER-LEFT CORNER (PERIOD I)

DD 1a (bottom, 400x), 1b (center, 200x), 1c (top, 200x), visible light

DD 1a (bottom, 400x), 1b (center, 200x), 1c (top, 200x), UV light

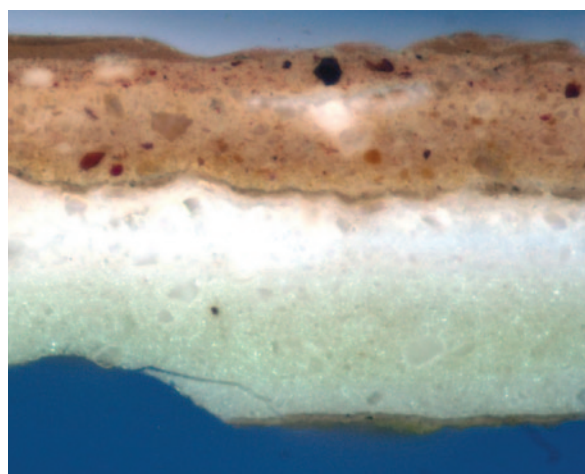
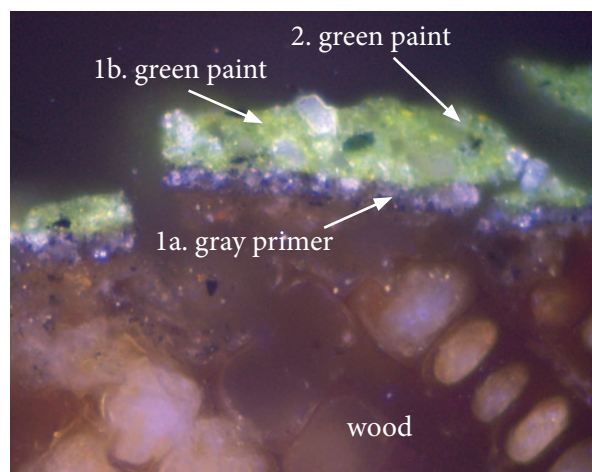
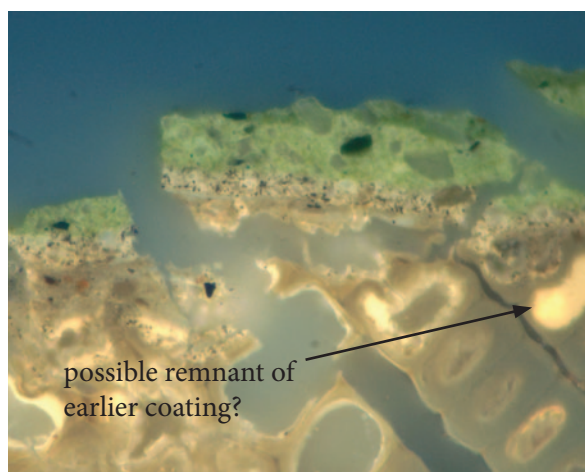
SAMPLE DD 2: SAME FACE OF DOOR, BOTTOM OF LEFT STILE 1/2" FROM THE BOTTOM RAIL, 2" ABOVE FLOOR (PERIOD I)

DD 2a (bottom, 400x), 2b (top, 200x), visible light

DD 2a (bottom, 400x), 2b (top, 200x), UV light

The earliest paint on the door leaf (previous page, and above) is the gray primer (1a) and coarsely ground green paint (1b) found on all of the period 1 elements in the house. There is some pale orange autofluorescent material in the wood cells which could be the remnant of an earlier coating (compare to stair newel, p. x), but this could also be some oil from the first generation paint flowing into the wood cells (a condition commonly observed by the author and confirmed through instrumental analyses).

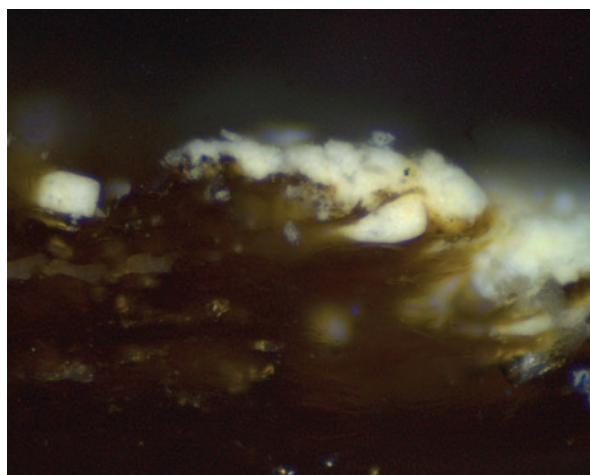
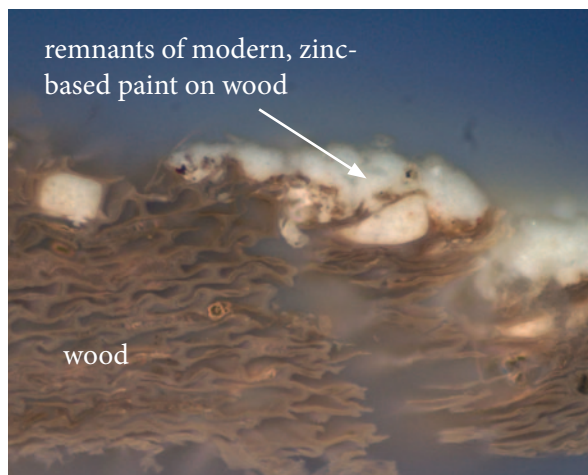
SAMPLE DD 3: GHOST OF AN UPPER HL HINGE AT THE JOINT BETWEEN THE HORIZONTAL AND VERTICAL ARM.

DD 3a (bottom, 200x), 3b (top, 200x), visible light

DD 3a (bottom, 200x), 3b (top, 200x), UV light

Following removal of the hinge, the door was painted with ten layers of finely ground, dimly autofluorescent modern paints (20th c.). This suggests the hinge was removed in the mid-late 20th c.

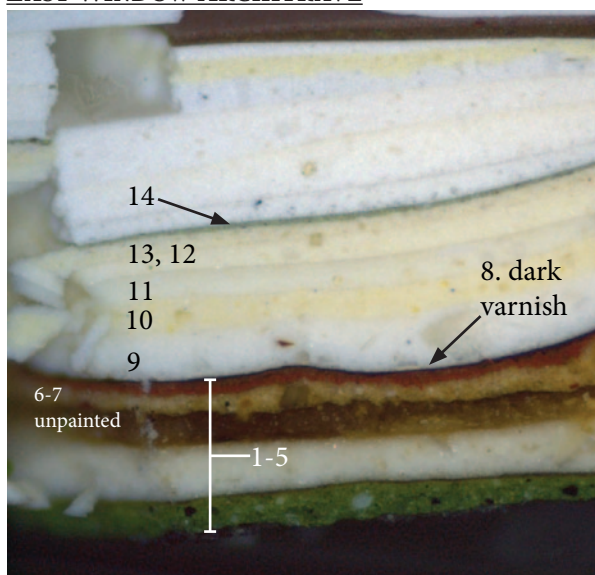
EAST WINDOW ARCHITRAVE

DD 8, visible light, 100x. Wood missing from bottom of sample.

Generation three on the architrave and upper sash is the same white, zinc-based paint found throughout the house. The rest of the paint history on both elements is very similar to that found in the rest of the house.

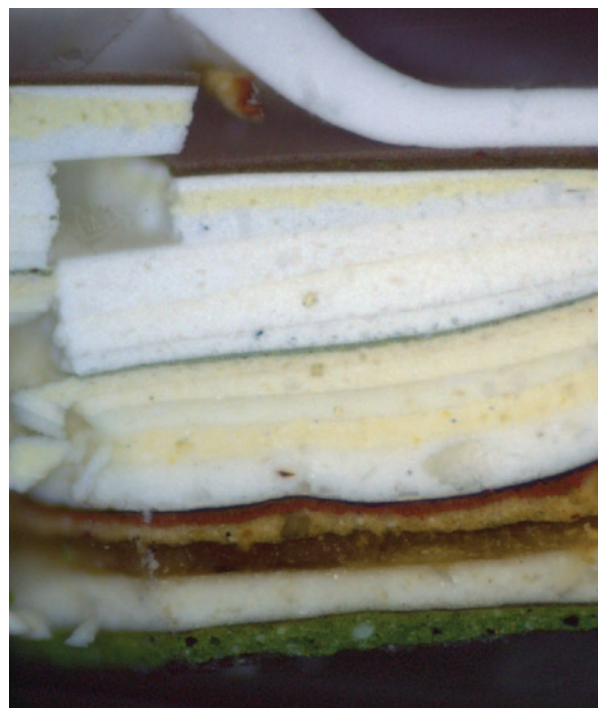
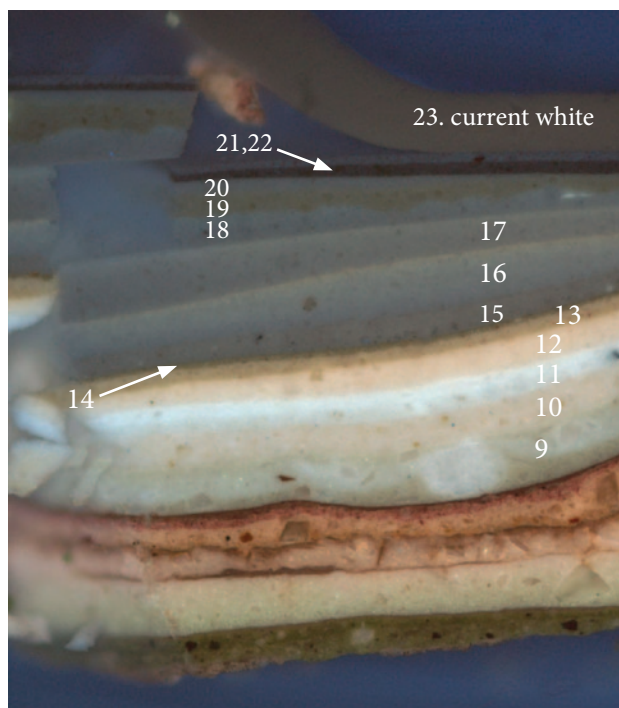
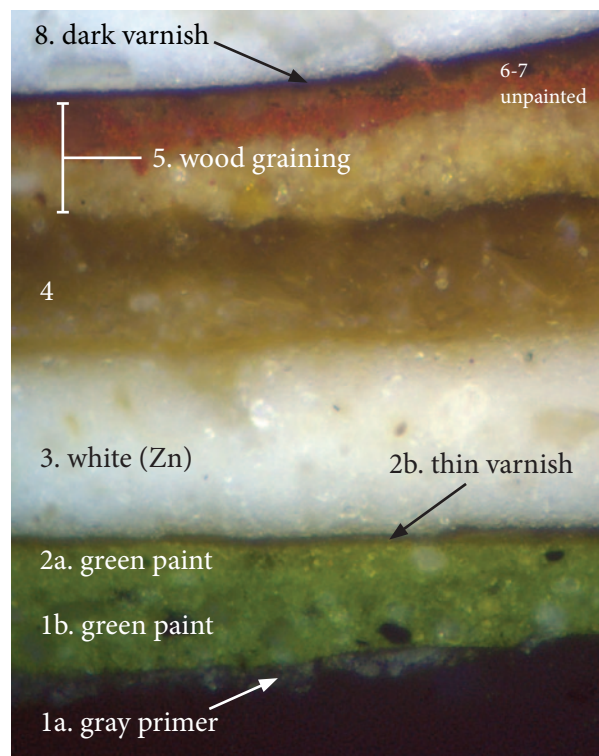
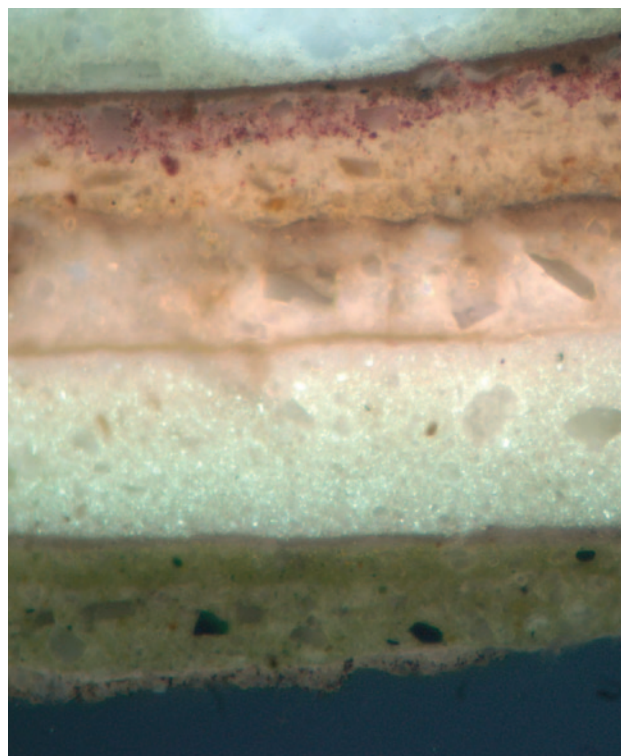
SAMPLE DD 8: EAST WINDOW, NORTH (LEFT) ARCHITRAVE, ON BEAD 2'2" ABOVE SILL (PERIOD II)

DD 8 (bottom, 400x), top (100x), visible light

DD 8 (bottom, 400x), top (100x), UV light

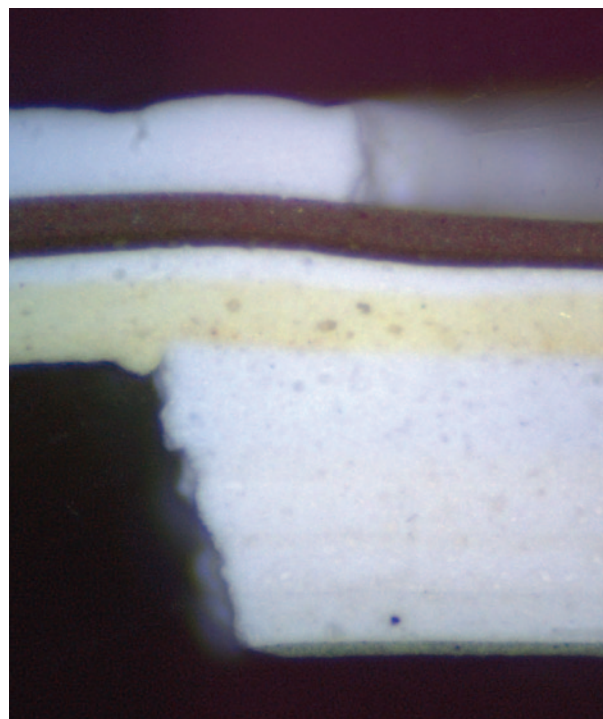
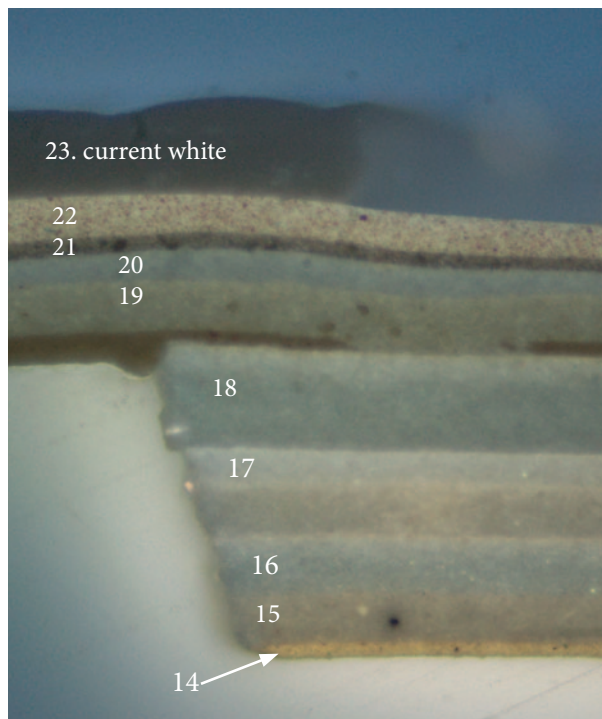
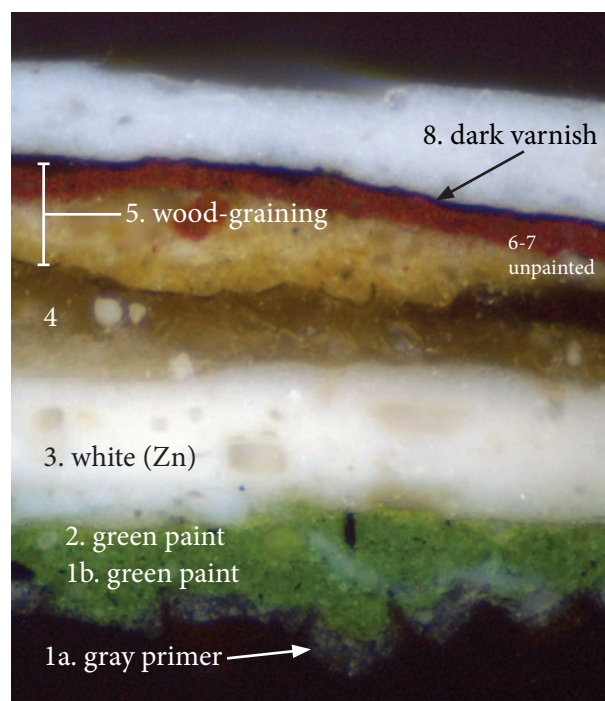
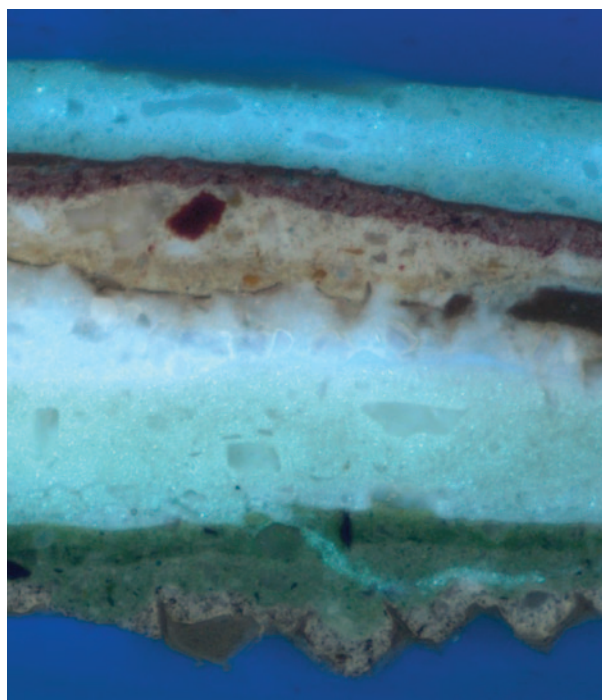
SAMPLE DD 4: WEST WINDOW, CONVEX SURFACE OF NORTH (RIGHT) CYMA BACKBAND, 2' BELOW THE UPPER CORNER (PERIOD II)

DD 4a (bottom, 400x), 4b (top, 200x), visible light

DD 4a (bottom, 400x), 4b (top, 200x), UV light

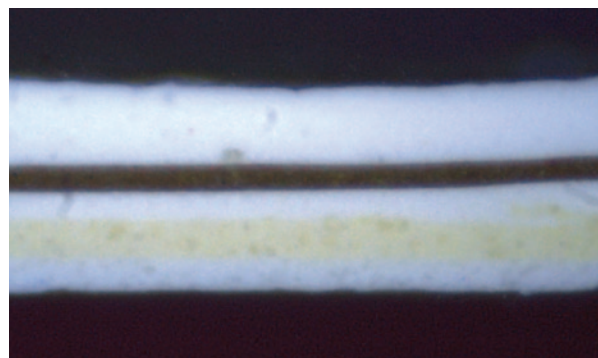
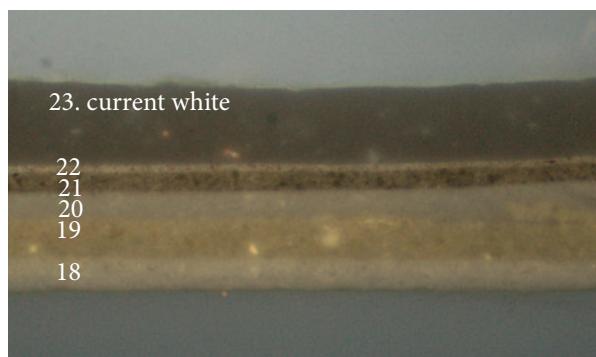
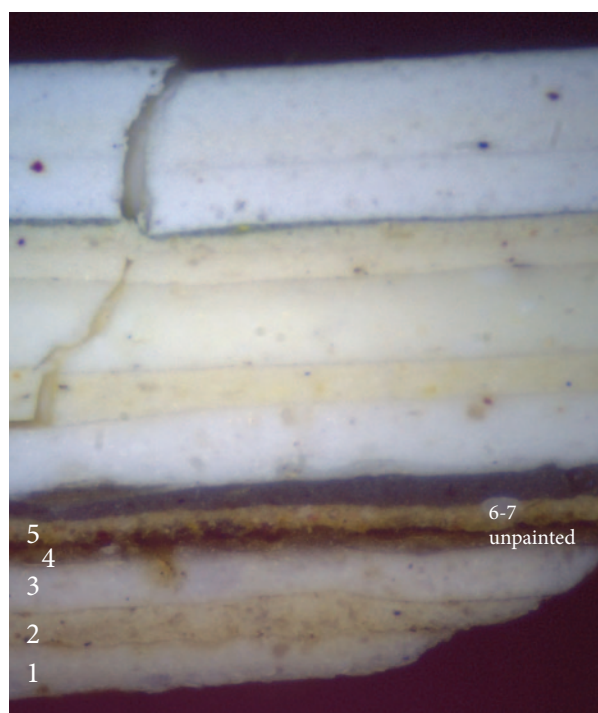
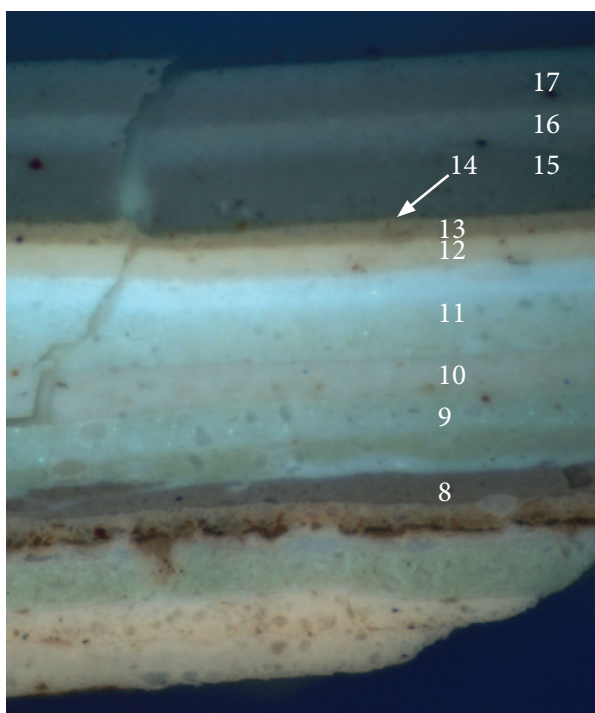
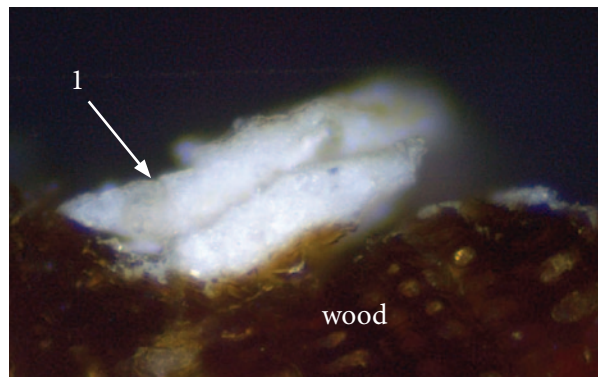
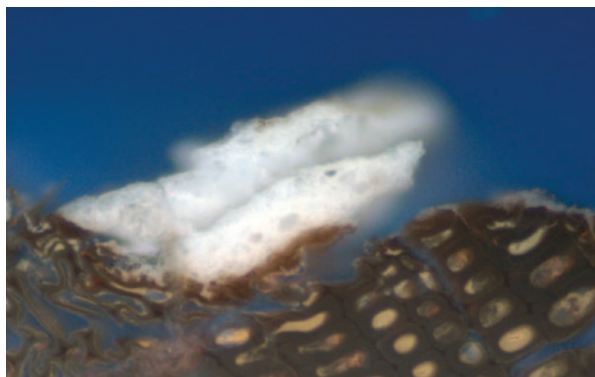
SAMPLE DD 7: EAST WINDOW, UPPER SASH, NORTH (LEFT) STILE, 1'4" BELOW RAIL

DD 7a (bottom, 200x), 7b (center 200x), 7c (top, 200x), visible light

DD 7a (bottom, 200x), 7b (center 200x), 7c (top, 200x), UV light

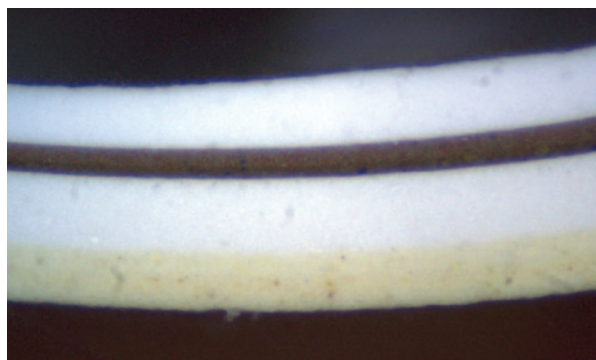
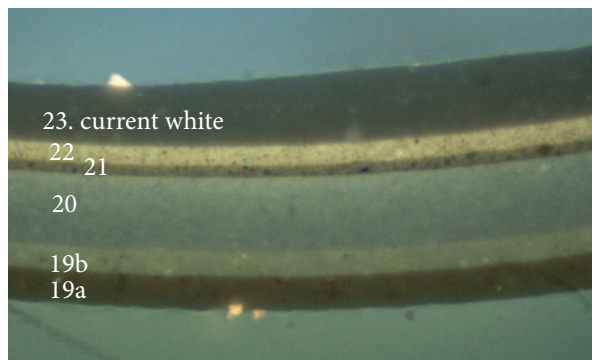
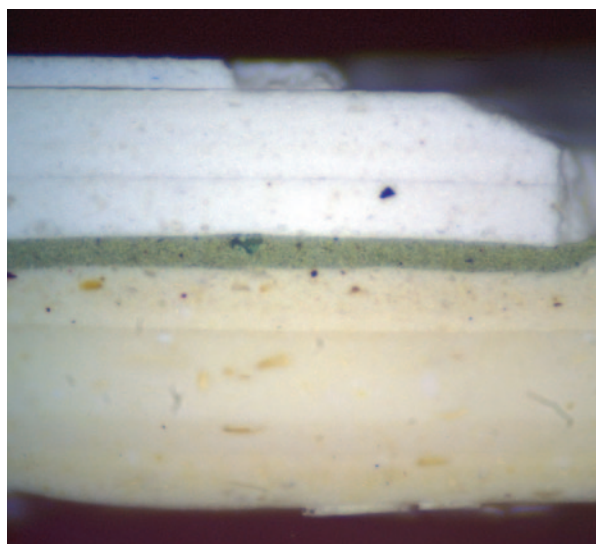
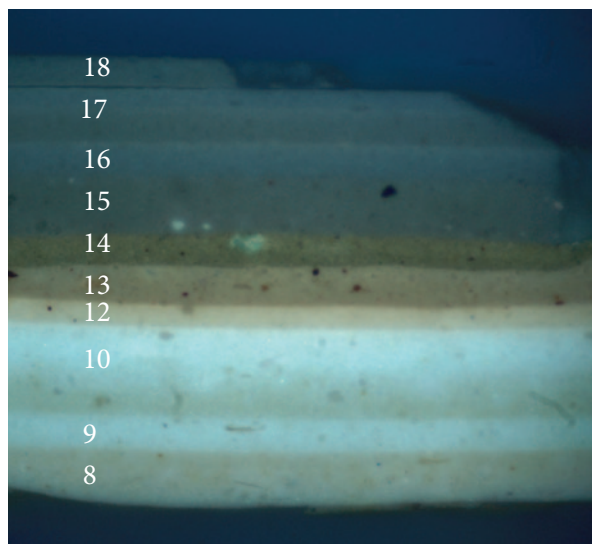
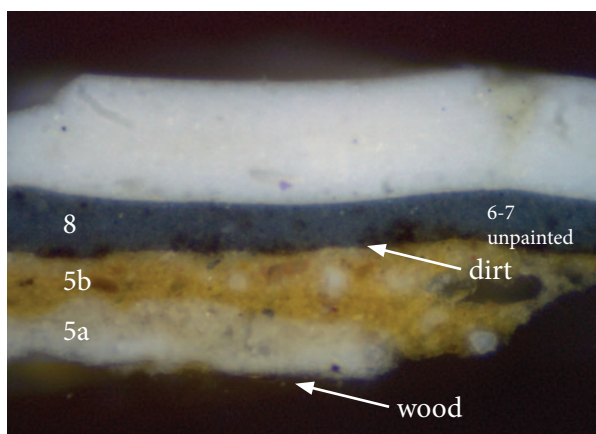
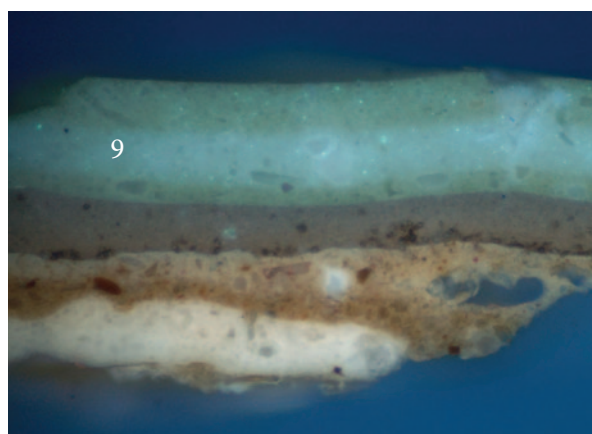
SAMPLE DD 5: WEST WINDOW, LOWER 2ND PERIOD SASH, SOUTH (LEFT) STILE, FACE, 1' BELOW TOP RAIL

DD 5a (bottom, 200x), 5b (center 200x), 5c (top, 200x), visible light

DD 5a (bottom, 200x), 5b (center 200x), 5c (top, 200x), UV light

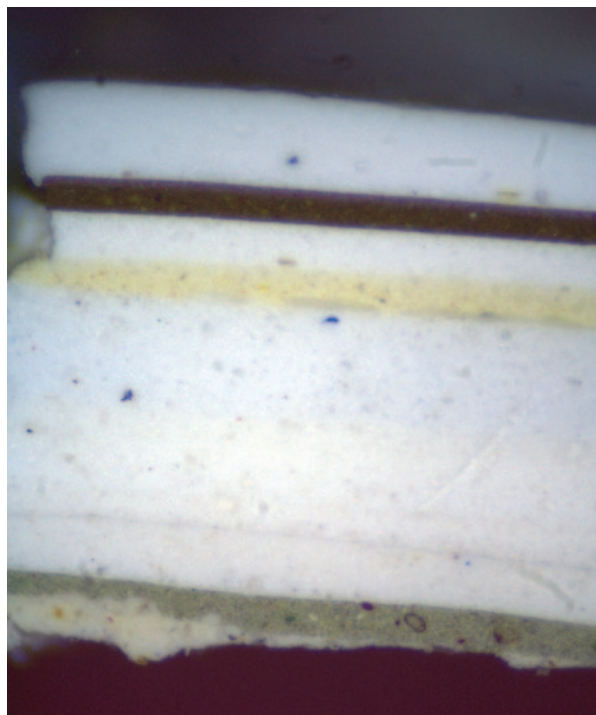
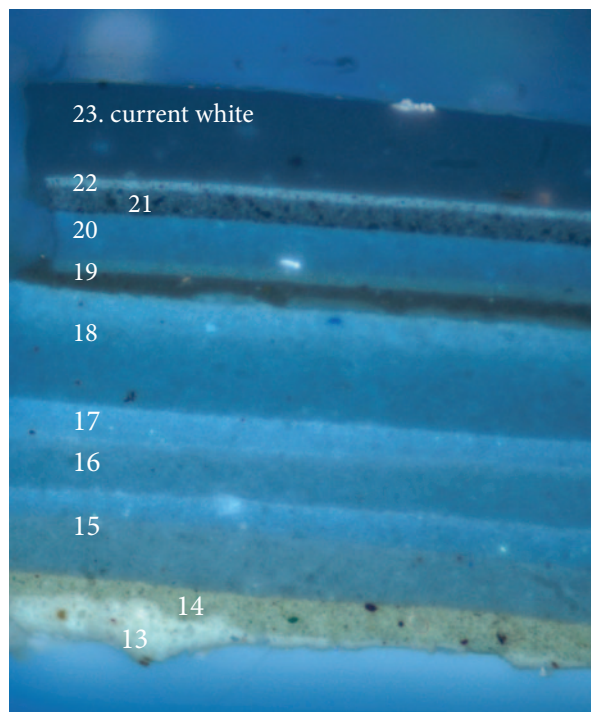
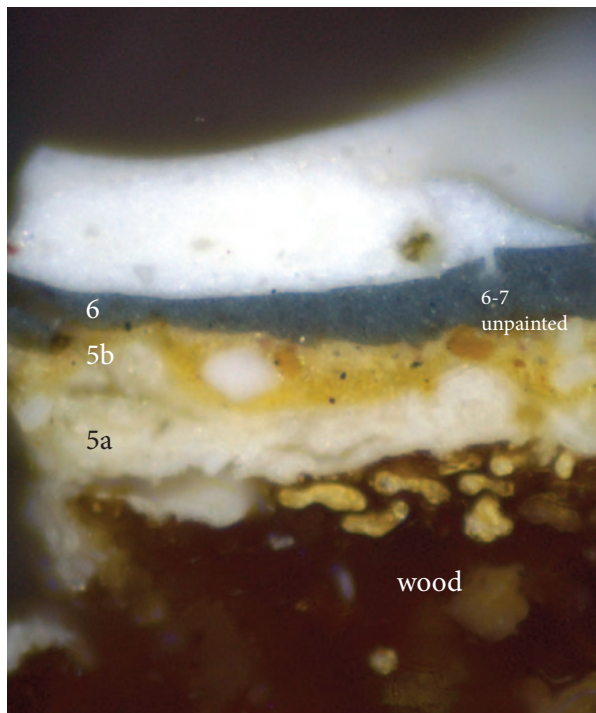
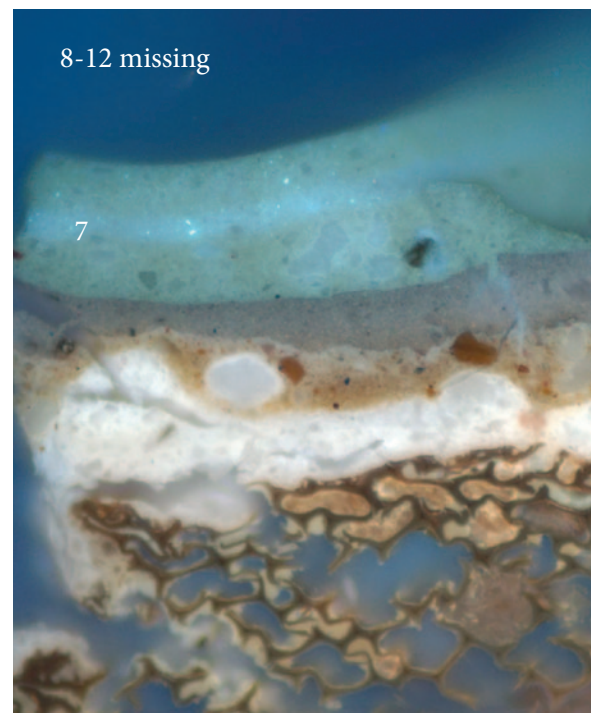
SAMPLE DD 6: WEST WINDOW, UPPER SASH, SOUTH (LEFT) STILE, FACE NEXT TO OVOLO 1'6" BELOW TOP RAIL

DD 6a (bottom, 200x), 6b (top 200x), visible light

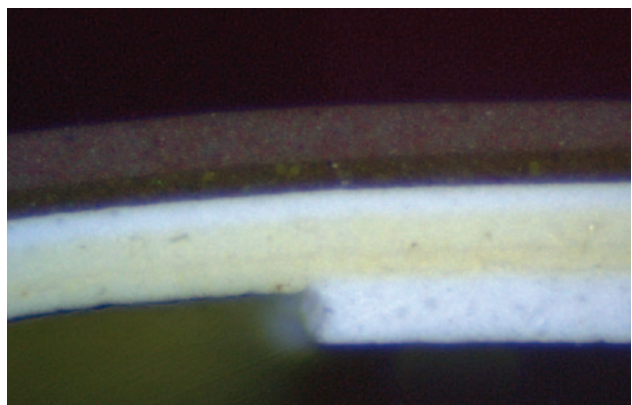
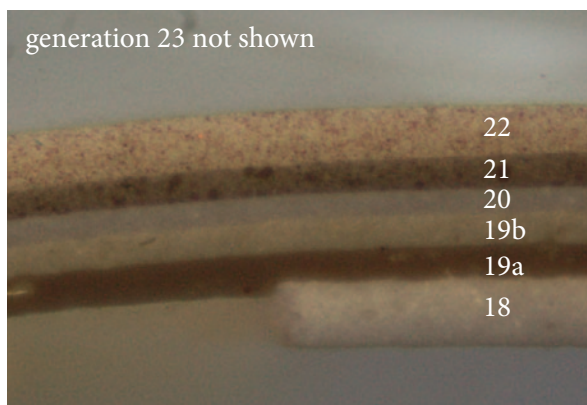
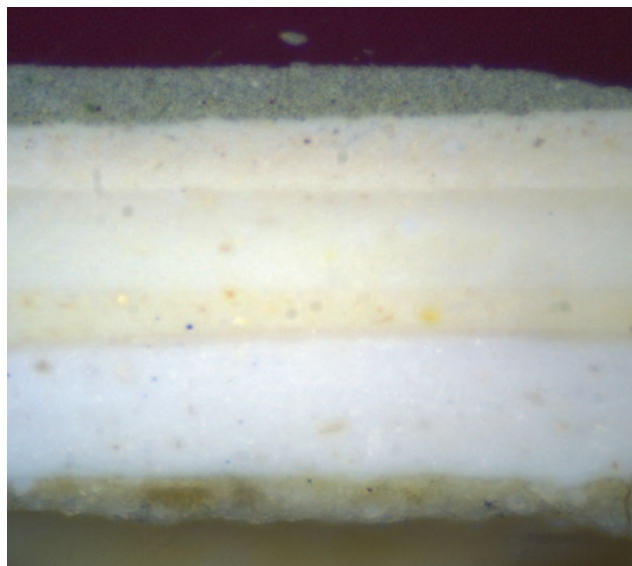
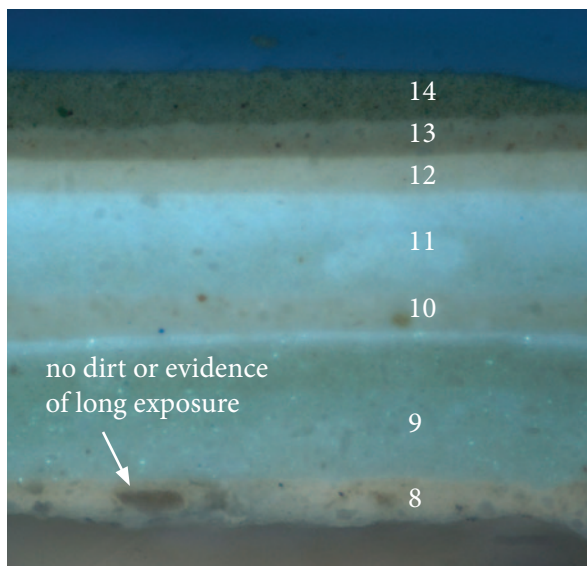
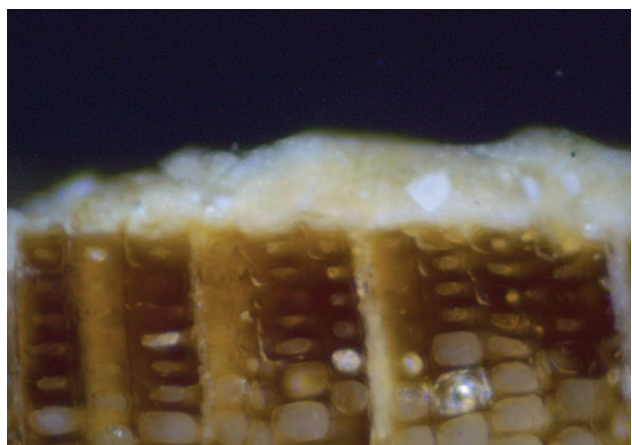
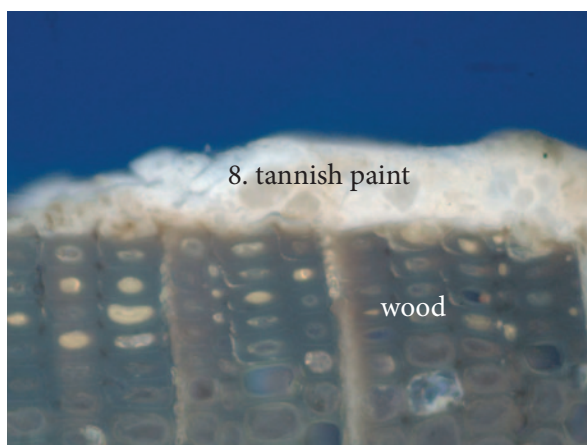
SAMPLE DD 12: MANTEL, UPPER LEFT CORNER OF FASCIA BOARD ABOVE HEARTH

The sample from the mantel contained mostly modern (late 19th - 20th c.) paints that align with generations 9-22 on the rest of the woodwork (see comparison below). However, the earliest generation on the mantel appears to be a hand-ground tan-colored paint not seen elsewhere. This is not unusual, since mantels were often painted differently from the rest of the woodwork. The alignment suggests it could date to generation eight, although it could be even earlier. However, the lack of dirt or wear on its surface suggests the tan paint was not exposed for a significant amount of time. While the paint stratigraphy confirms the mantel is later (which was expected), there is not enough evidence to confidently place its installation within the context of the house.

DD 12a (bottom, 200x), 12b (center, 200x), 12c (top, 200x), visible light

DD 12a (bottom, 200x), 12b (center, 200x), 12c (top, 200x), UV light

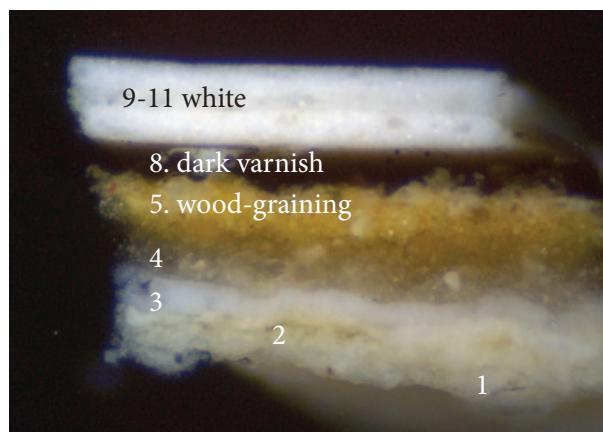
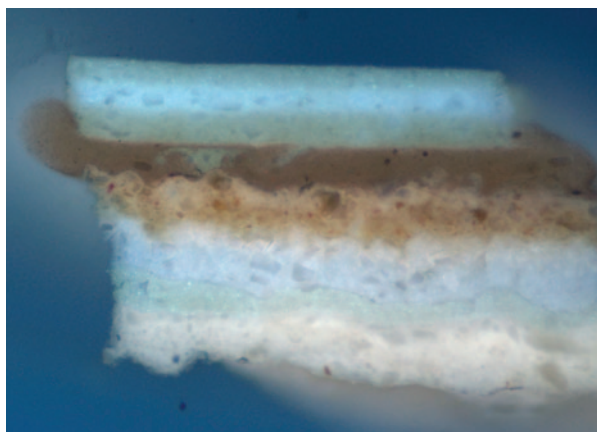
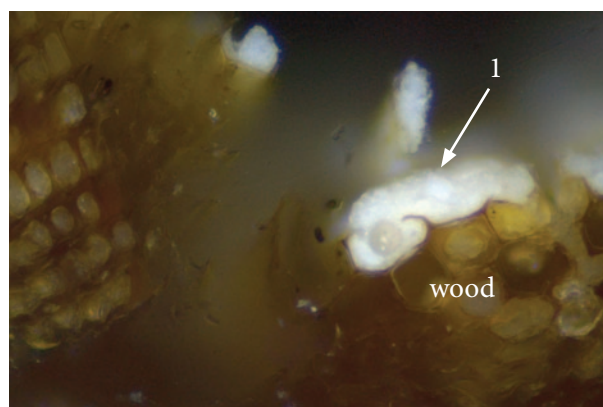
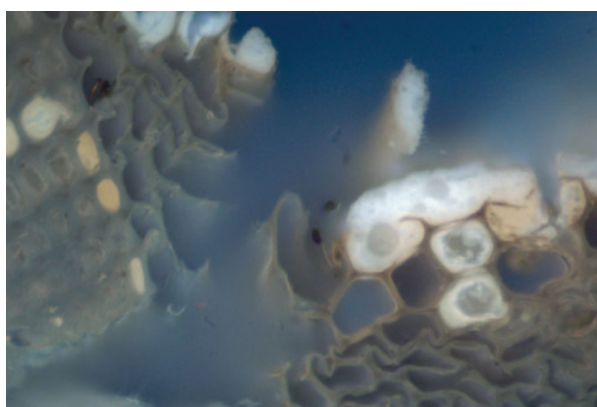
SAMPLE DD 16: EAST WINDOW, UPPER SASH, NORTH (LEFT) STILE, 1'2" BELOW TOP RAIL

DD 16a (bottom, 200x), 16b (center, 200x), 16c (top, 200x), visible light

DD 16a (bottom, 200x), 16b (center, 200x), 16c (top, 200x), UV light

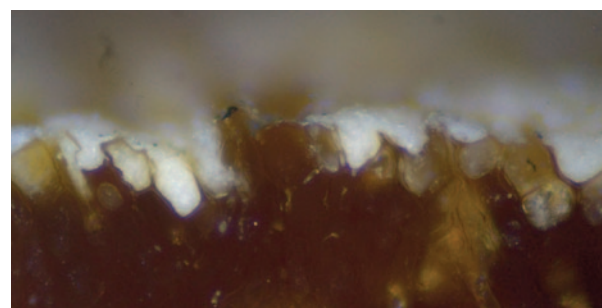
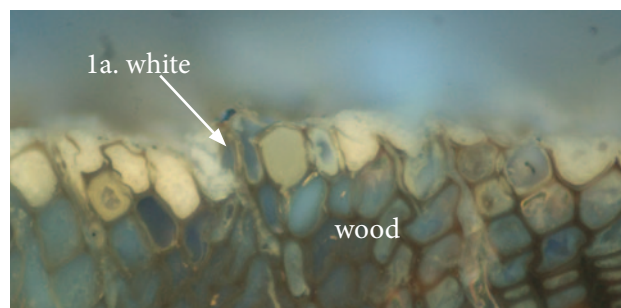
SAMPLE DD 14: MANTEL, RECESSED FACE OF EAST (LEFT) PILASTER AT UPPER-LEFT CORNER

DD 14a (bottom, 200x), 14b (center, 200x), 14d (top, 100x), visible light

DD 14a (bottom, 200x), 14b (center, 200x), 14d (top, 100x), UV light

This mantel contains a number of early paints that are unique to this element. The first generation could be a multi-layered decorative finish, consisting of a white, opaque base coat (1a), a tannish, translucent layer (1b), a dark brown ish-red layer with some deep red pigments (1c), and a resinous varnish (1d). This varnish is deeply cracked and disrupted suggesting a long period of exposure.

Generation five is the same wood-graining finish found on many elements in the house.

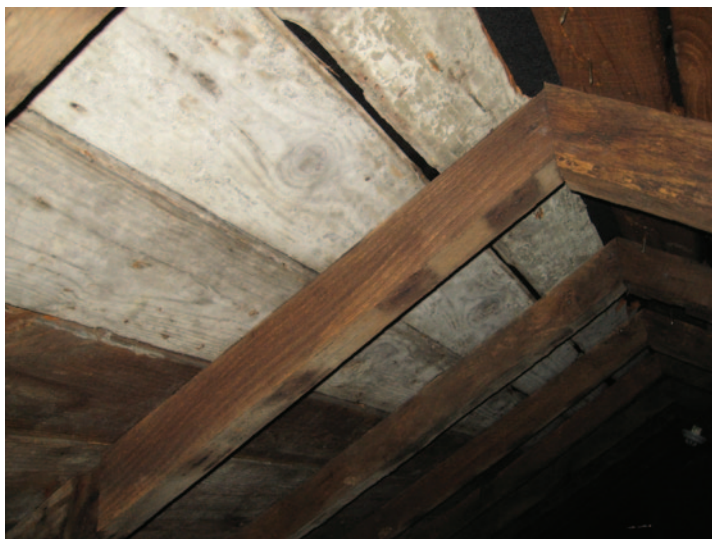
*Digges House, attic*

The HSR report mentions “evidence of whitewashing” (p. 21) on some of the early attic rafters, and suggests that this could indicate that the attic was an occupied space. During the *in-situ* examination, the white material on the boards was noted to look more like mortar than limewash (Chappell sample memo, Oct. 2017). Chappell believes these boards could have been re-used from a construction site.

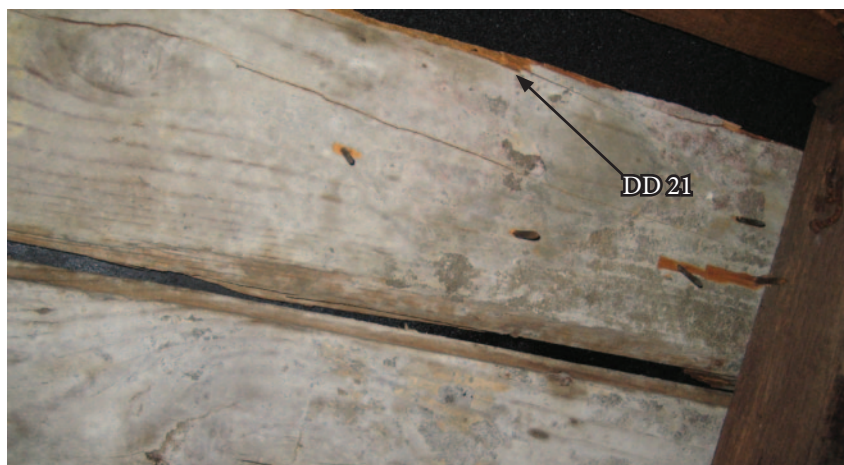
ATTIC - SAMPLE LOCATION IMAGES

Sample	Description	Results
DD 21	Sample from underside of board between 10th and 11th rafters, counting from the north end, top board on west slope, taken from the edges	p. 44

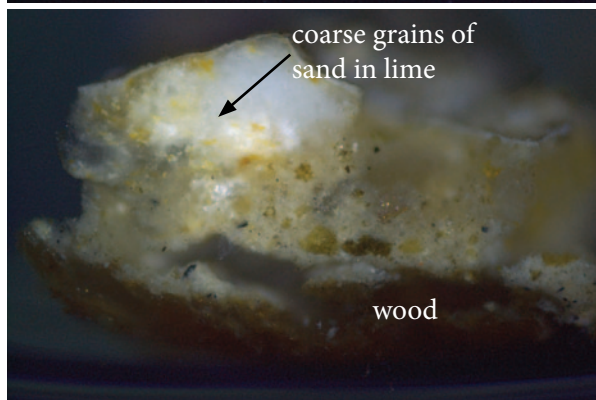
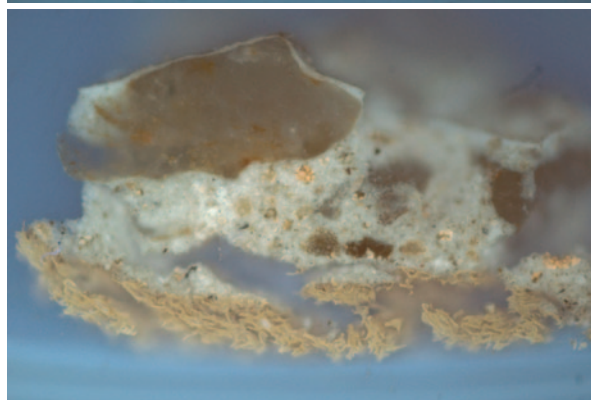
SAMPLE DD 21: SAMPLE FROM UNDERSIDE OF BOARD BETWEEN 10TH AND 11TH RAFTERS, COUNTING FROM THE NORTH END, TOP BOARD ON WEST SLOPE, TAKEN FROM THE EDGES

The results found that the material on the attic boards does appear to be a mortar, rather than a limewash. There is a thick, single layer of what appears to be a lime-based coating that contains a good deal of sandy aggregate. This is very unlike a limewash, which is typically very thin and contains no aggregate. The purpose of this mortar-like material on the surface seems to confirm that these boards were re-used from a construction site, possibly as a scaffolding platform.

DD 21a (bottom, 100x), 21b (top, 100x), visible light

DD 21a (bottom, 100x), 21b (top, 100x), UV light
