**A PRESERVATION PLAN FOR THE
MATTHEW JONES HOUSE
FORT EUSTIS, VIRGINIA**

Technical Report Series No. 3

January 17, 1991

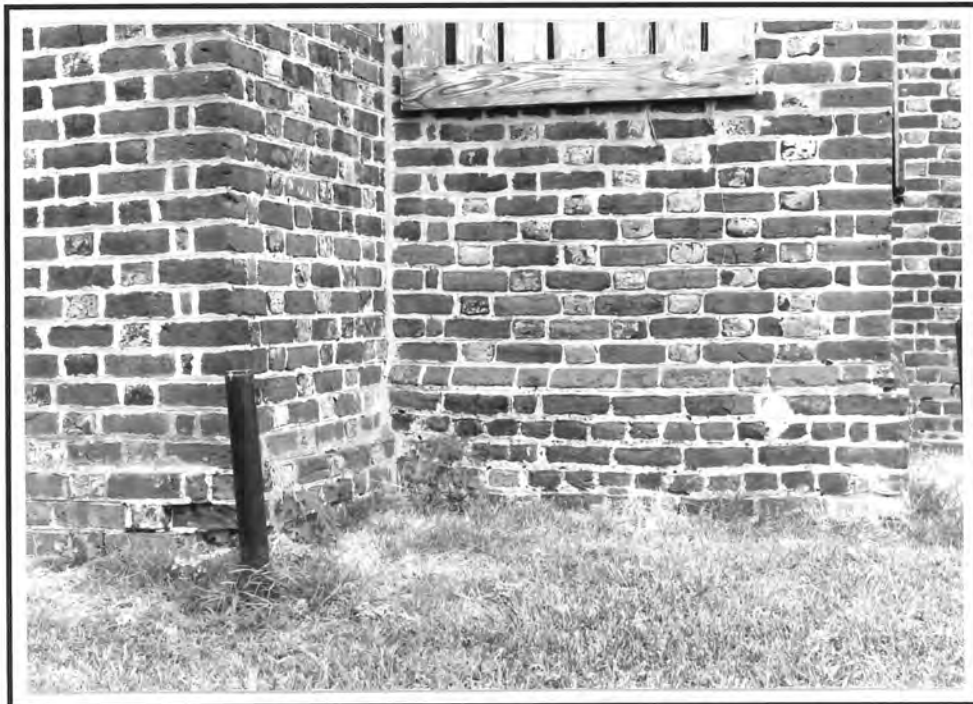
Figure 27. Matthew Jones House, detail of water table at juncture of chimney and west gable.

The Period II brickwork is beautifully executed and has survived well over the years. The water table is laid in English bond with random glazing, while the walls above were erected in Flemish bond using all glazed headers (see Figure 27). This includes a glazed-header course just below the bargeboards on all three gables. Bright red rubbed bricks were used on all exterior corners above the water table, including the shed. Only the windows on the porch tower, the two windows on the front facade of the main block, the two windows on the east gable, and the front door have rubbed brick jambs and arches. The semicircular arch over the front door was rebuilt in this century, following the original curve. The jack arches over the front windows have gauged and rubbed bricks laid with narrow, bright white joints. None of the arches on the rear wall or shed are currently visible. A belt course of gauged and rubbed bricks was used on the tower, the only two-story section of the house until the late nineteenth century.

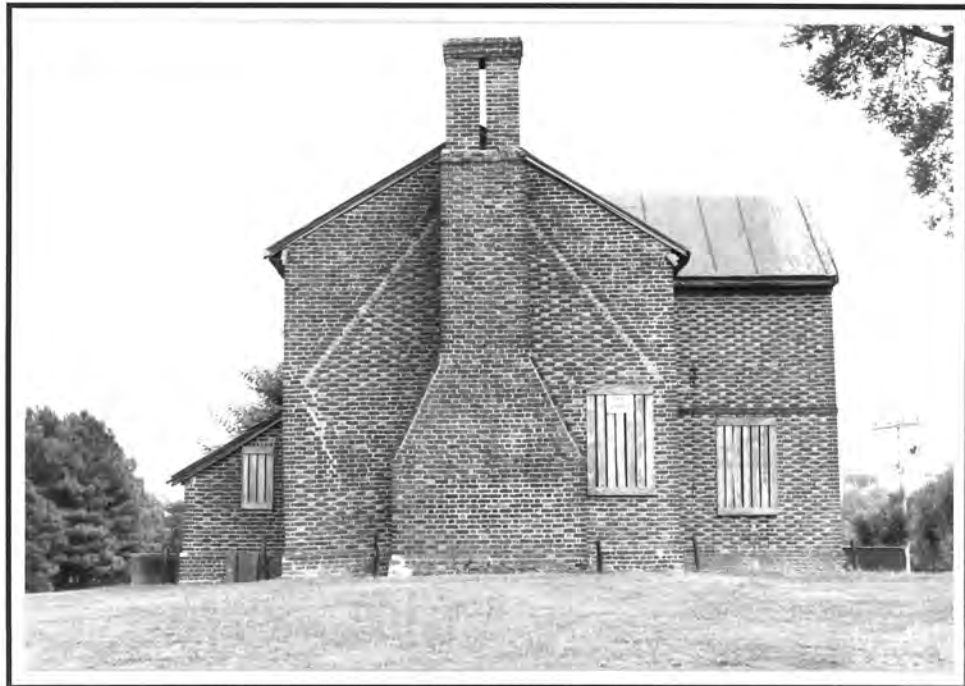
Figure 34. Matthew Jones House, west gable showing original chimney, 1730 brick walls, porch tower, and rear shed. The main block of the house was raised to two stories and the chimney stack extended in 1893.

When raising the exterior walls to two stories, the new brickwork was laid in seven-course American bond. The 1730 all-glazed-header, Flemish bond brickwork is still quite evident below the strikingly different 1893 work (see Figure 34). Equally as odd to the gable elevations is the manner in which the original chimney stacks were lengthened. The old stubby stacks, complete with what seems to be their original caps, were lengthened by adding twin stacks on top of each chimney.

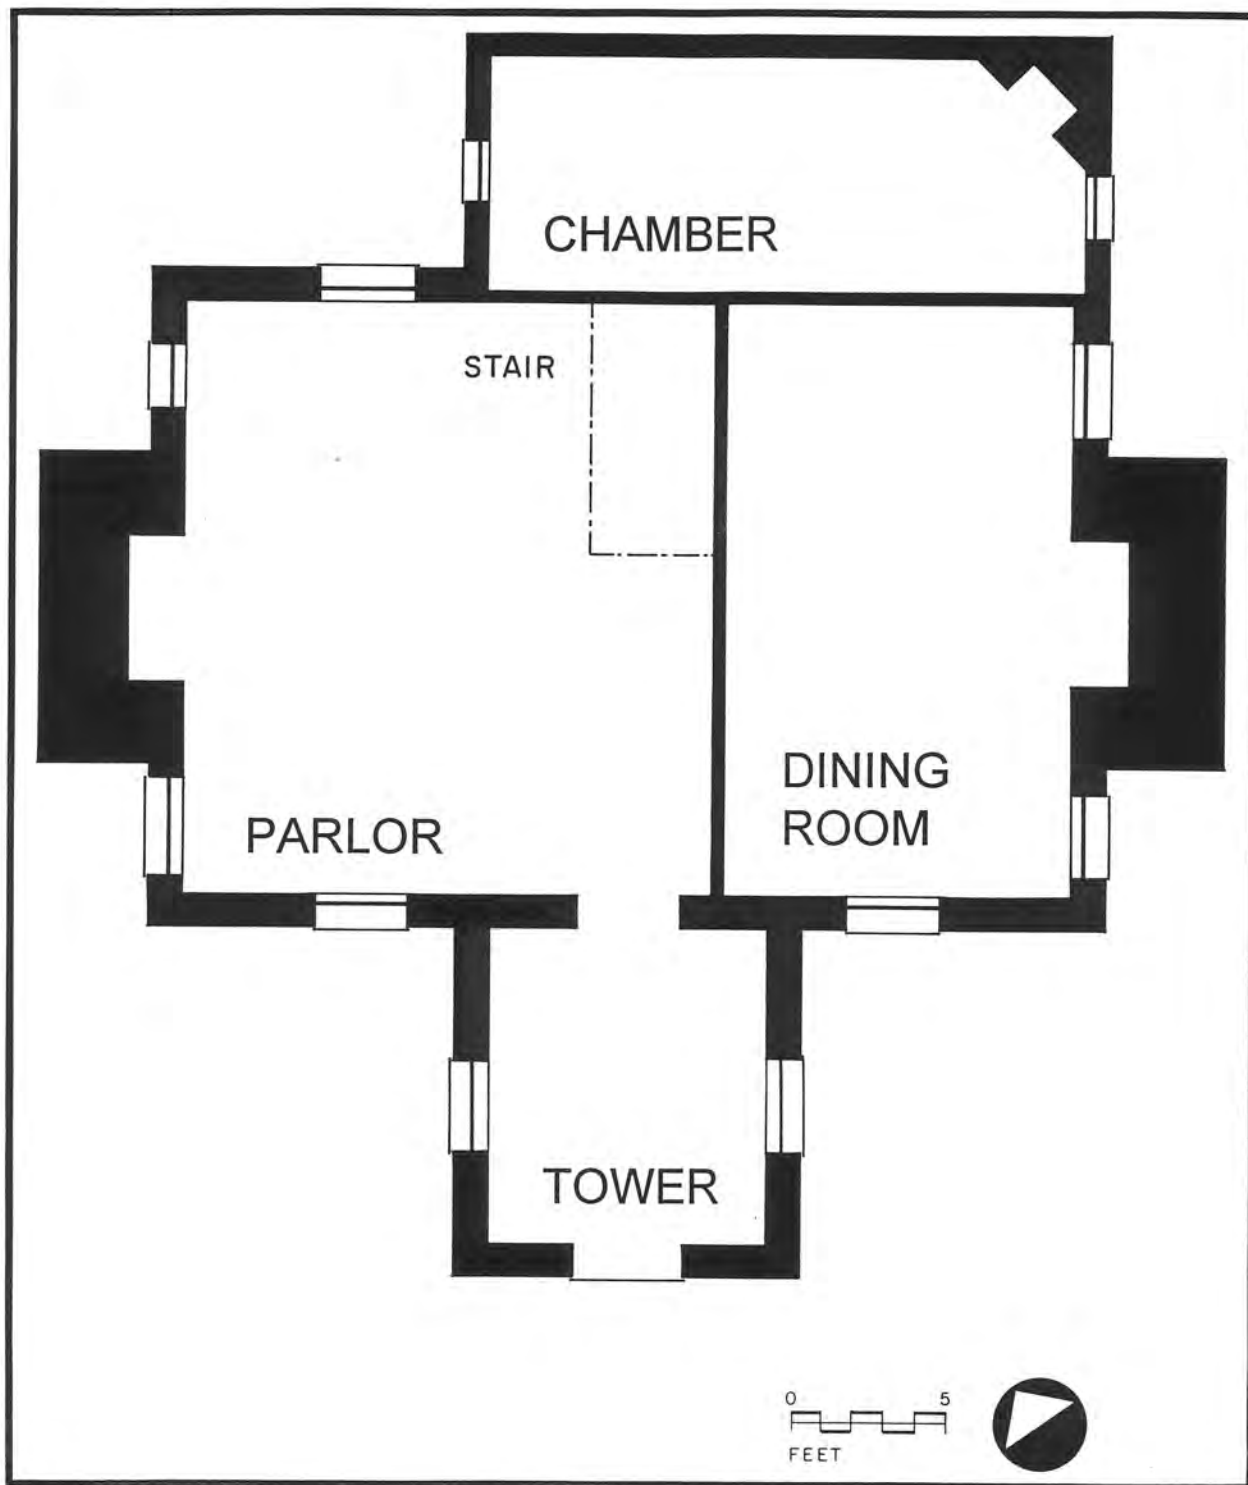
Figure 35. Matthew Jones House, first-floor plan in its Period II (1730) form.

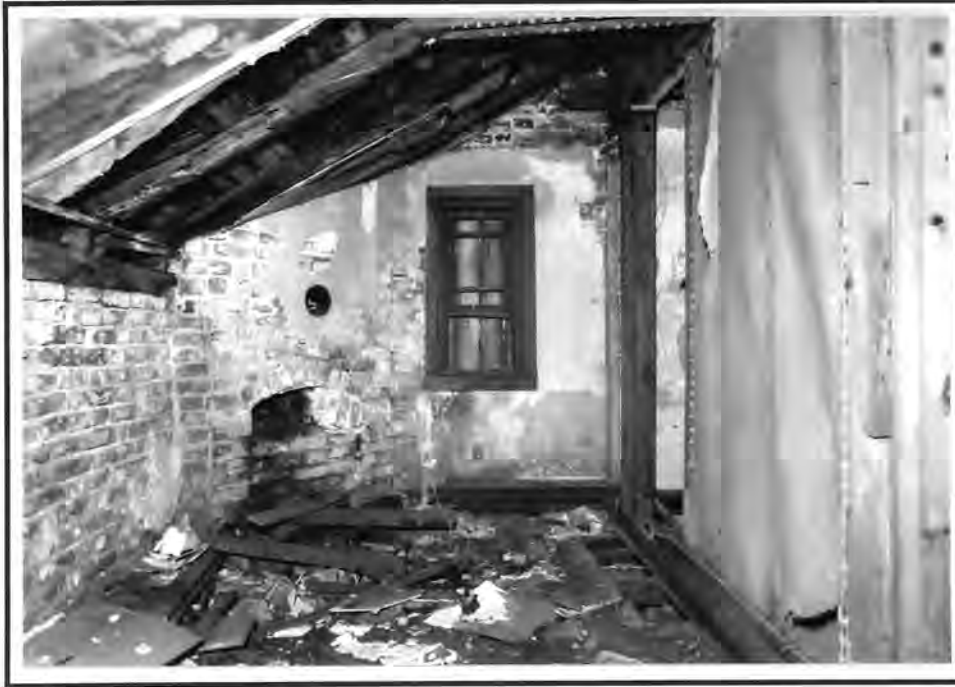
The inclusion of a rear shed during Period II provided the third necessary space for gentry living during the second quarter of the eighteenth century (Figure 36). A fireplace was included, one that was supported by corbeled bricks from the corner of the foundation walls immediately below the floor (Figure 37). The shed provided space for a new chamber since the sleeping functions had been largely, if not completely, eliminated from the new dining room. Interestingly, the chamber was so reduced in importance as to be inferior even to those in the attic story. Since all of the entertaining functions that the old chamber served would have been moved into the new dining room, this may have been quite an acceptable solution. The chamber does not have the relative pretensions found in many other three-room-plan houses and does not allow for a large bed with hangings. This arrangement illustrates the evolutionary process that the Virginia house underwent and describes an early, unmaturing version of the three-room plan.

Figure 36. *Matthew Jones House, corner fireplace in shed.*

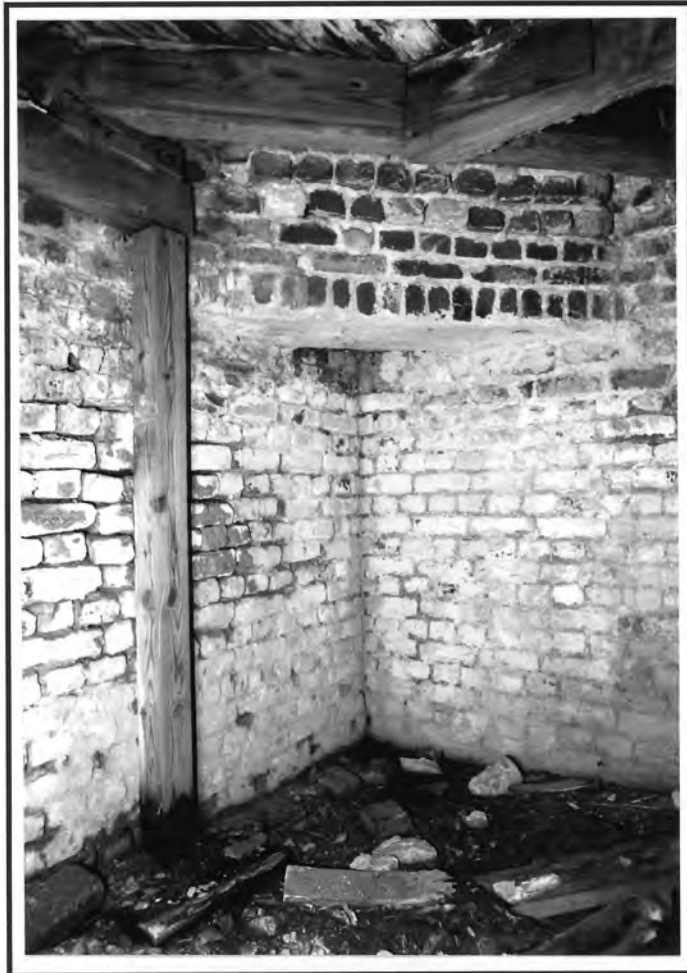
Figure 37. Matthew Jones House, corbeled base for shed chimney.

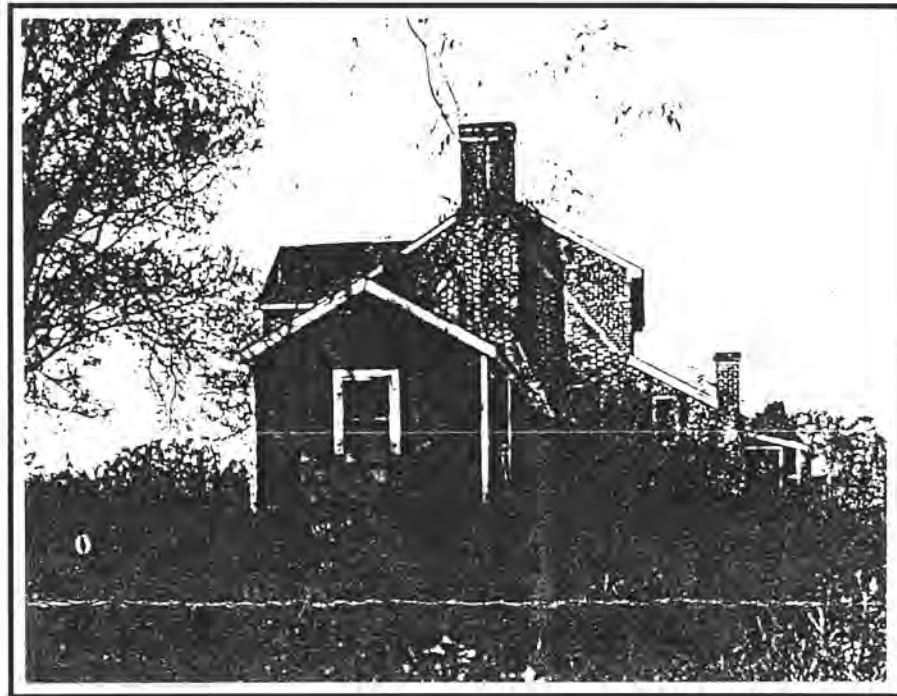
8 in. × 19 ft. 5 in. The room contains a small window to the west and an interior corner fireplace and window at the opposite end. The date of the chimney is not certain, but the use of white shell mortar and glazed bricks suggests an early date, probably 1730, as does the offset nature of the east window. The small triangles between the outside edges of the chimney and the brick walls were later infilled with salmon brick and lime mortar (without shell). The original opening was 2 ft. 2 in. wide and 2 ft. 10 in. tall, but was blocked when a stove was added to the room, presumably in 1893. The stack, now missing, is clearly delineated in the 1940 HABS drawings of the house (Figure 38).

Figure 38. Matthew Jones House, ca. 1934–1935 HABS photo showing stack of shed chimney. Note also the frame addition in the foreground. (Photo credit: Albert S. Burns, HABS.)

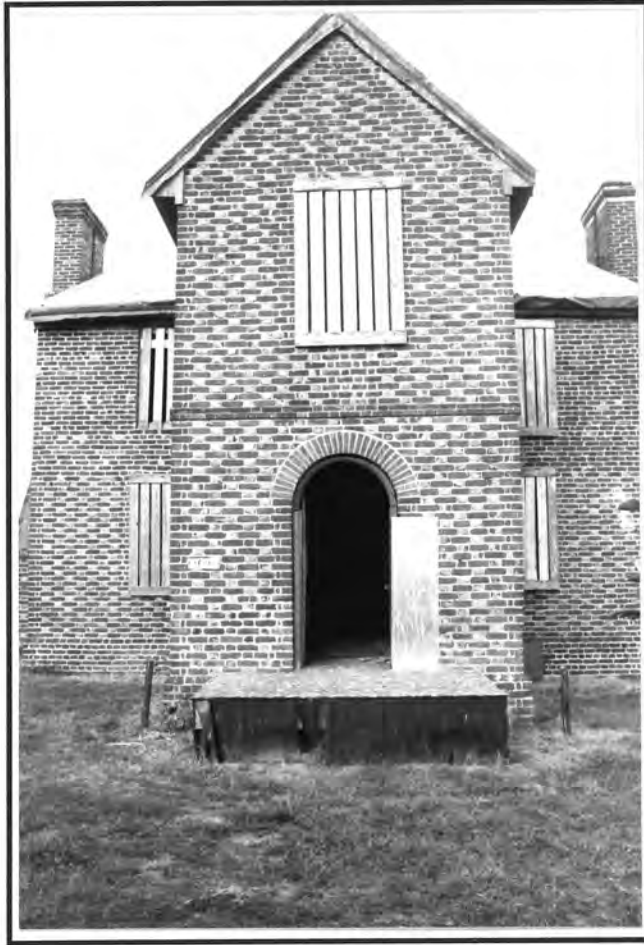
Figure 39. Matthew Jones House, porch tower added in 1730. Arch over door was rebuilt after 1940, but following the original configuration.

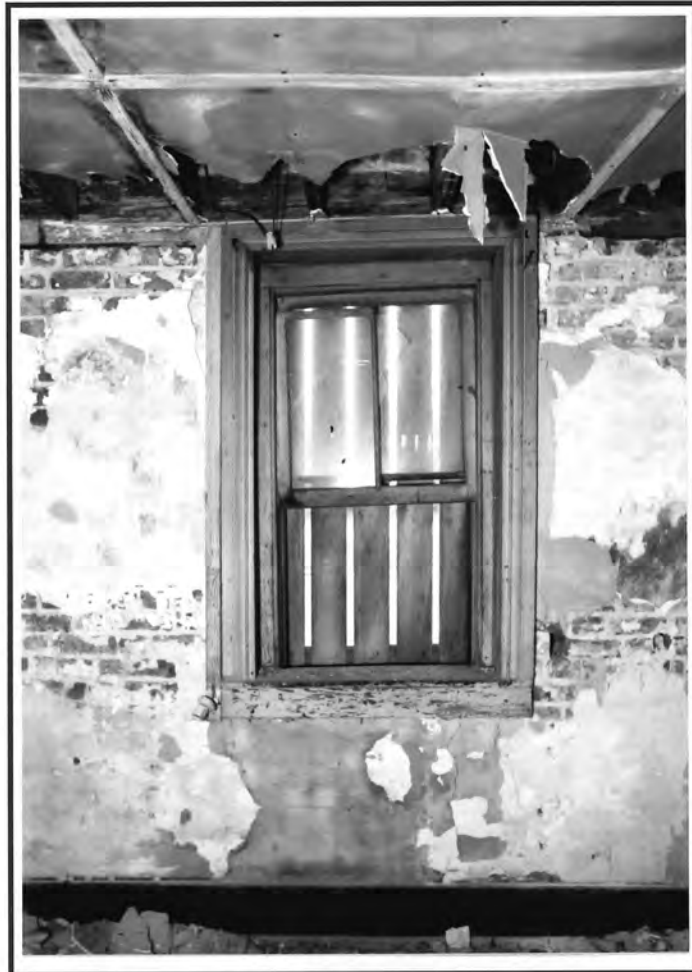
Figure 42. Matthew Jones House, interior view of hall window, remodeled in 1893.

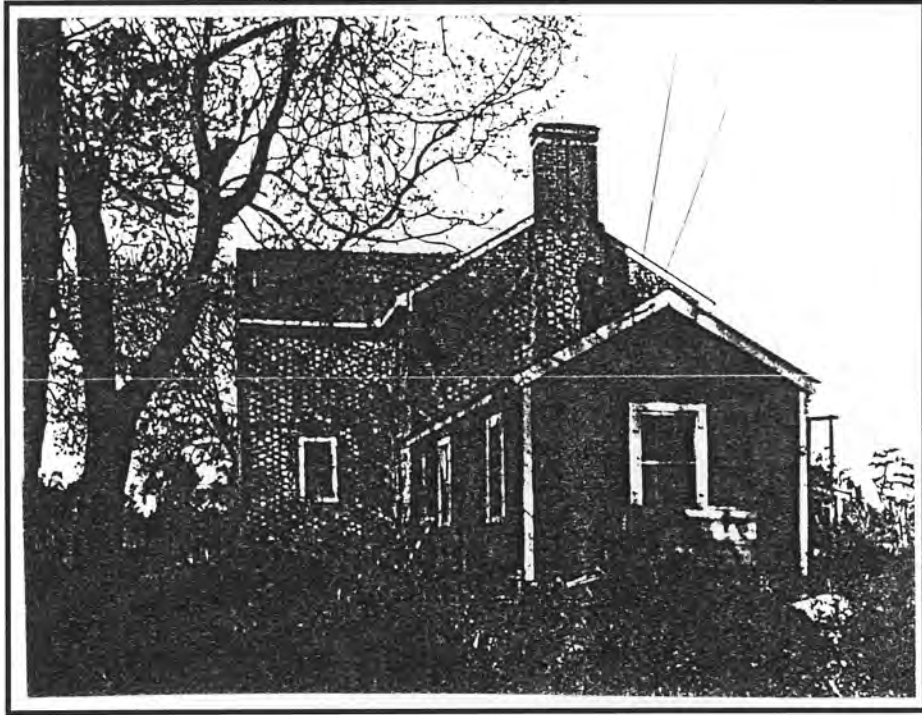
but has since been demolished (Figure 43). The date of the addition is not known, but can be no earlier than 1893 and probably no later than the 1910s, when the site was acquired by the federal government.

Figure 43. Matthew Jones House, 1930s photograph showing an early twentieth-century frame addition protruding from the east gable. (Photo credit: Albert S. Burns, HABS.)

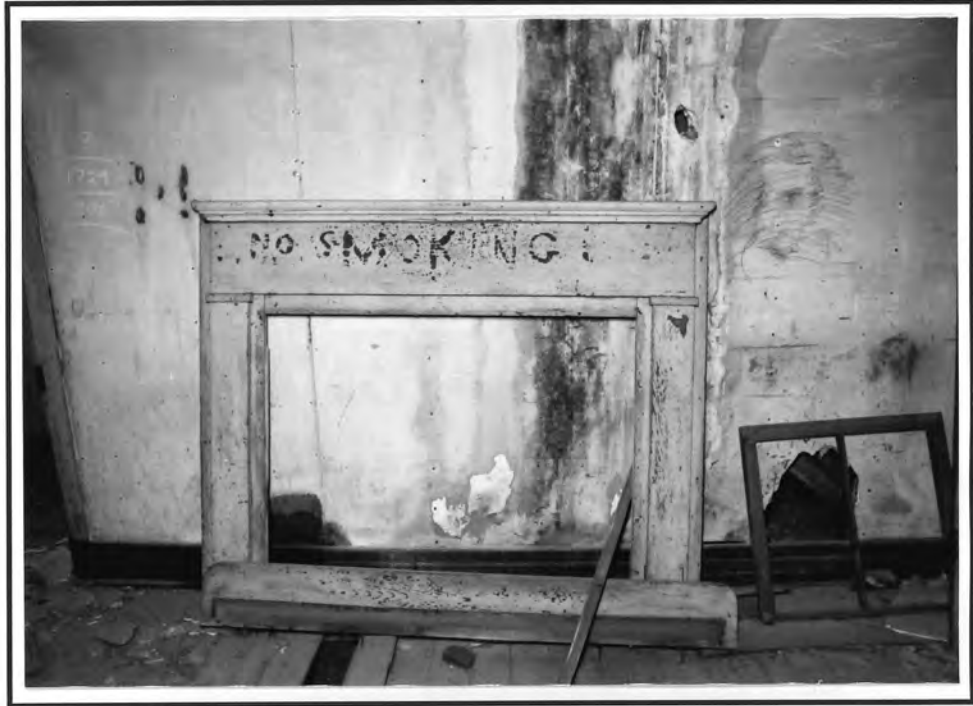
To complete the remodeling, matching mantels were used on the first floor. Plain wood mantels with flat pilasters and a wide, undecorated frieze were chosen for these two spaces. The fireplaces were lined with new brick. Simple beaded casings surround the doors and windows with a backband added to the latter for effect (Figures 45 and 46). In all, the 1893 modifications were quite extensive but of an inferior quality.

Figure 45. Matthew Jones House, 1893 mantel from first-floor west room.

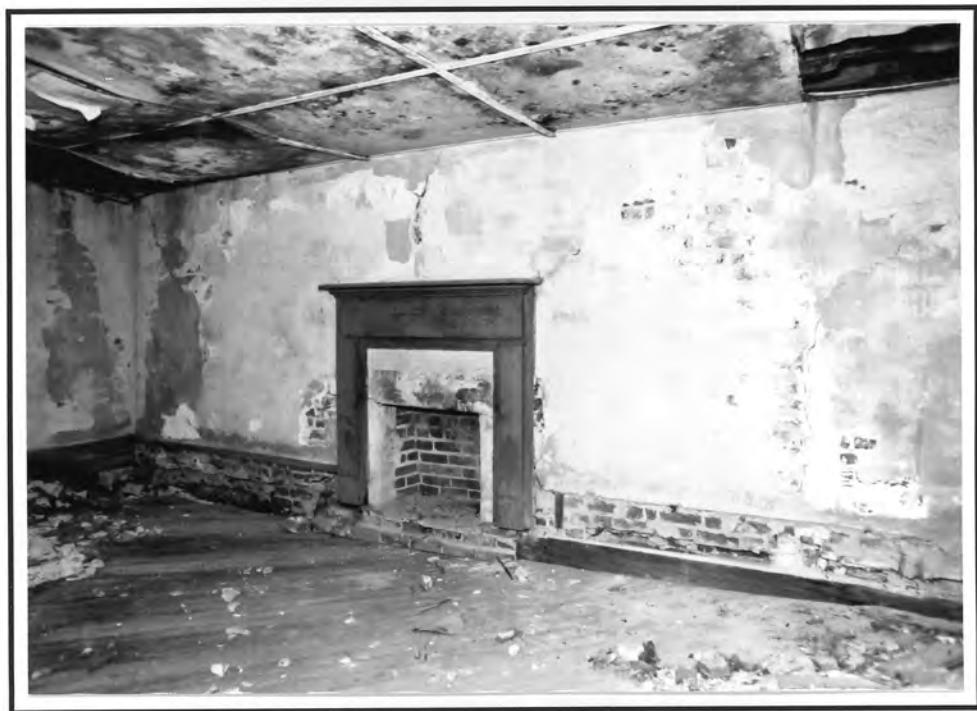
Figure 46. Matthew Jones House, 1893 mantel from second-floor west room.
