## 6: Analysis of Vessel Remains

The VDOT is constructing a new bridge-tunnel west of and parallel to the existing Hampton Roads I-64 Bridge-Tunnel (HRBT) facilities. Initial onsite work included dredging operations to remove obstructions in the project corridor. In December 2020, that activity resulted in the discovery of previously unknown vessel remains west of the north island on the HRBT. In addition to tons of granite that represented cargo, clearing the site resulted in the discovery of historic vessel remains. Subsequently identified as Site 44HT0125, the site and recovered vessel structure were ultimately determined to be historically significant.

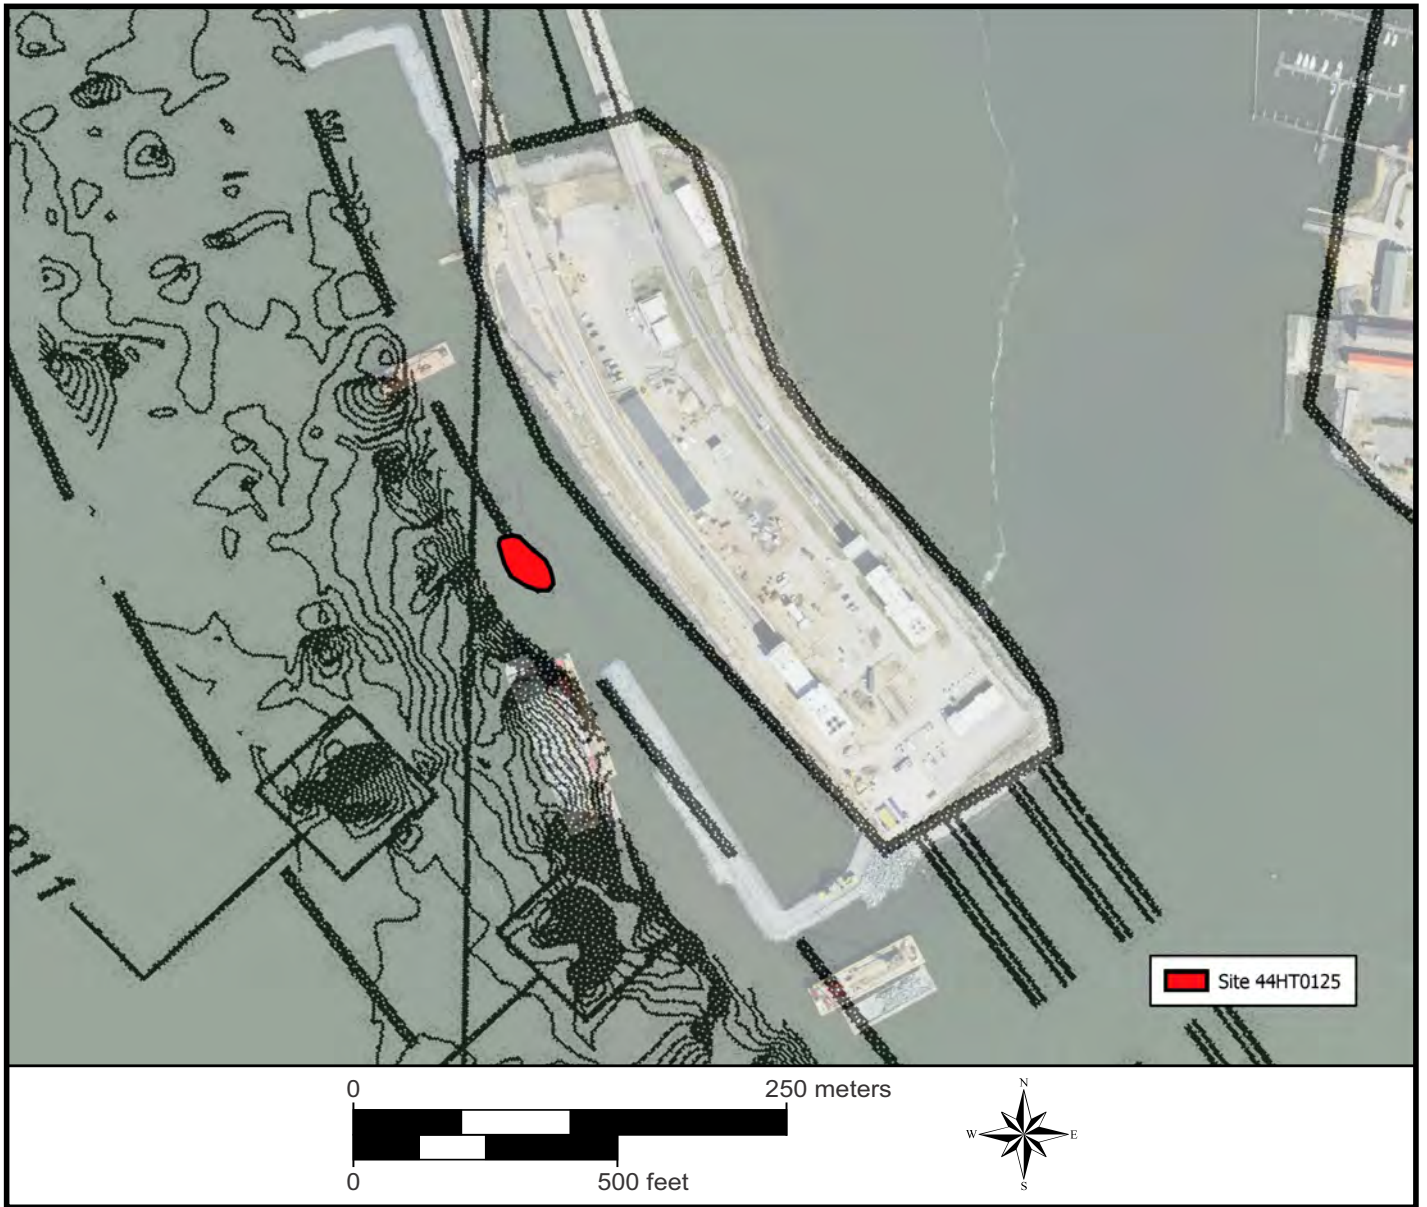
Figure 6.2. Anomalies in vicinity of the I-64 north island identified during 1998 (detail of image presented in Cox 1999).

HRBT (Figure 6.1). Previous submerged cultural resource surveys were carried out in 1998 (Cox 1999) and in 2017 (AECOM 2017). Overlays of the survey areas indicate that Site 44HT0125 was located immediately to the east and outside the limits of the 1998 survey (Figure 6.2). Magnetic data collected from the 2017 AECOM survey also identified anomalies in the vicinity of the I-64 North Island (Figure 6.3). However, none of the anomalies located during 2017 corresponded with either the anomalies located in 1998 or those associated with Site 44HT0125.

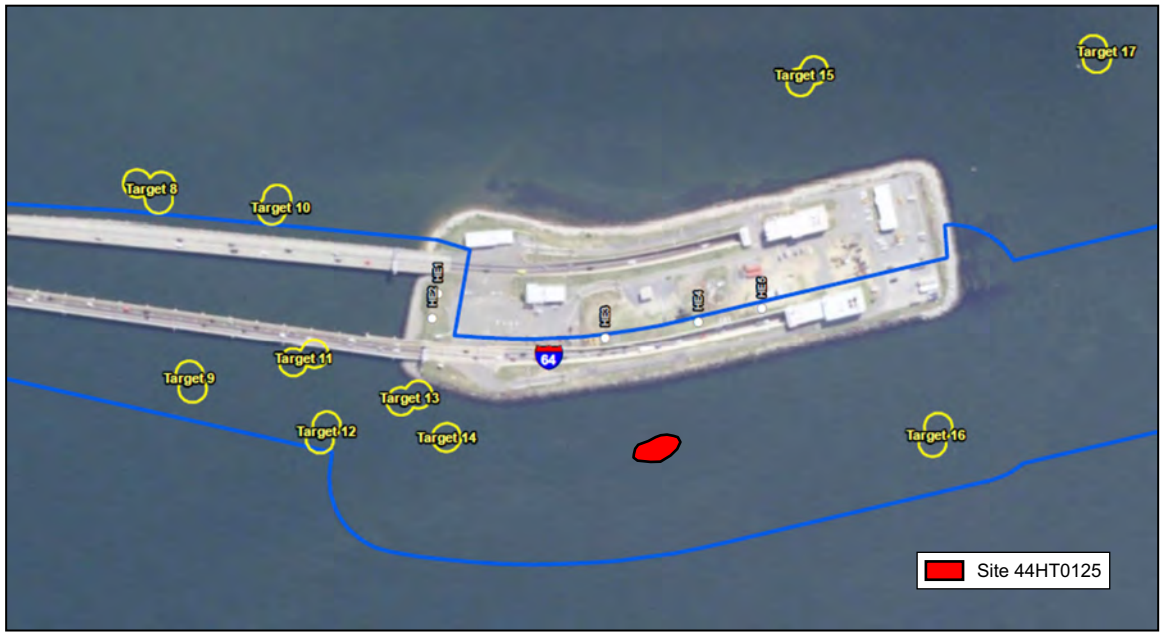
Figure 6.3. Anomalies in vicinity of the I-64 north island identified during 2017 (detail of image presented in AECOM 2017).

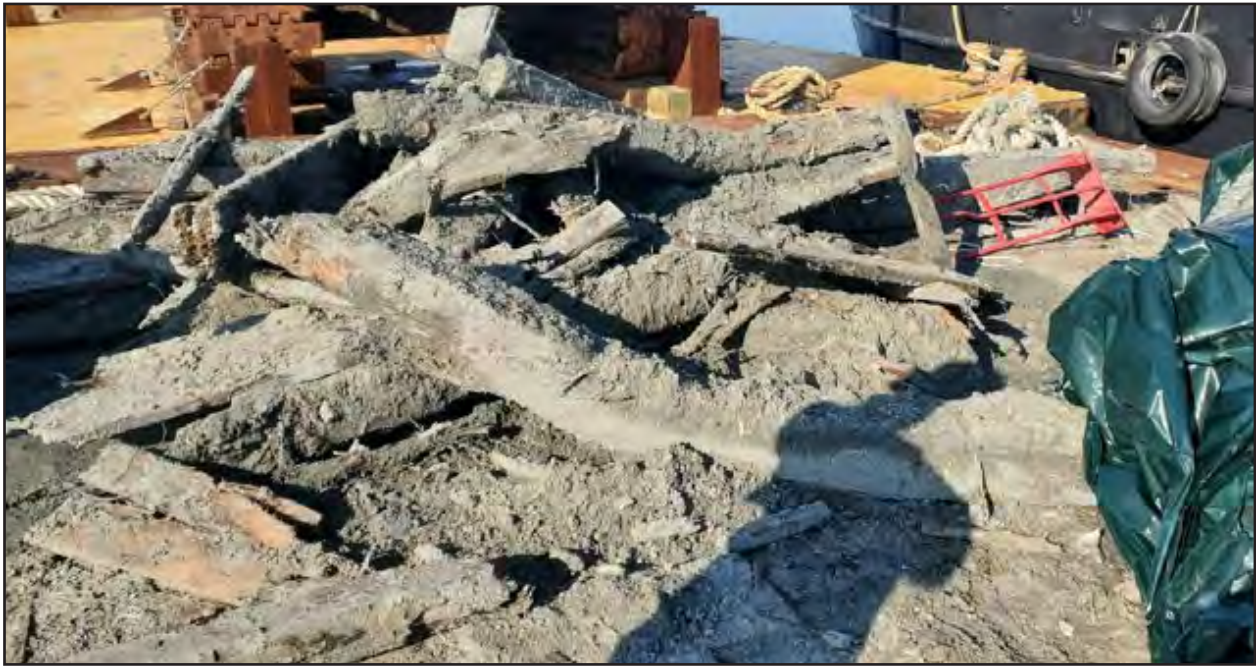
Figure 6.4. Vessel structure recovered from Site 44HT0125 (presented in: Wright 2021).

In November 2020 dredging off the western side of the I-64 North Island resulted in the discovery and recovery of elements of the historic vessel structure under consideration (Figure 6.4)

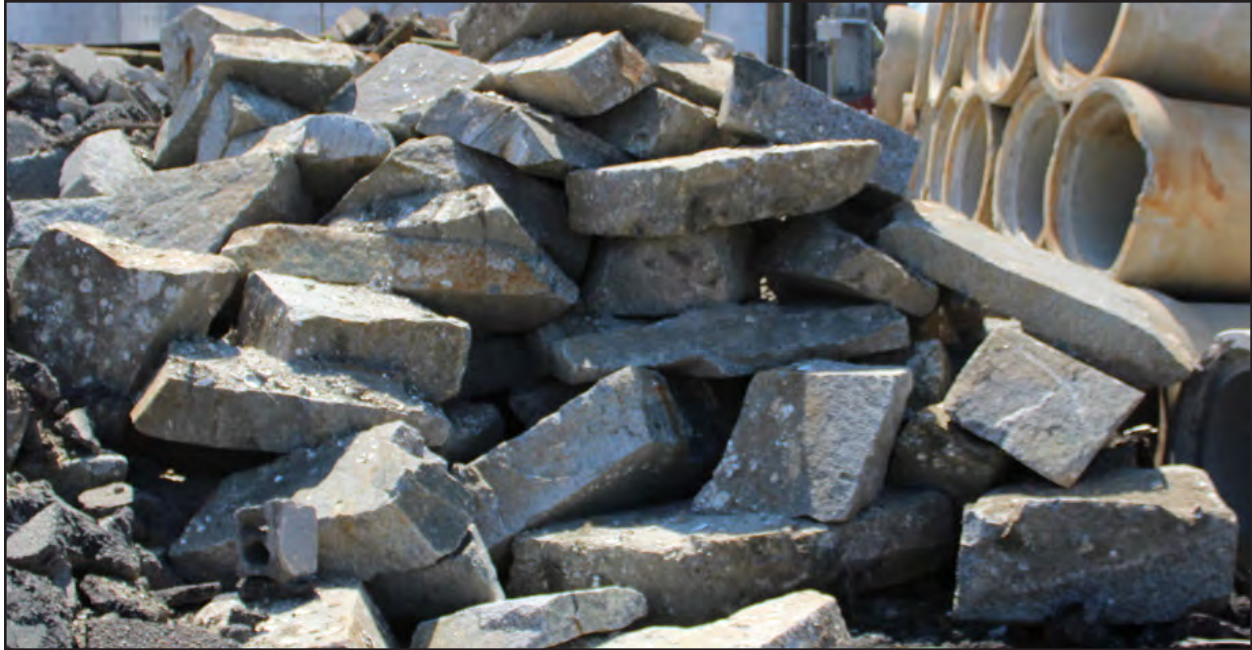
Figure 6.5. Granite cargo recovered from Site 44HT0125 (Presented in: Wright 2021).

and tons of granite that apparently represented associated cargo (Figure 6.5).

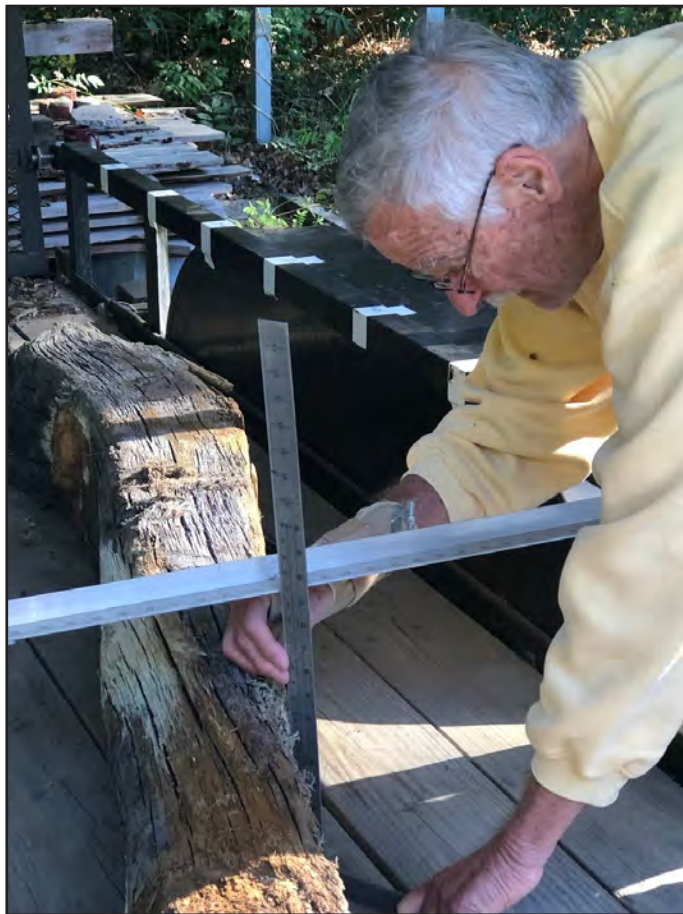
*Figure 6.8. Documenting floors on the trailer grid.*

The TAR analysis of the 44HT0125 wreck remains differs significantly from the interpretation submitted by Goodwin (Wright 2021). The structural remains examined and documented by TAR included 12 floor timbers, one futtock, one possible carling, two sections of keel, three sections of keelson, five sections of plank, and a heavy timber identified by TAR as a forefoot knee (See Glossary, pp. vi-viii). Structural elements were loaded with assistance from VDOT (Figure 6.6) and transported to the North Carolina TAR facility for comprehensive documentation and assessment (Figure 6.7). A trailer designed with a frame and grid for documentation was used to record elements of the vessel structure (Figure 6.8). Each

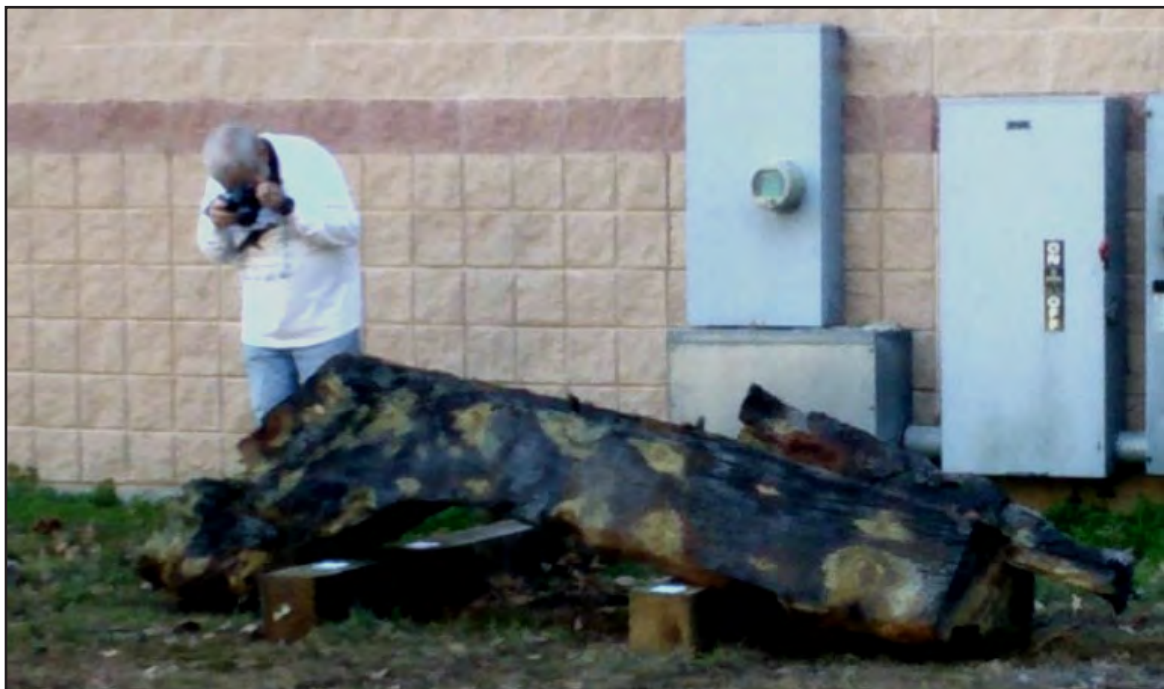
*Figure 6.9. Photographic recording of the forefoot knee.*

recovered component of the wreck structure was photographed (Figure 6.9) for detail and recorded in scale drawings (Figure 6.10). Elements of the wreck structure (i.e. lengthy sections of the keel and keelson) which precluded safe transportation to North Carolina via trailer were documented at the VDOT Chesapeake facility (Figure 6.11).

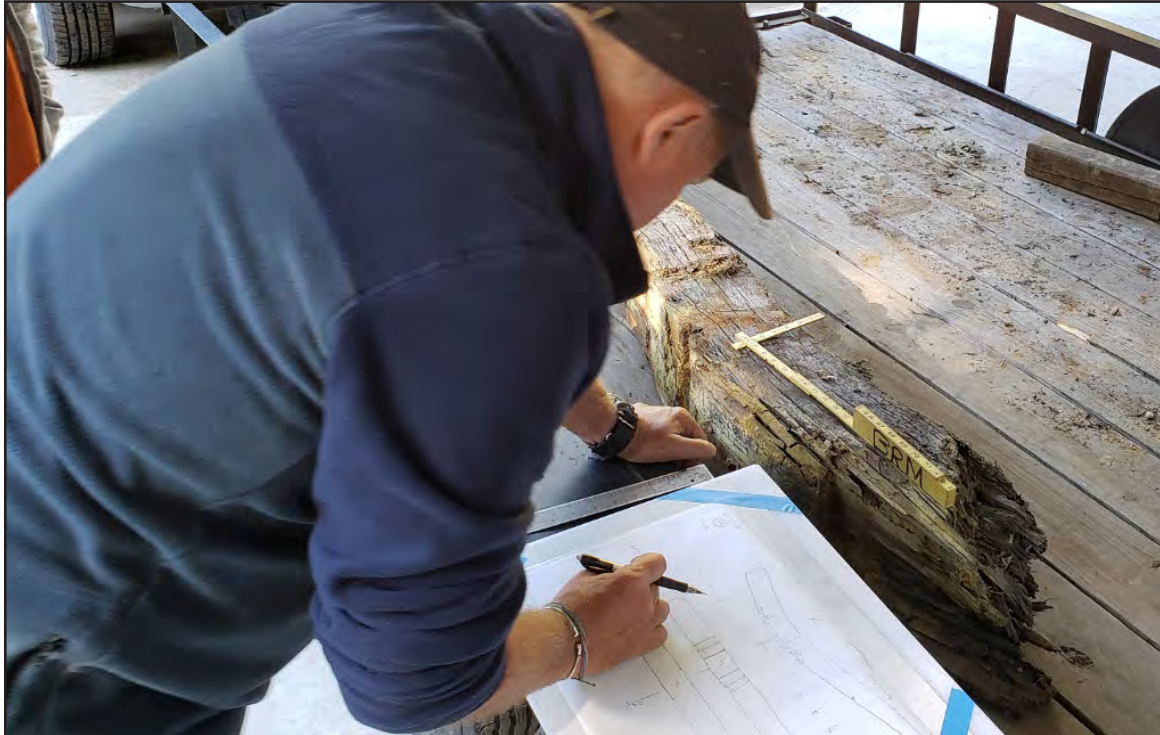
*Figure 6.10. Creating scale drawings of each element of structure.*

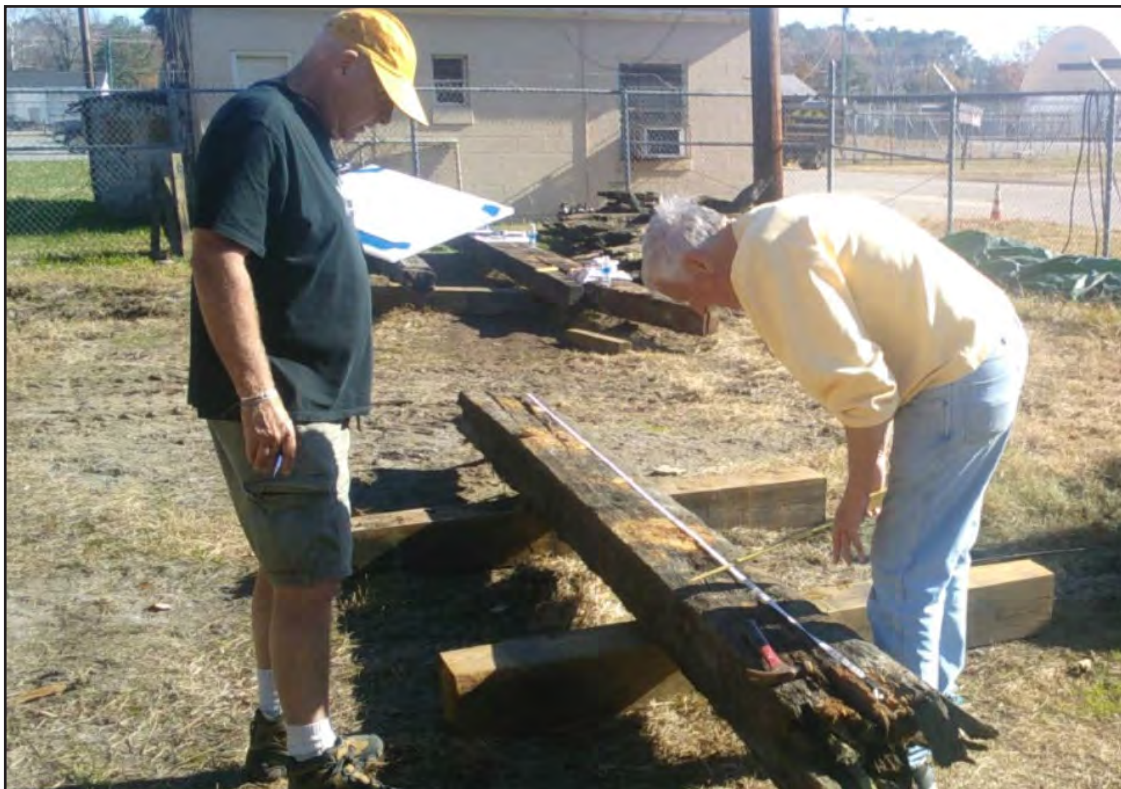
*Figure 6.11. Documenting keel and keelson timbers at the VDOT facility.*

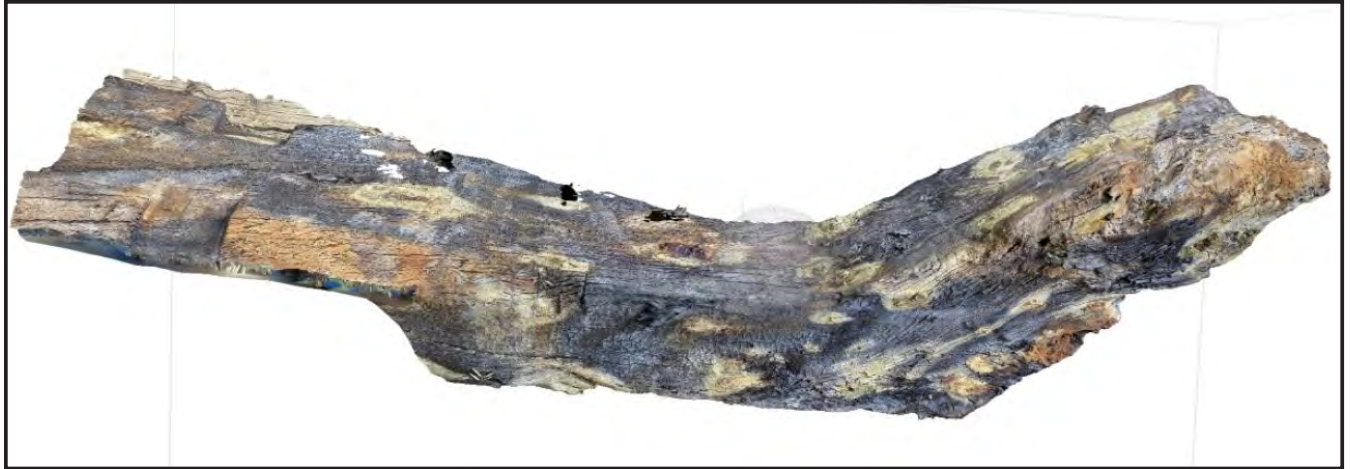
*Figure 6.12. AgiSoft 3D image of the forefoot knee.*

In addition to making scale drawings of the each of the wreck elements and photographing any relevant details, a Russian software program AgiSoft was used in an effort to record each structural element in three dimensions. Using a 35-mm camera, each element of the wreck structure was recorded in a series of overlapping photographs. Those photographs were pieced together to create a three dimensional image in AgiSoft. A few of the generated images provided 3D data on the one side and the upper and lower surfaces. One of those was the forefoot knee (Figure 6.12). The majority of the AgiSoft images lacked acceptable surface definition and some were extremely distorted (Figure 6.13). None of the 3D images included all sides. Perhaps under

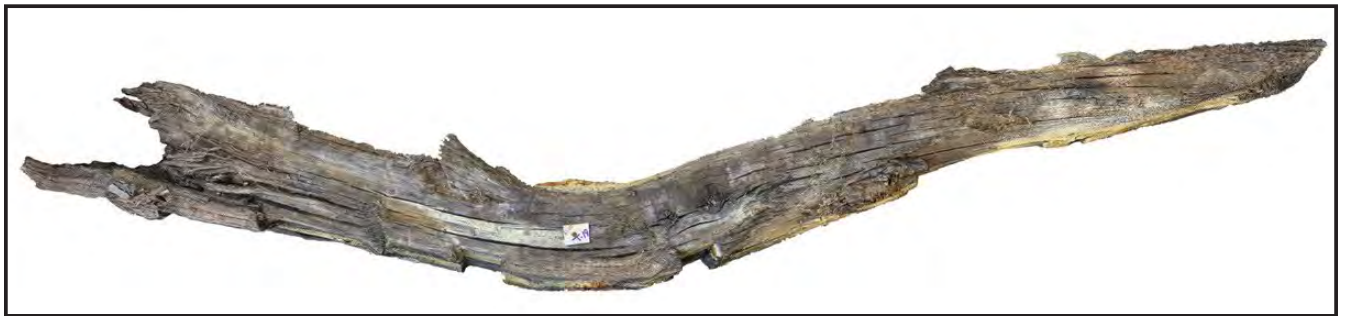
*Figure 6.13. AgiSoft 3D distorted image of the floor TAR #10.*

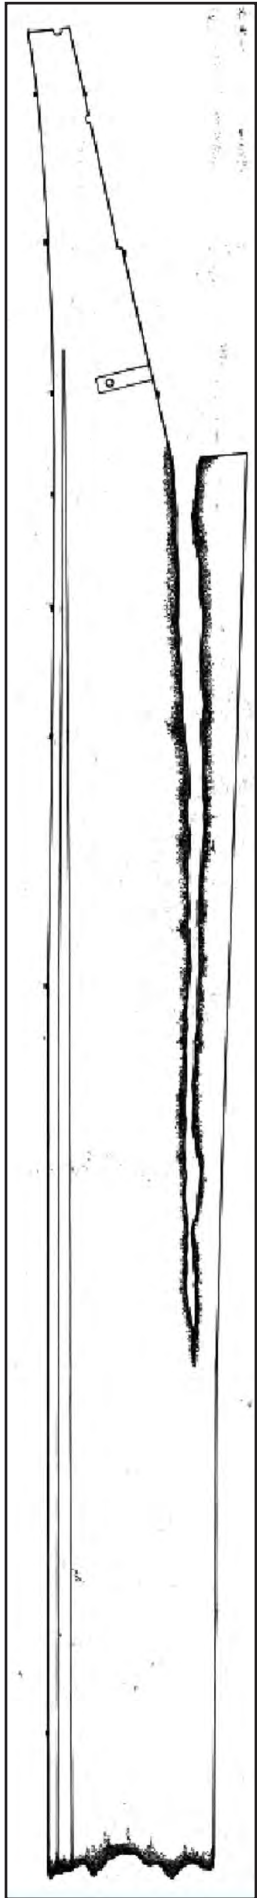
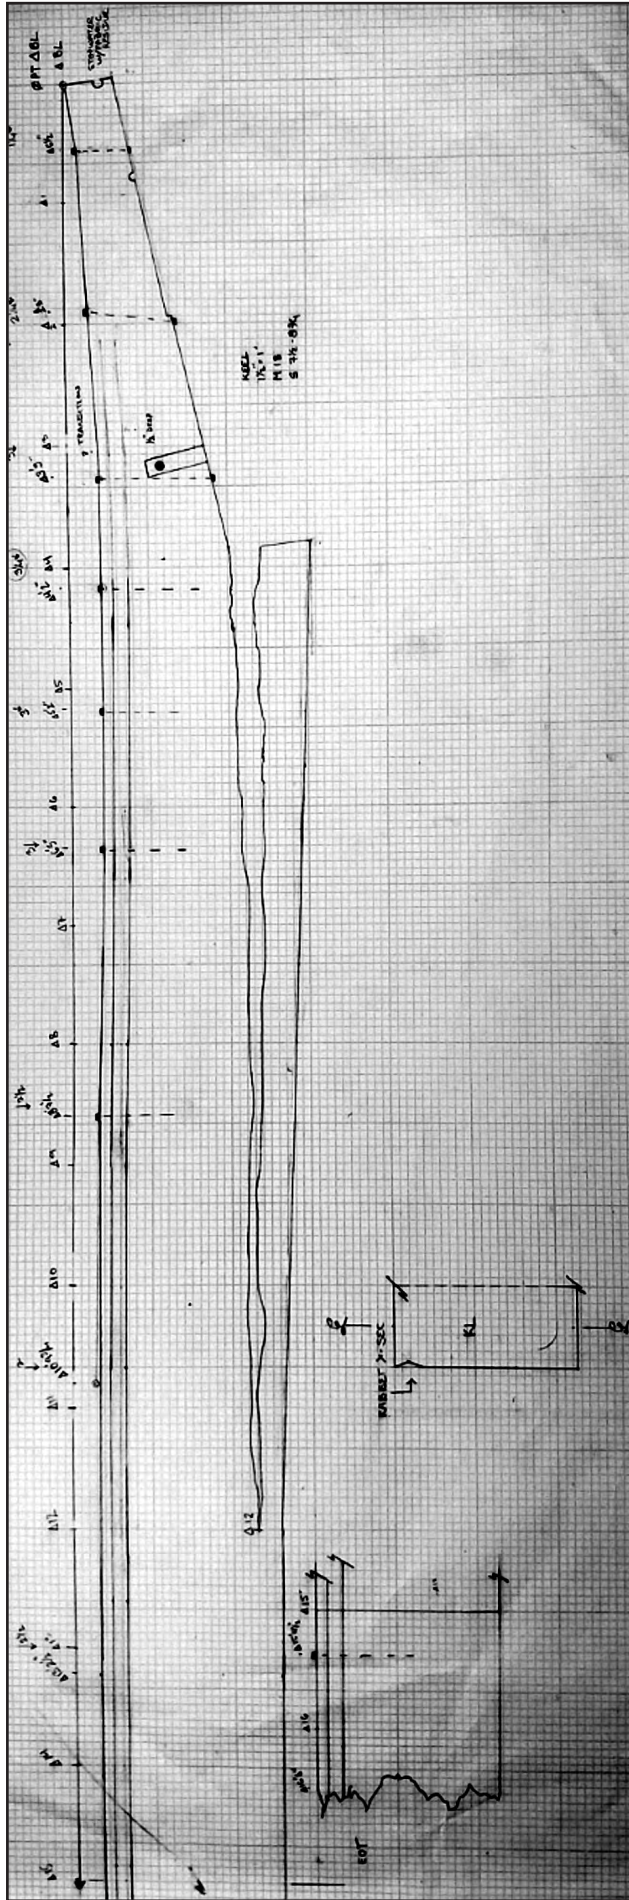
Figure 6.14. Keel section KL-1 inked drawing (forward to right).

Figure 6.15. Keel section KL-1 scale drawings (forward to right).

The largest section of keel structure (KL-1) measured 22 feet, 9 ½ inches in overall length (Figures 6.14 and 6.15). The height measured 18 inches aft of the scarf and the width varied from 8¾ inches aft to 7 ½ inches forward approaching the stem. This section of keel was degraded and split from the bottom butt of a scarf. The split is possibly a consequence of destruction of the bow and perhaps contributes to the rise apparent in the timber.

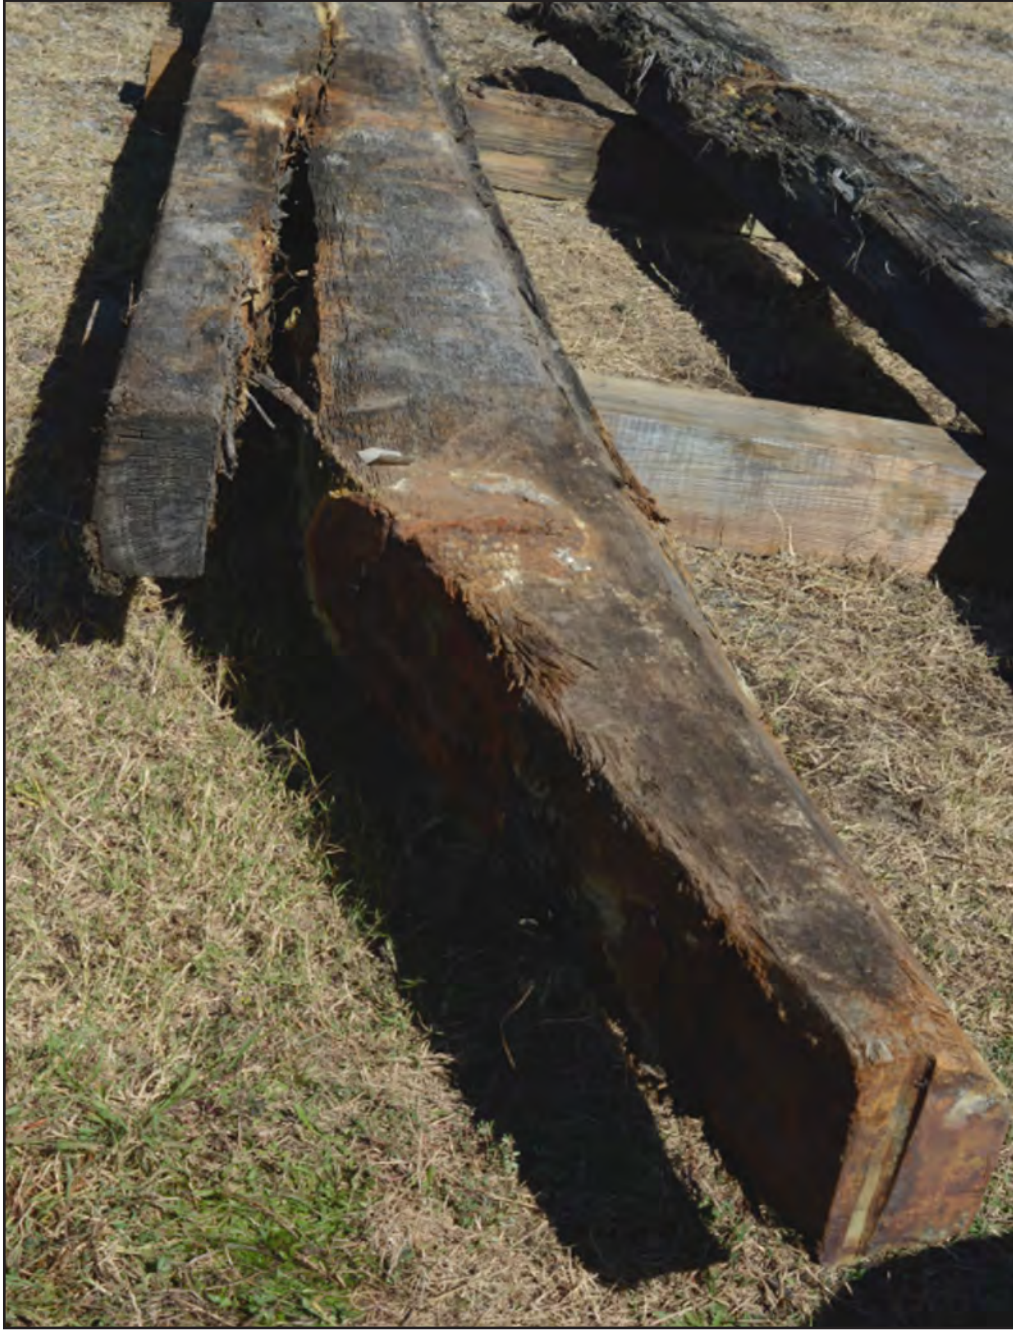
*Figure 6.16. Keel scarf looking aft.*

The forward end of the section terminated in a diagonal scarf 3 feet, 9 inches in length (Figure 6.16). The forward end of the scarf contained half of a 1-inch round horizontal recess for a stop water (Figure 6.17). A pattern inside the feature indicates that the stopwater dowel was fabric wrapped. A second stopwater was located in the face of the scarf approximately 9 inches from that end.

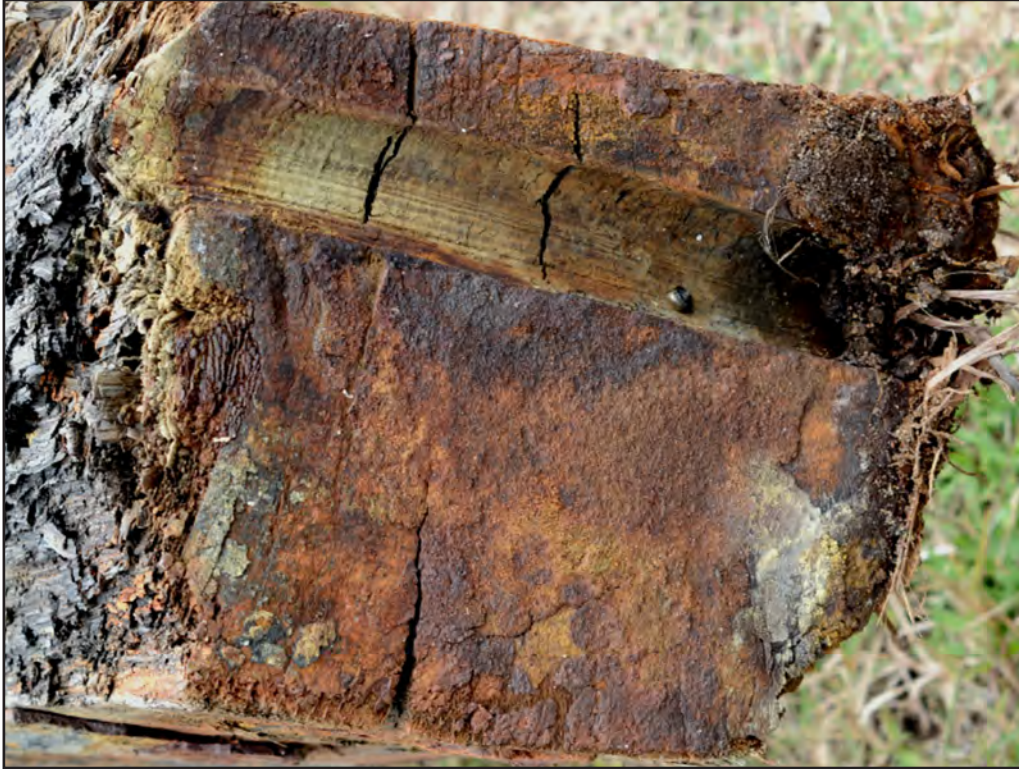
*Figure 6.17. Stopwater recess in the forward end of the keel scarf.*

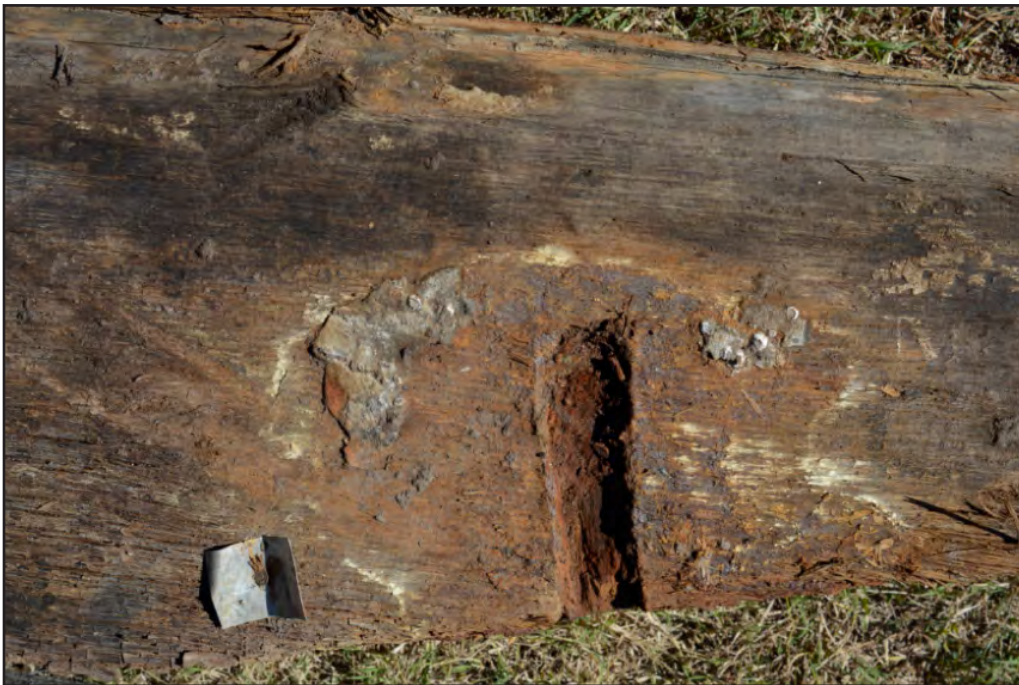
*Figure 6.18. Recess for the keel scarf fishplate.*

A 6-inch long recess for an iron fishplate was located three feet aft of the forward end (Figure 6.18). The top of the keel was cut to fashion a shallow rabbet for the garboard strake (Figure 6.19).

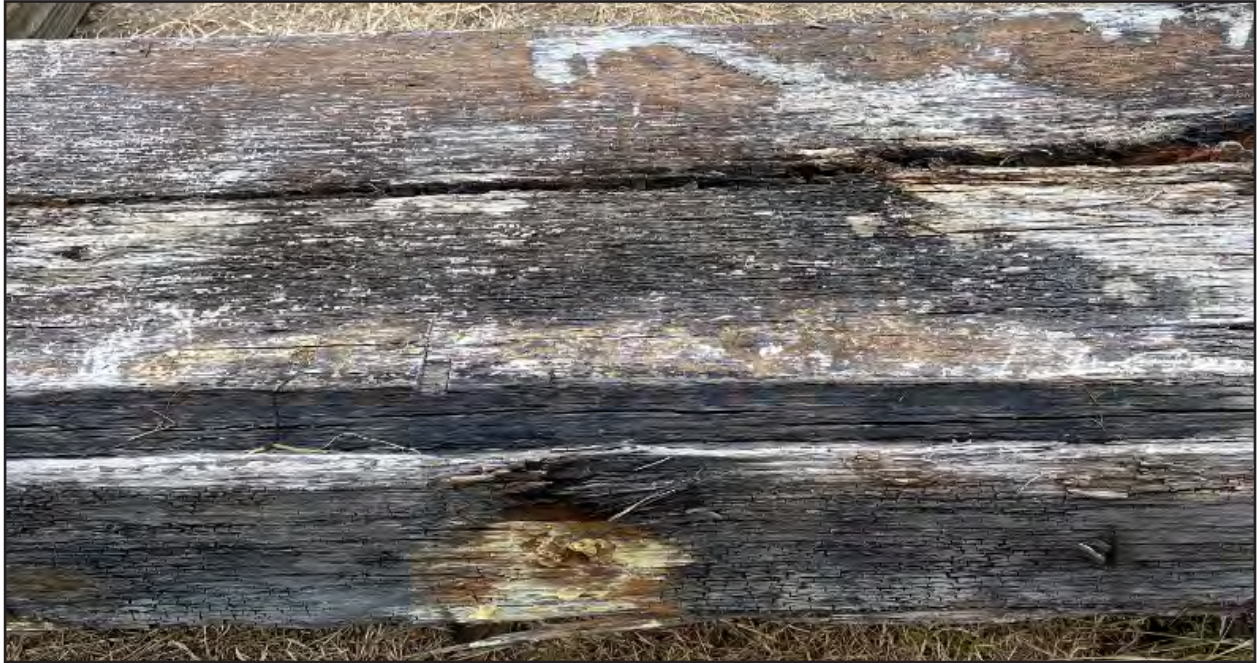
*Figure 6.19. Shallow rabbet in top of K-1 section.*

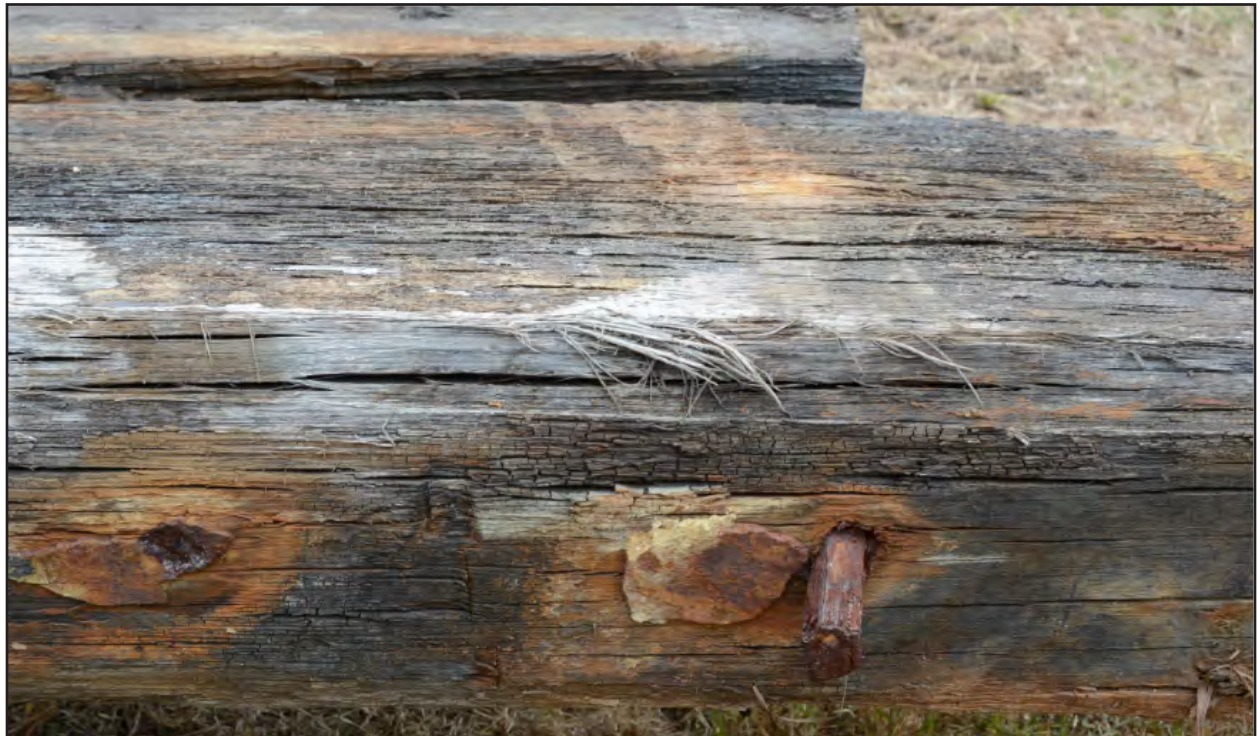
*Figure 6.20. Remains of a square bolt driven through a round hole drilled into the keel.*

Remains of a square bolt in a drilled hole confirms they were used to attach floors (Figure 6.20). The bolt pattern on the top of this section of keel indicates that every other floor was bolted to the keel. According to Goodwin (Wright 2021:8), this section of keel was fashioned from chestnut. That identification was not confirmed by TAR and both sections of keel appear to have been fashioned from oak.

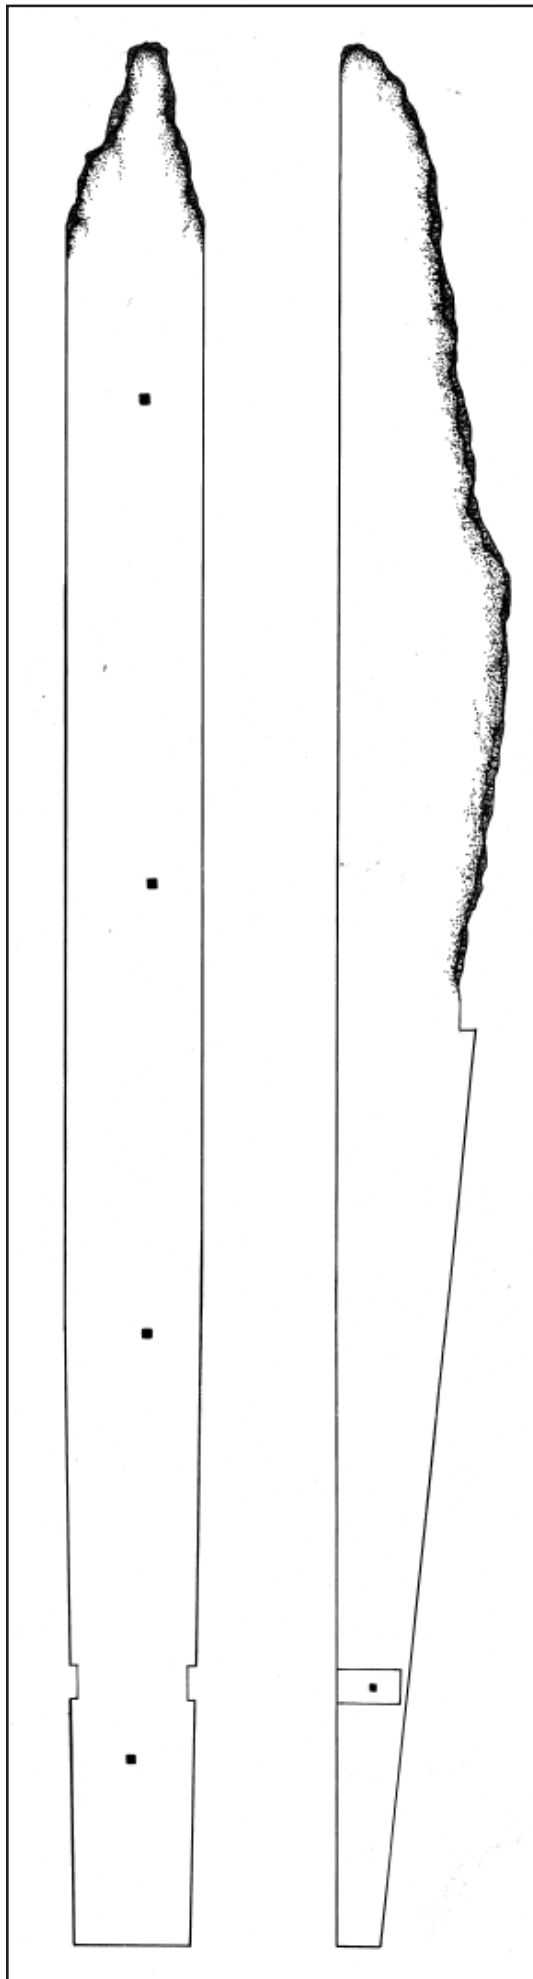
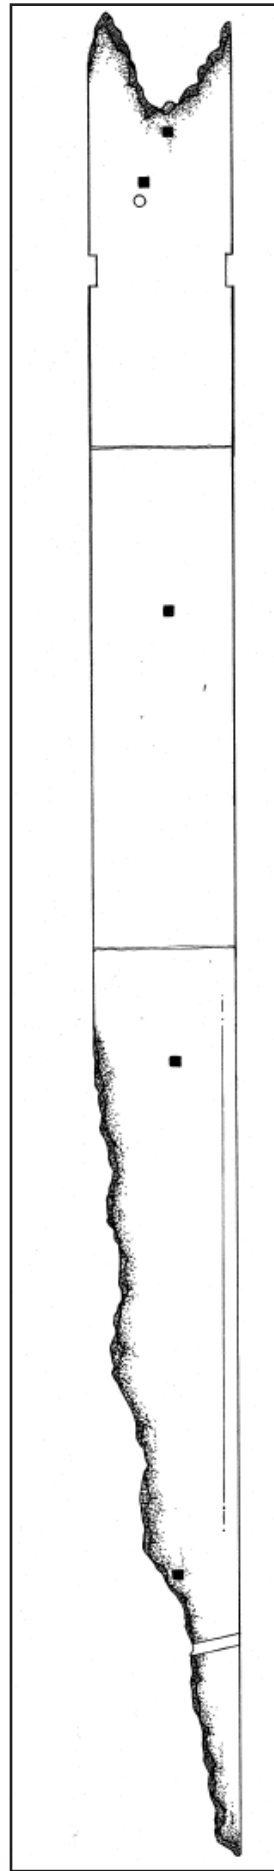
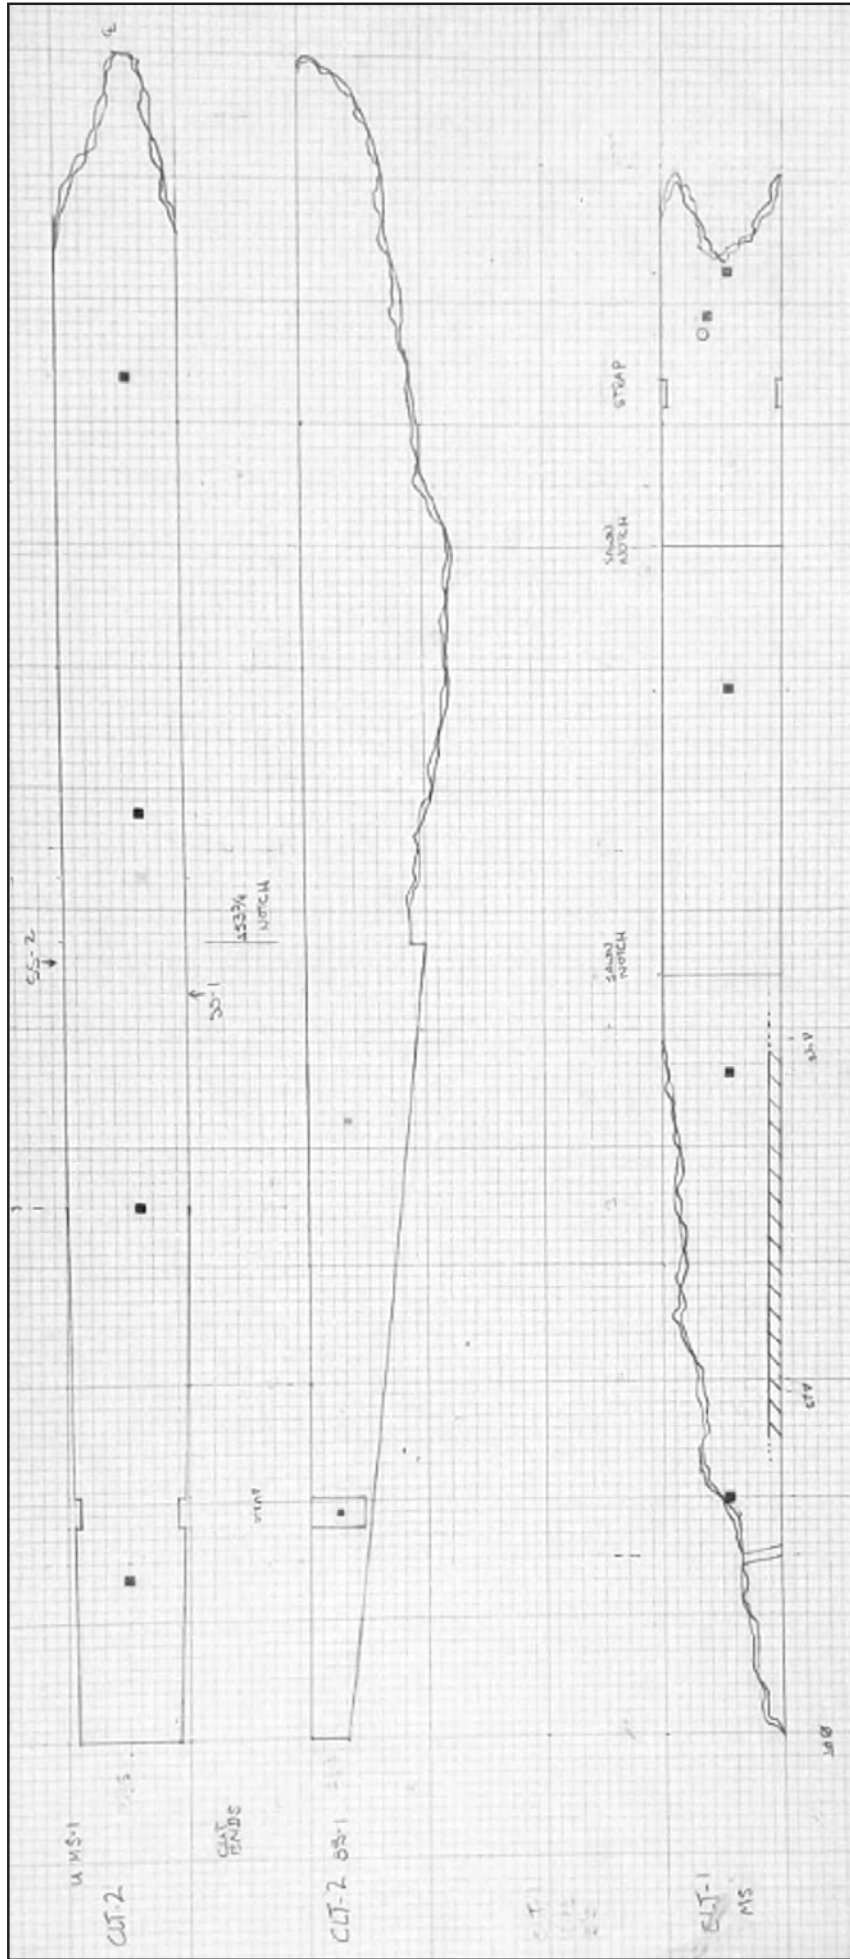
Figure 6.21. Keel section KL-2 inked drawing (top and side).

Figure 6.22. Keel section KL-2 inked drawing (bottom).

Figure 6.23 Keel section KL-2 scale drawing (all views).

The smaller, and likely aft, section of keel structure was heavily damaged and deteriorated. It measured 9 feet, 4 inches in overall length. The height remaining measured 10 inches beyond the remains of a scarf and the width varied from 8 inches to 7 5/8 inches. The section terminates on one end in a diagonal scarf of undetermined length (Figures 6.21–6. 23).

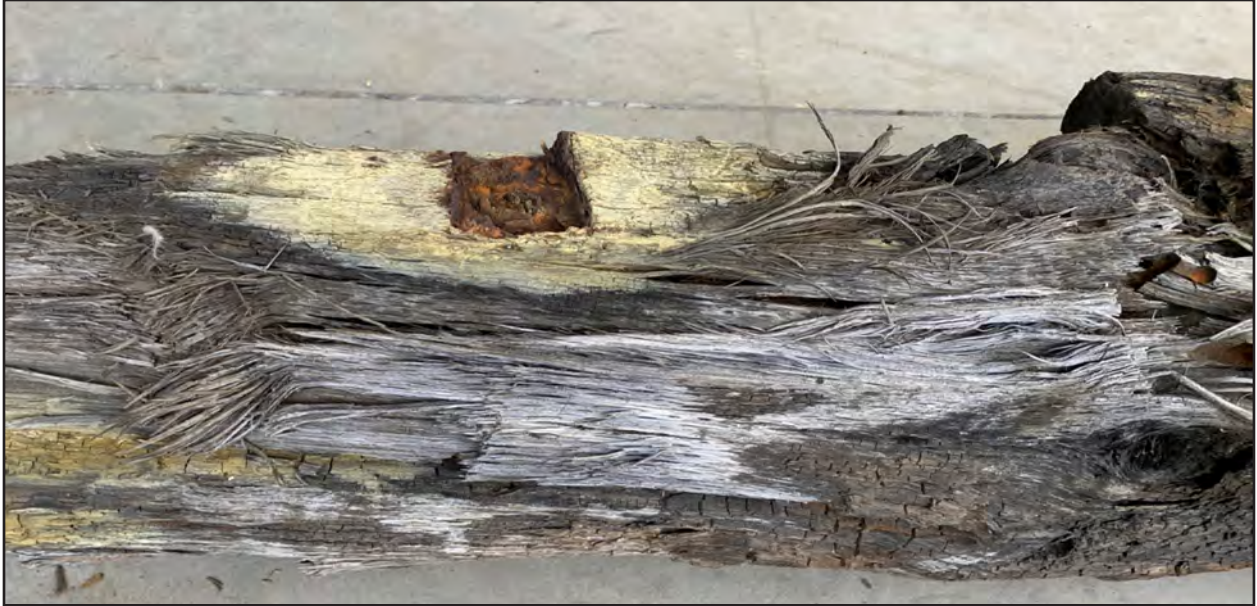
*Figure 6.24. Rebate for fishplate at the scarf on KL-2.*

Recesses on either side of KL-2 identify the location of fishplates that reinforced the scarf are present (Figure 6.24). The opposite end is too badly damaged to reliably characterize. The shallow rabbet, identical to the other section of keel, is present where the top surface survives (Figure 6.25). The bolt pattern on the top of this keel section also confirms that every floor was not bolted to the keel. This section of keel was fashioned from oak.

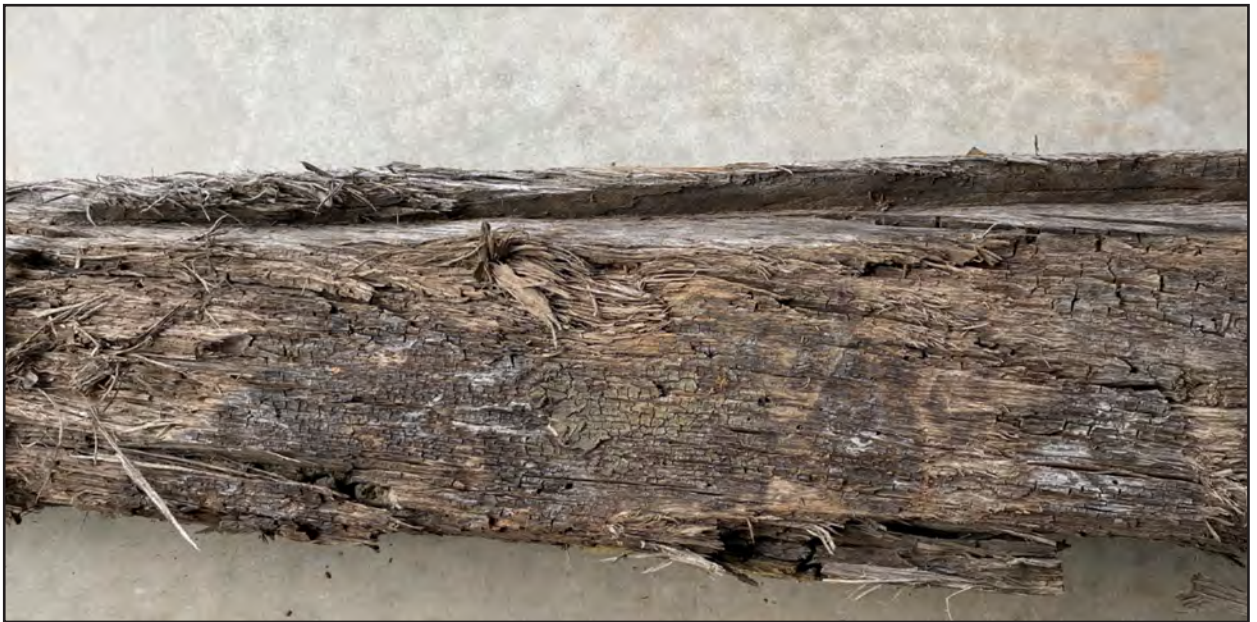
*Figure 6.25. Shallow rabbet in top of KL-2 section.*
