## 6: Analysis of Vessel Remains

The VDOT is constructing a new bridge-tunnel west of and parallel to the existing Hampton Roads I-64 Bridge-Tunnel (HRBT) facilities. Initial onsite work included dredging operations to remove obstructions in the project corridor. In December 2020, that activity resulted in the discovery of previously unknown vessel remains west of the north island on the HRBT. In addition to tons of granite that represented cargo, clearing the site resulted in the discovery of historic vessel remains. Subsequently identified as Site 44HT0125, the site and recovered vessel structure were ultimately determined to be historically significant.

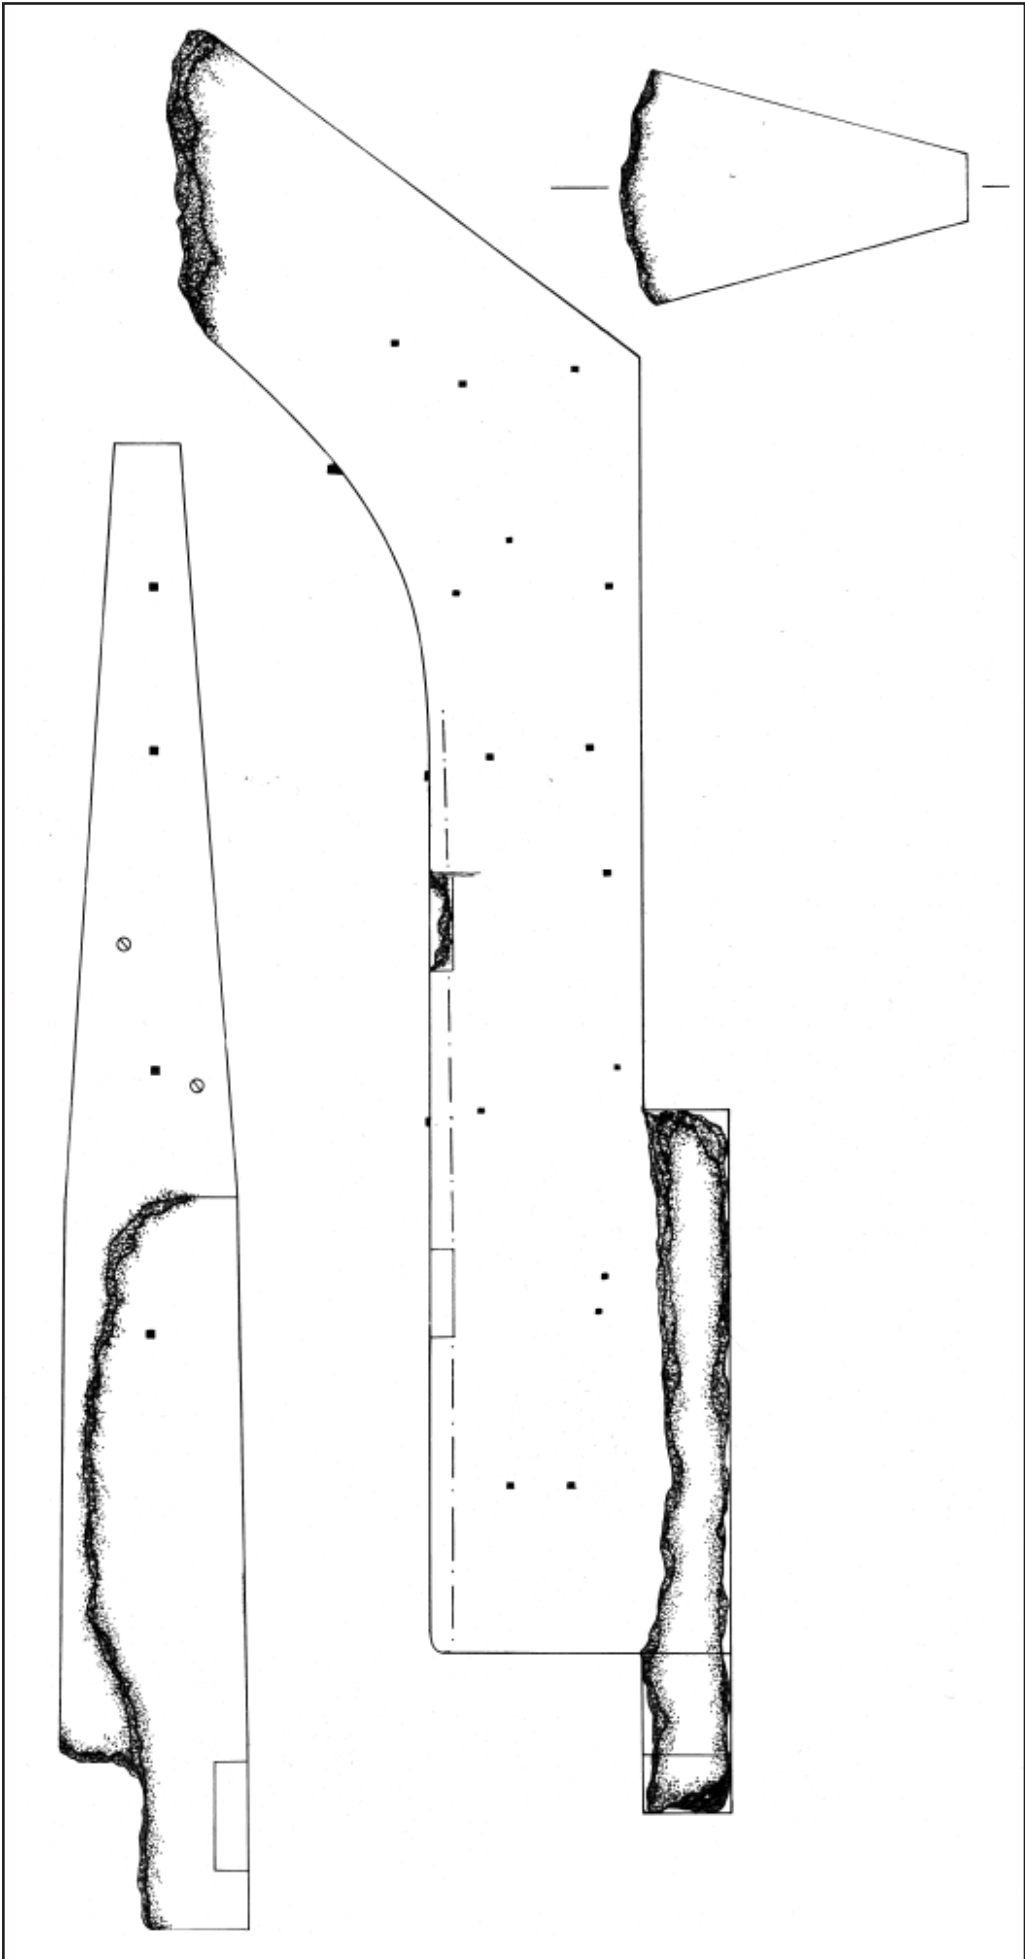
Figure 6.26. Forefoot knee (bottom, side, and section [lower right]) inked drawing

Figure 6.27. Forefoot knee (bottom, side, and section [lower right]) scale drawing

The most unusual element of the 44HT0125 vessel structure is a large knee. For lack of current documentation of a similar feature, it will be referred to as the “forefoot knee” as the component was clearly designed to form the forefoot of the hull (Figures 6.26 and 6.27). The overall maximum length of the forefoot knee is 12 feet, 8 ½ inches (Figures 6.28 and 6.29).

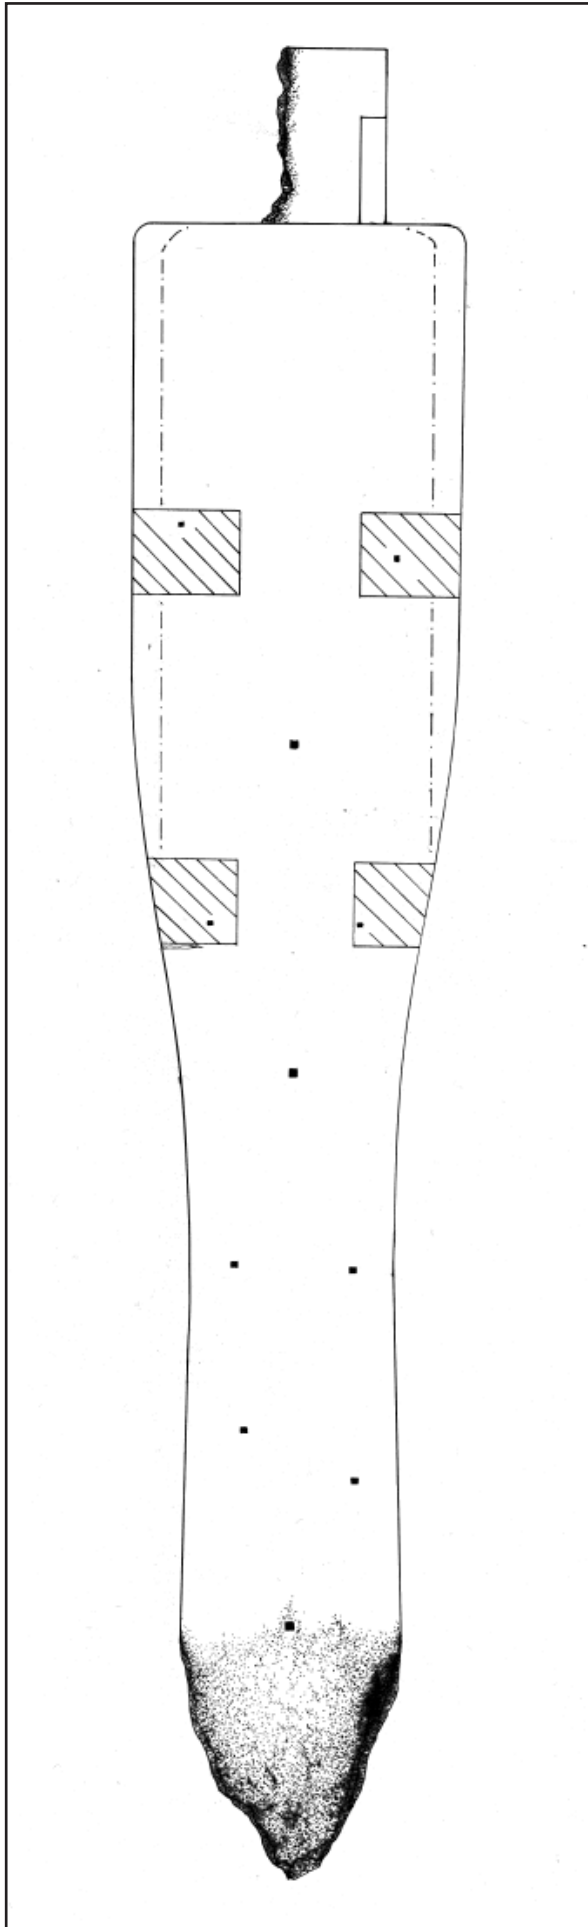
Figure 6.28. Forefoot knee (top) inked drawing.

Figure 6.29. Forefoot knee (top and aft end) scale drawing.

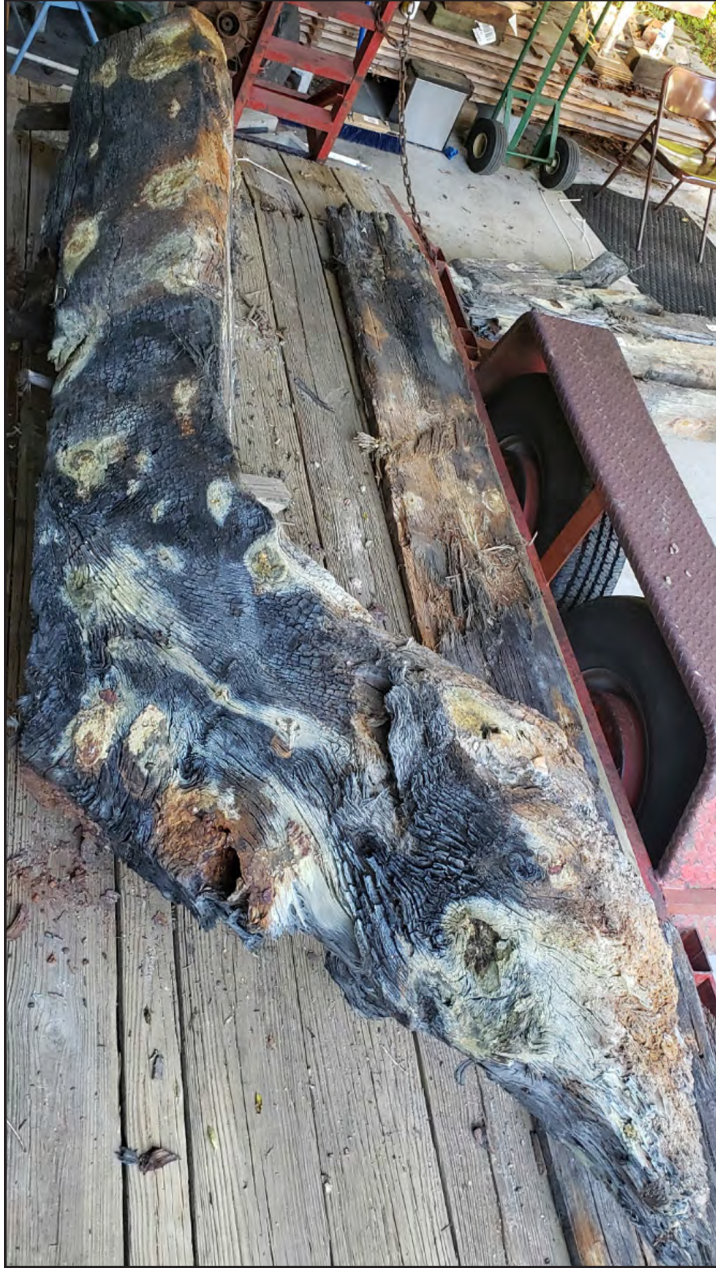
*Figure 6.30. Forefoot knee starboard side looking aft.*

The forefoot knee is V-shaped in both vertical and horizontal planes (Figure 6.30). The vertical planes narrow at the base to a width that likely mated with the top of the keel possibly forming a made rabbet. The horizontal planes narrowed forward and mated with the stem. The aft face of the stem may have been cut to a width that formed a made rabbet for the hull plank butts. Near the base at the stem facet and the forward end of the keel facet, the forefoot knee “V” was the narrowest in shape both vertically and horizontally. Moving aft the V shape of the knee widened. Moving up the stem facet the shape of the V also widened (Figure 6.31).

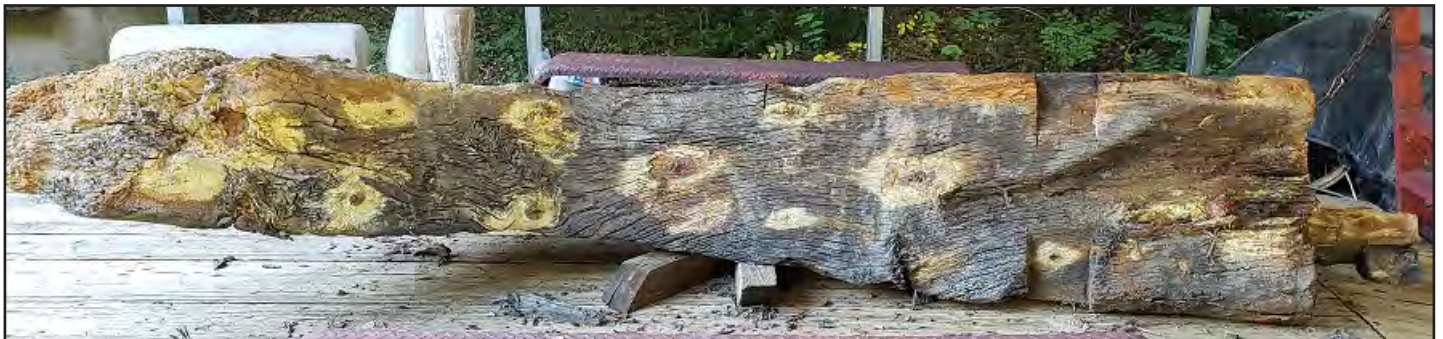
*Figure 6.31. Top view of the forefoot knee.*

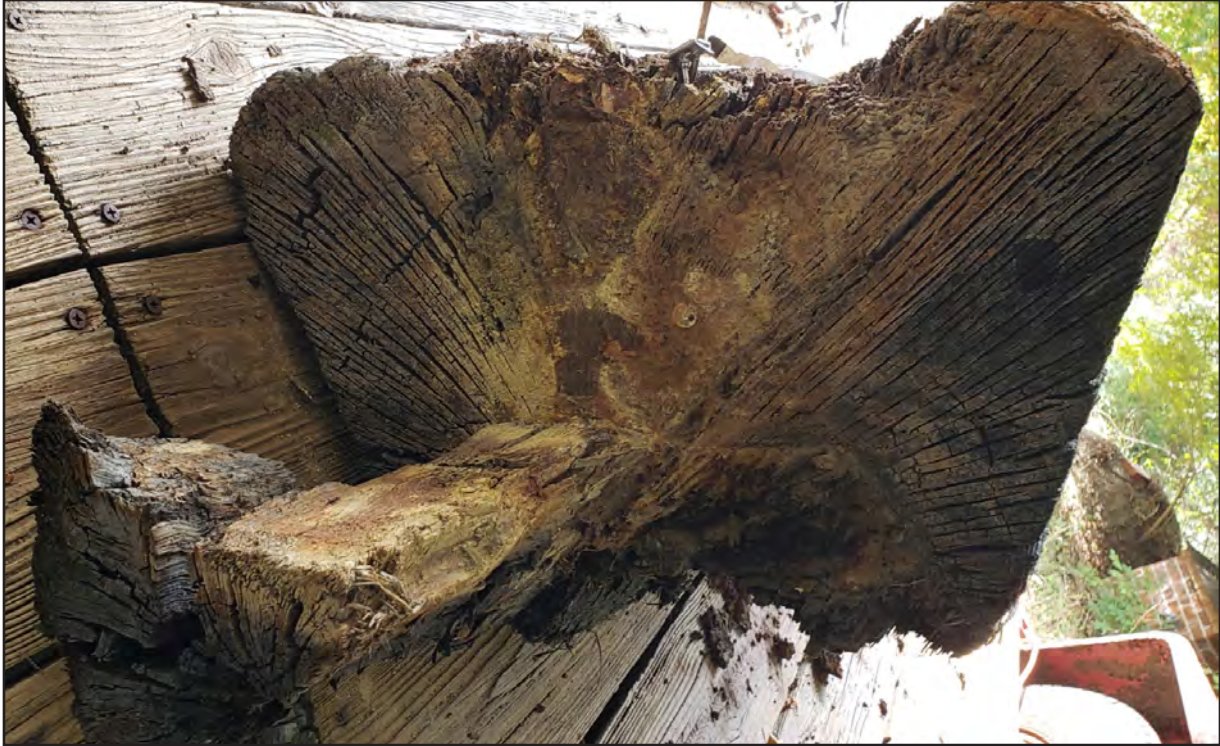
*Figure 6.32. Aft end view of the forefoot knee.*

Underneath the forward section of the knee, a fillet piece is obviously missing. That piece likely extended the forefoot down to mate with the keel. The aft end of the knee is also deeply mortised to accept futtocks (Figure 6.32). Additional futtocks appear to have been attached to the knee approximately 1 foot, 8 inches further forward (Figure 6.33). The vertical face of the forefoot knee also contains fastener patterns that suggest the location of cant frame attachment or the possible presence of breast hooks (Figure 6.34).

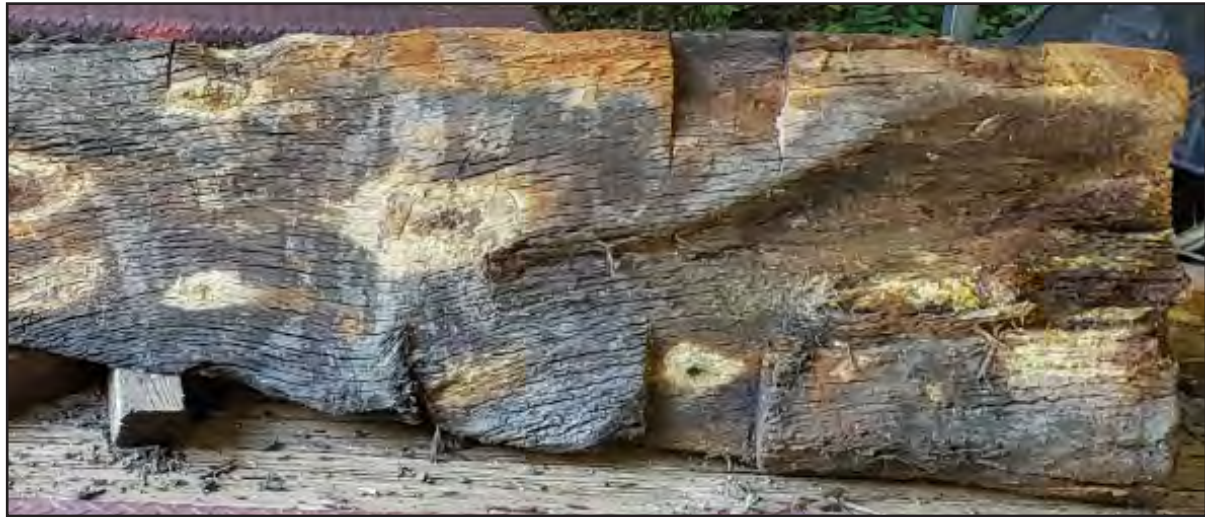
*Figure 6.33. Top view of the forefoot knee showing rebates for futtocks.*

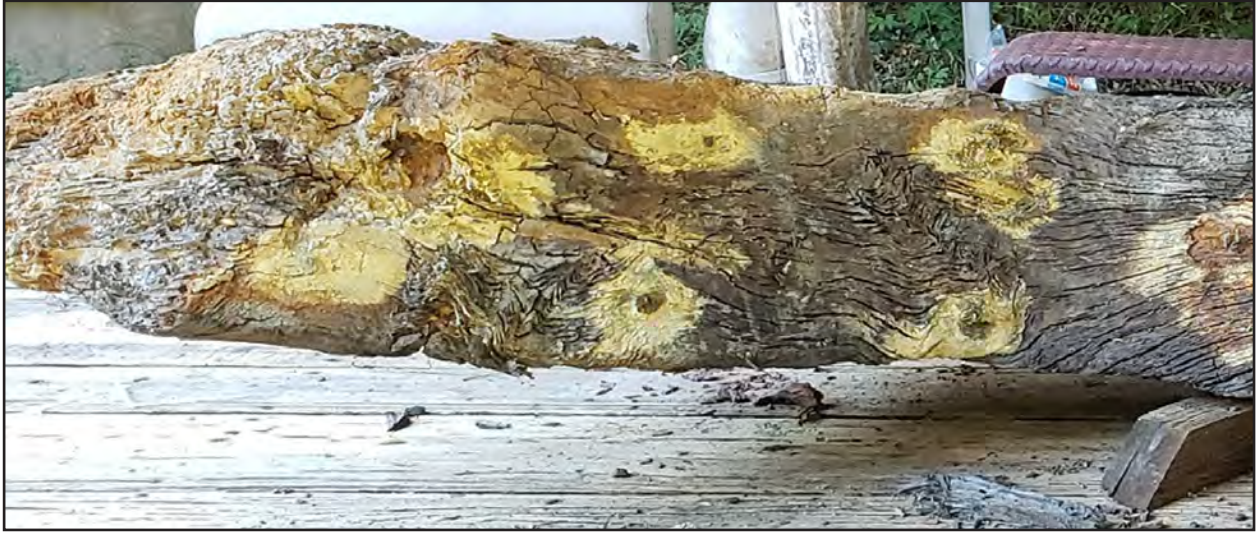
*Figure 6.34. Fastener pattern suggesting possible presence of cant frames or breast hooks.*

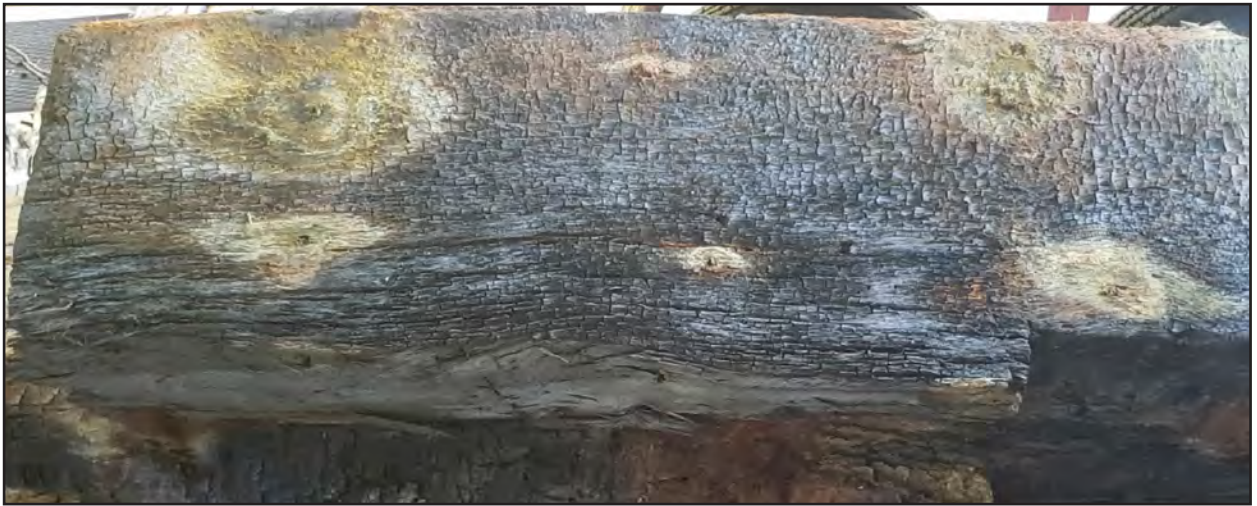
*Figure 6.35. Spike pattern associated with hull plank attachment.*

Both sides of the forefoot knee contain spike pattern evidence of the direct attachment of hull planking (Figure 6.35).

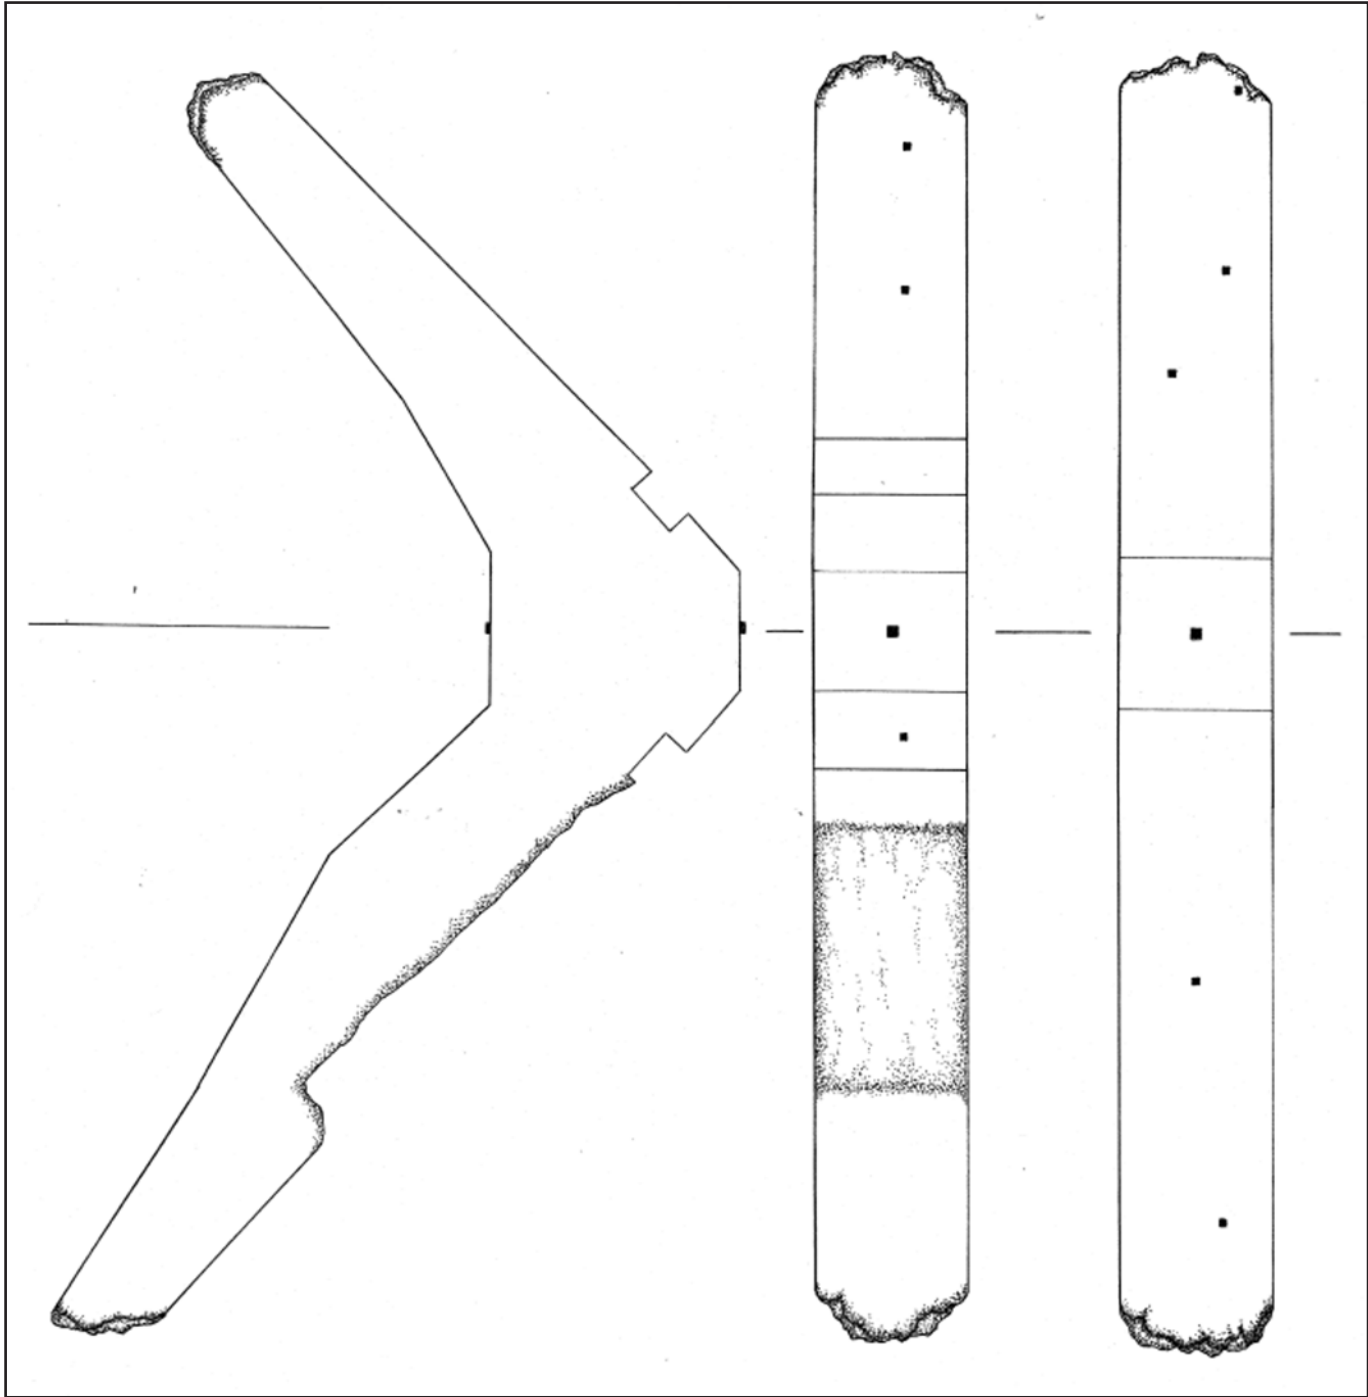
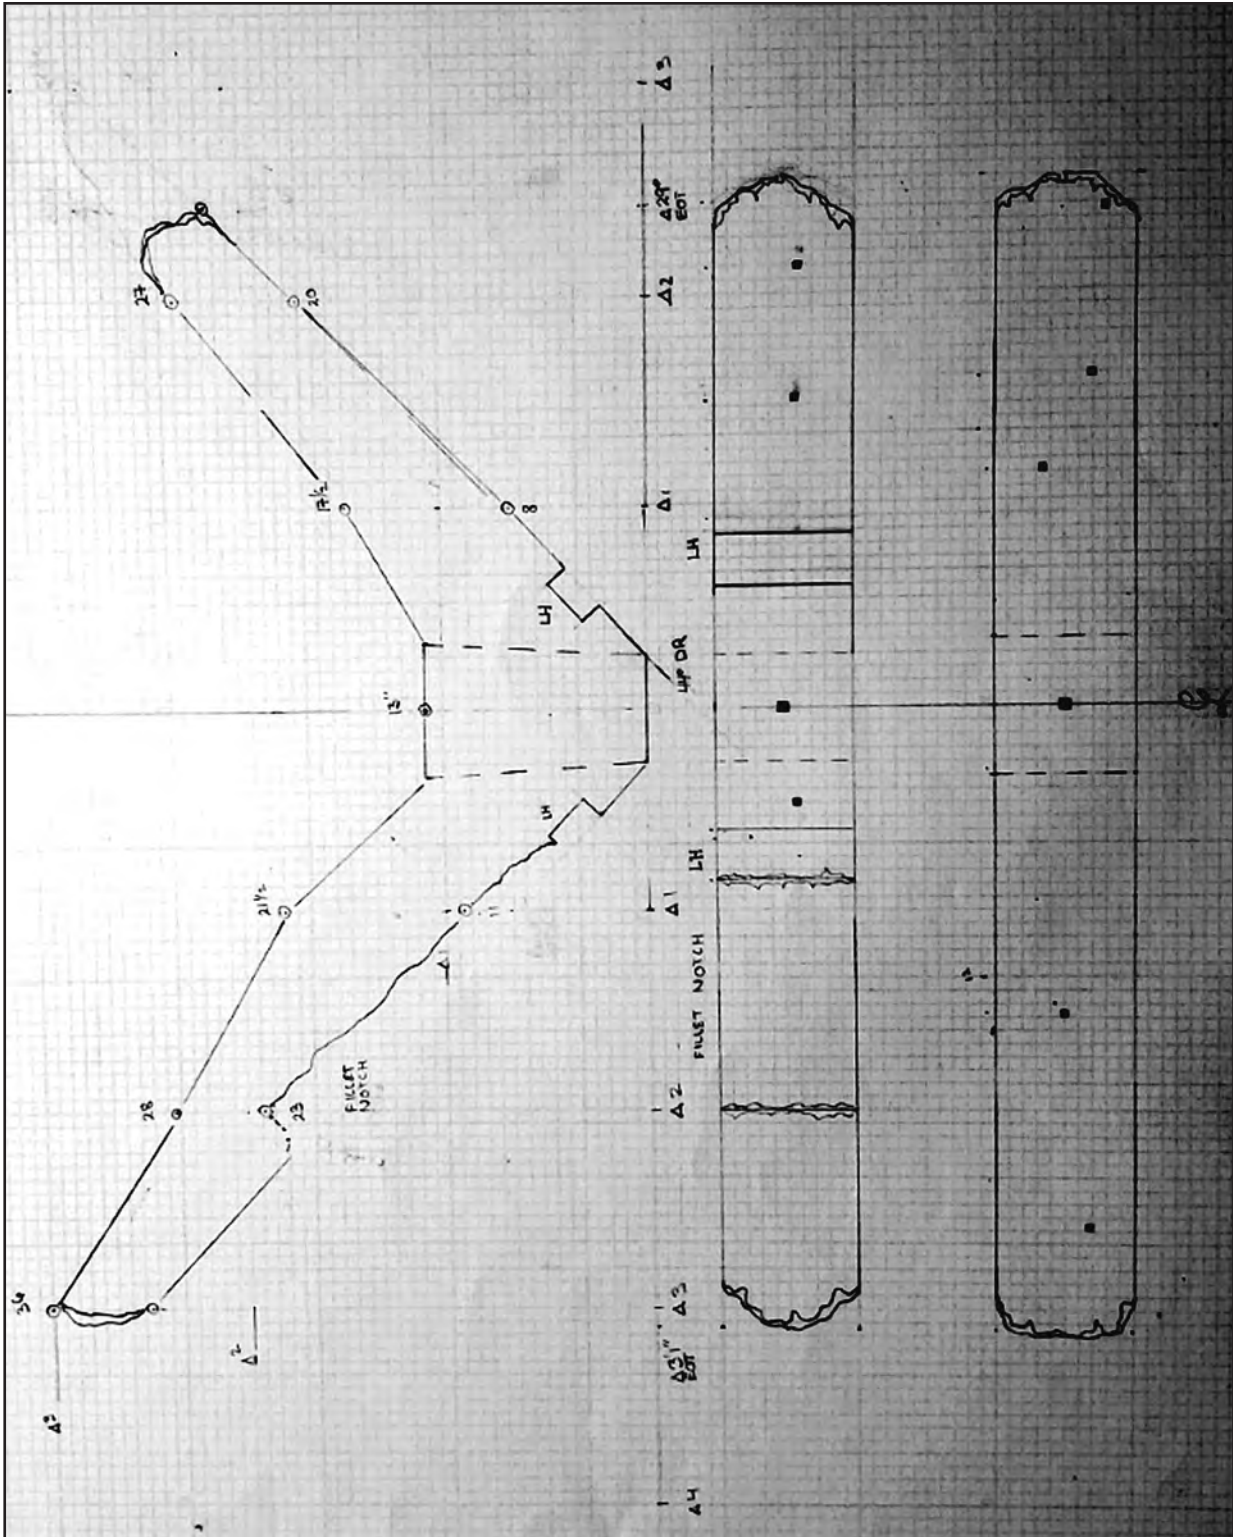
Figure 6.36. Floor timber FL-1 inked drawing.

Figure 6.37. Floor timber FL-1 scale drawing.

FL-1 was fashioned from oak and measured 5 feet, 5 inches in horizontal length (Figures 6.36 and 6.37). The most accurate sided dimension was 7 inches and the most accurate molded dimension was 9¼ inches. Deadrise of the floor measured 44 degrees. The base flat that rested on the keel measured 7¾ inches in width and the remains of a ¾-inch- square bolt driven into a drilled round hole identified the method of attachment. Limbers were cut 3 inches outboard of the keel flat and measured 3 inches wide and approximately 1 inch deep. Deterioration eliminated evidence of tool marks on the timber surfaces. There is no evidence of any futtock attachment.

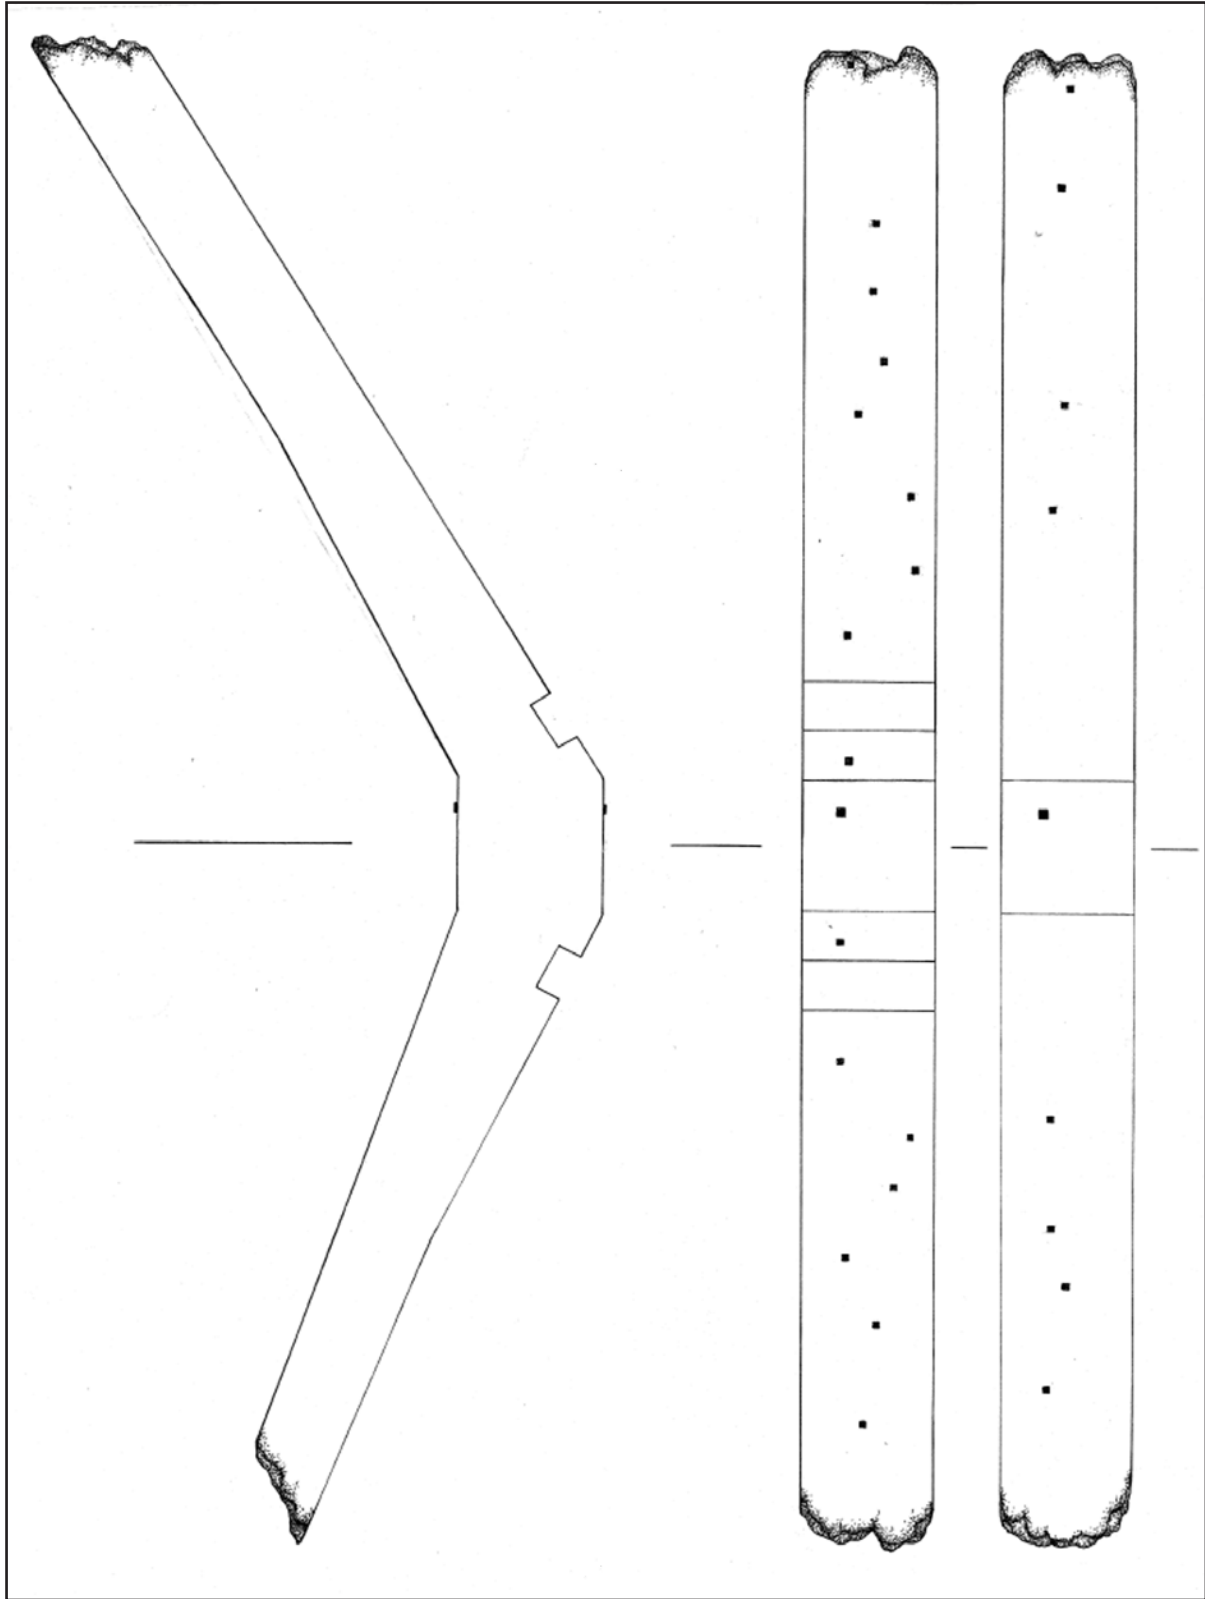
Figure 6.38. Floor timber FL-2 inked drawing.

Figure 6.39. Floor timber FL-2 scale drawing.

FL-2 was fashioned from oak and measured 7 feet, 6 inches in horizontal length (Figure 6.38 and 6.39). The most accurate sided dimension was 8 inches and the most accurate molded dimension was  $8\frac{3}{4}$  inches. Deadrise of the floor measured 29.5 degrees on the left side as illustrated and 31 degrees on the right side as illustrated. The base flat that rested on the keel measured 8 inches in width and the remains of a  $\frac{3}{4}$ -inch-square bolt driven into a drilled round hole identified the method of attachment. That bolt was offset 2 inches from the centerline and  $2\frac{1}{2}$  inches from the face of the floor as illustrated. Limbers were cut 3 inches outboard of the keel flat and measured 3 inches wide and approximately  $1\frac{1}{4}$  inch deep. Deterioration eliminated evidence of tool marks on the timber surfaces. There is no evidence of a futtock attachment.

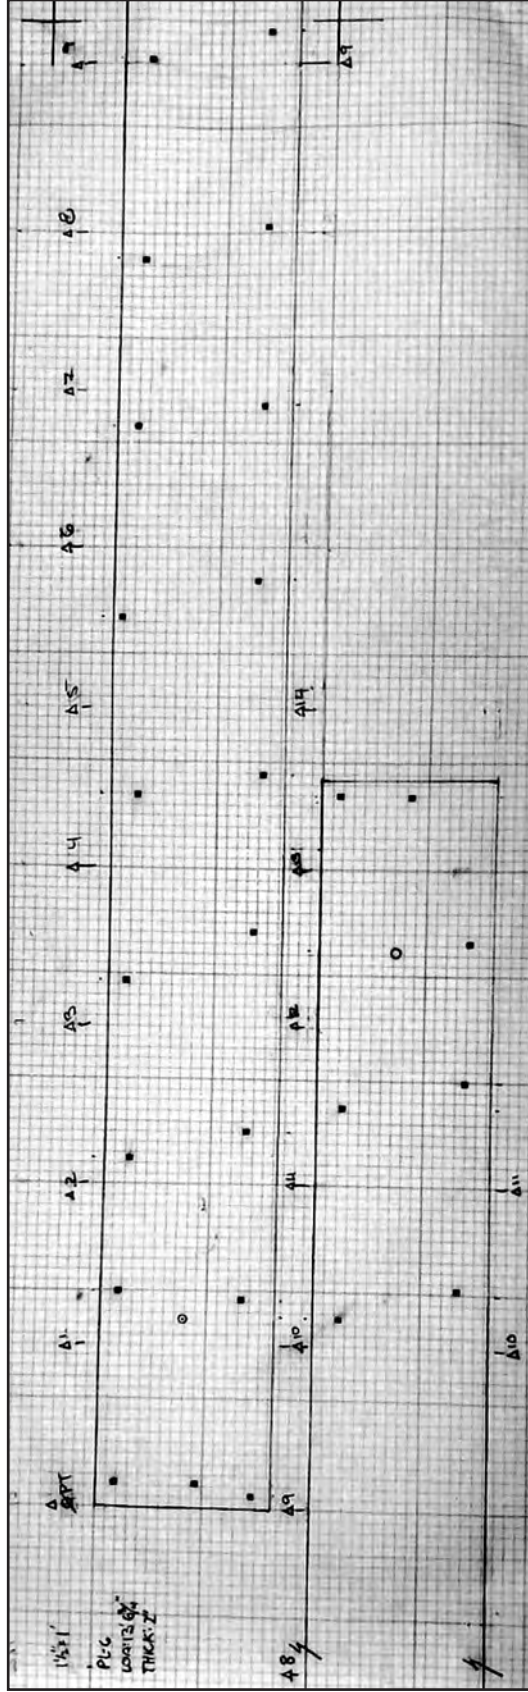
Figure 6.81. Plank example PL-6 scale drawing.

PL-6 was fashioned of oak and measured 13 feet 6¾ inches in length, 13 inches in maximum width, and 2 inches in thickness (Figures 6.80 and 6.81). Both ends were square cut for butt joints. Half-inch-square iron spikes were used to attach the section to floors or futtocks. Spikes were located from 1¼ to 2 inches inboard of the plank edges and sets were separated from 10 to 15 inches. Two spikes were apparently used to fasten the butt at one end while three were used at the other end. Two ½-inch-diameter trunnels were employed as fasteners roughly 14 inches inboard from the plank butts. Deterioration eliminated evidence of tool marks on the plank surfaces.

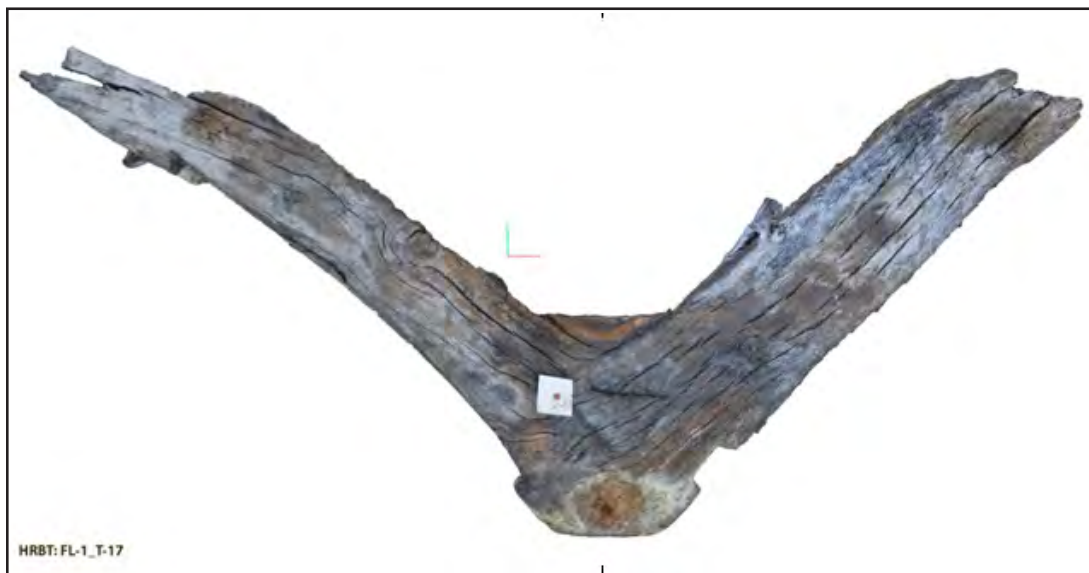
Figure 6.82. Floor timber FL-1 photomosaic image.

Comprehensive analysis of the overall design and construction of the Site 44HT0125 vessel is not possible due to the limited structural evidence that is available. In addition, the physical condition of the timbers affected analysis. Damage that occurred in the recovery process and deterioration that followed was evident. Post-recovery deterioration also virtually eliminated construction tool marks. Those impacts minimized the quality and subsequent usefulness of photographic documentation (Figure 6.82).

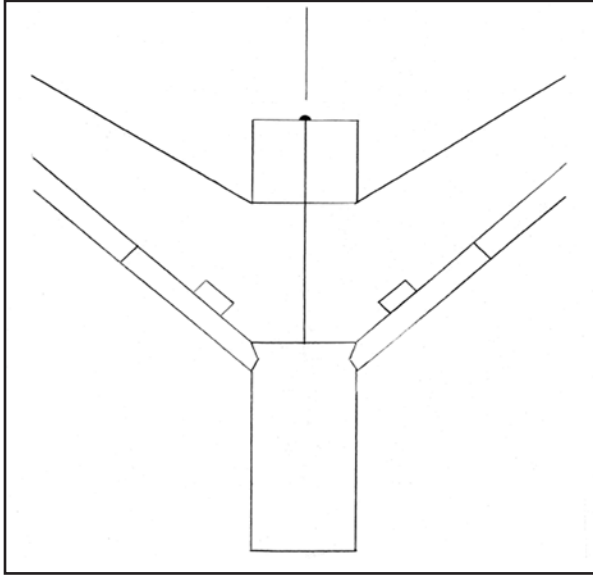
*Figure 6.83. Reconstructed cross section of floor timber FL-1.*

Judging from the deadrise, FL-1 was the most forward of the 12 floor timbers recovered. Dead rise on that floor timber measured approximately 44 degrees. That suggests it was located at a point on the keel aft of the forefoot knee where the deadrise was approximately 65 degrees. Deadrise of the remaining floor timbers decreases to 12 degrees at FL-12. Each of the recovered floor timbers was attached to the keelson with a 1-inch-square bolt driven through a 1-inch-diameter drilled hole. The wood block located on the bottom of FL-12 could be an indication that it filled an opening cut to inspect the condition of that timber (Figure 6.88). The hull plank fastener pattern on FL-9 may well be an indication that one or more strakes above the garboard had been replaced or refastened.

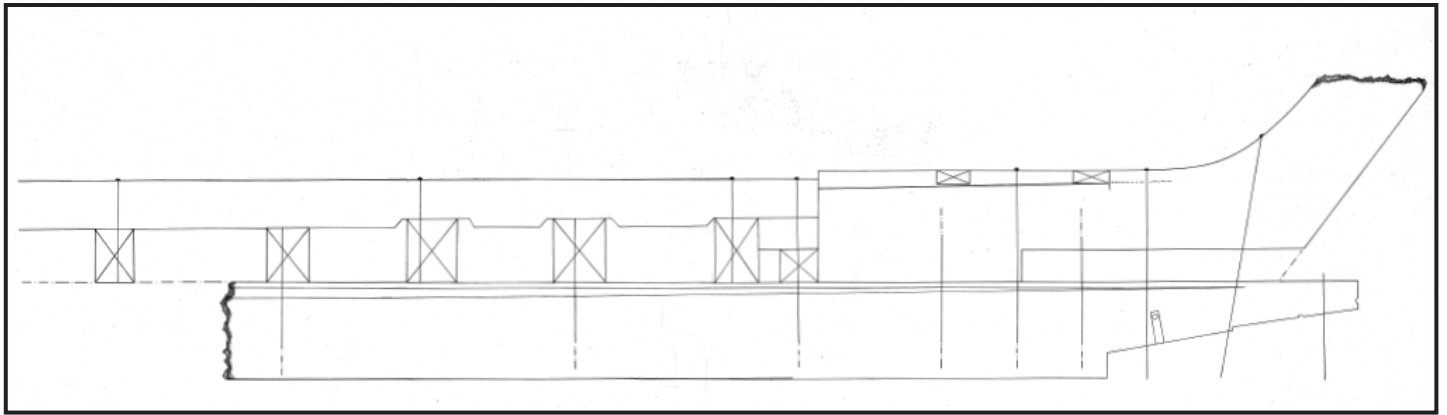
Figure 6.84. Reconstruction of Site 44HT0125 bow evidence.

The bolt pattern in the top of the keel confirms that not every floor was attached to the keel as might be considered traditional. That pattern suggests that moving aft from the bow every other floor or every fourth floor may have been bolted to the keel and possibly keelson (Figure 6.84). Those floors may represent loft masters employed

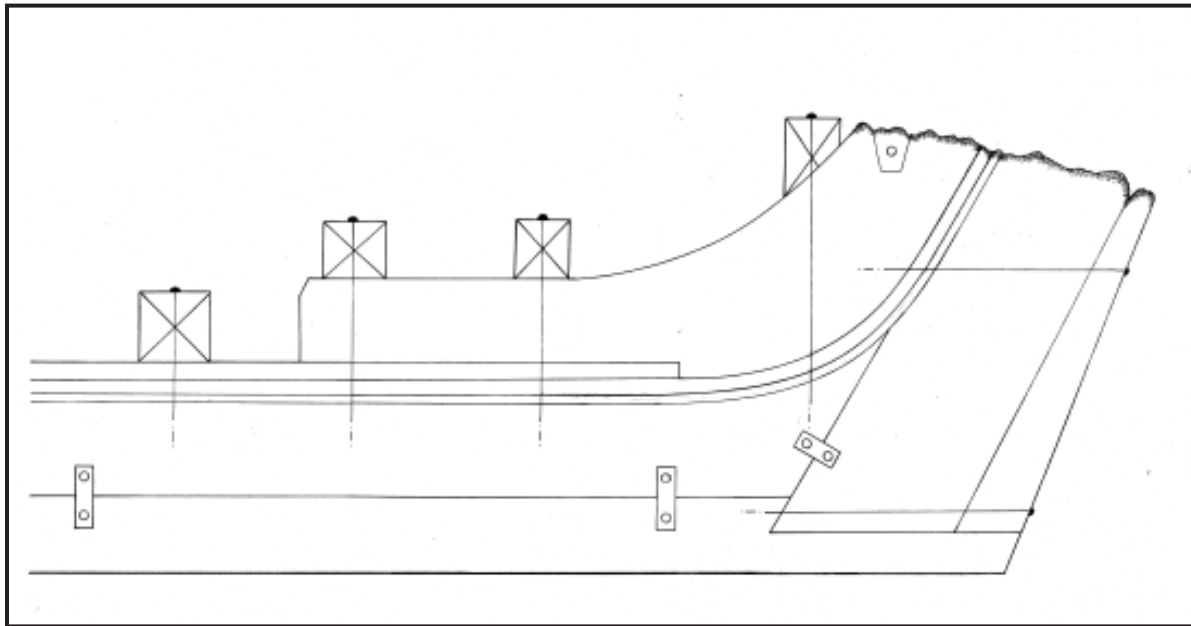
Figure 6.85. Inked image showing forefoot of Florida Site 8SR983 wreck.

A well-documented eighteenth-century wreck recorded off Town Point (Pensacola, Florida) contains a forefoot structure that parallels the Site 44HT0125 forefoot knee. Documentation of those remains (designated as Florida Site 8SR983) is presented in a report prepared for the Florida Bureau of Archaeology. An almost identical timber labeled as the “knee of the head” was found on that subject site (Franklin, Morris, and Smith 1991:119-122). Details from the Florida Site 8SR983 bow construction confirm the similarity with Site 44HT0125 bow construction (Figures 6.85 and 6.86).

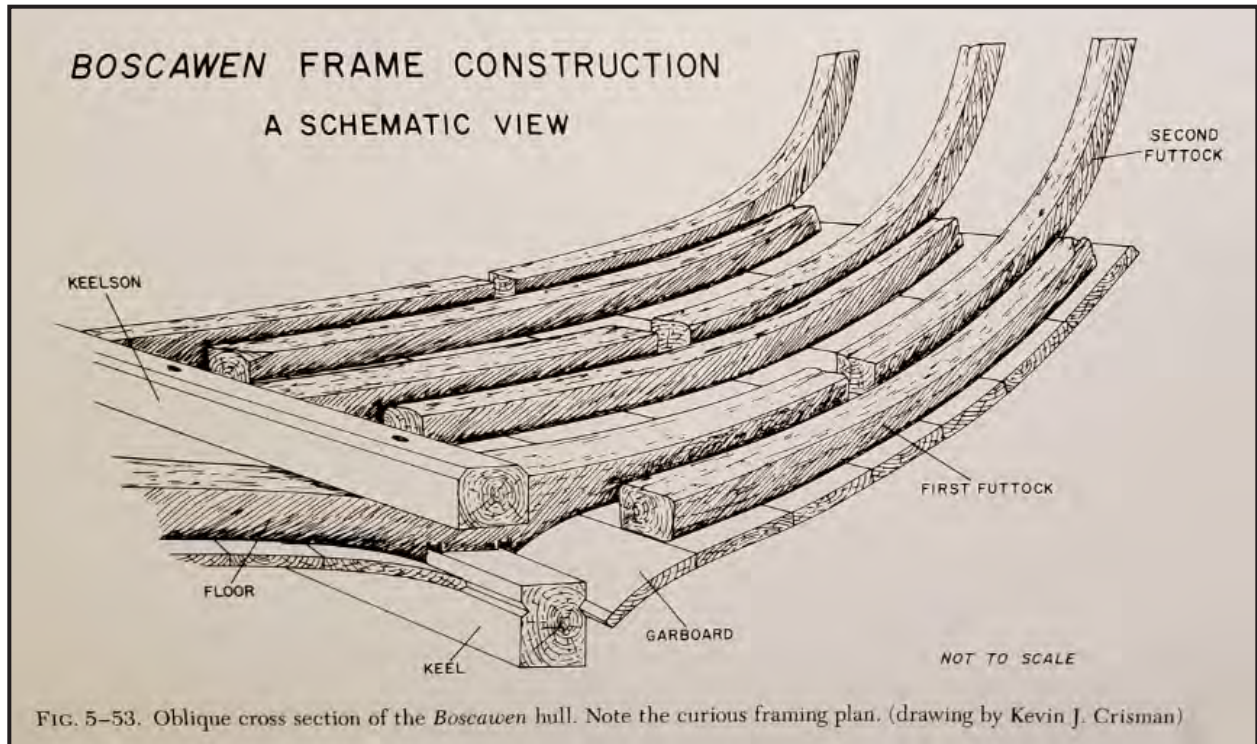
Figure 6.86. Framing pattern on *Boscawen* (courtesy of Kevin Crisman).

None of the recovered floor timbers contained evidence of attachment to associated first futtocks. That pattern became more prevalent towards the beginning of the nineteenth century. The pattern of floors and unattached futtocks was found in the remains of the British sloop *Boscawen* (Figure 6.87).

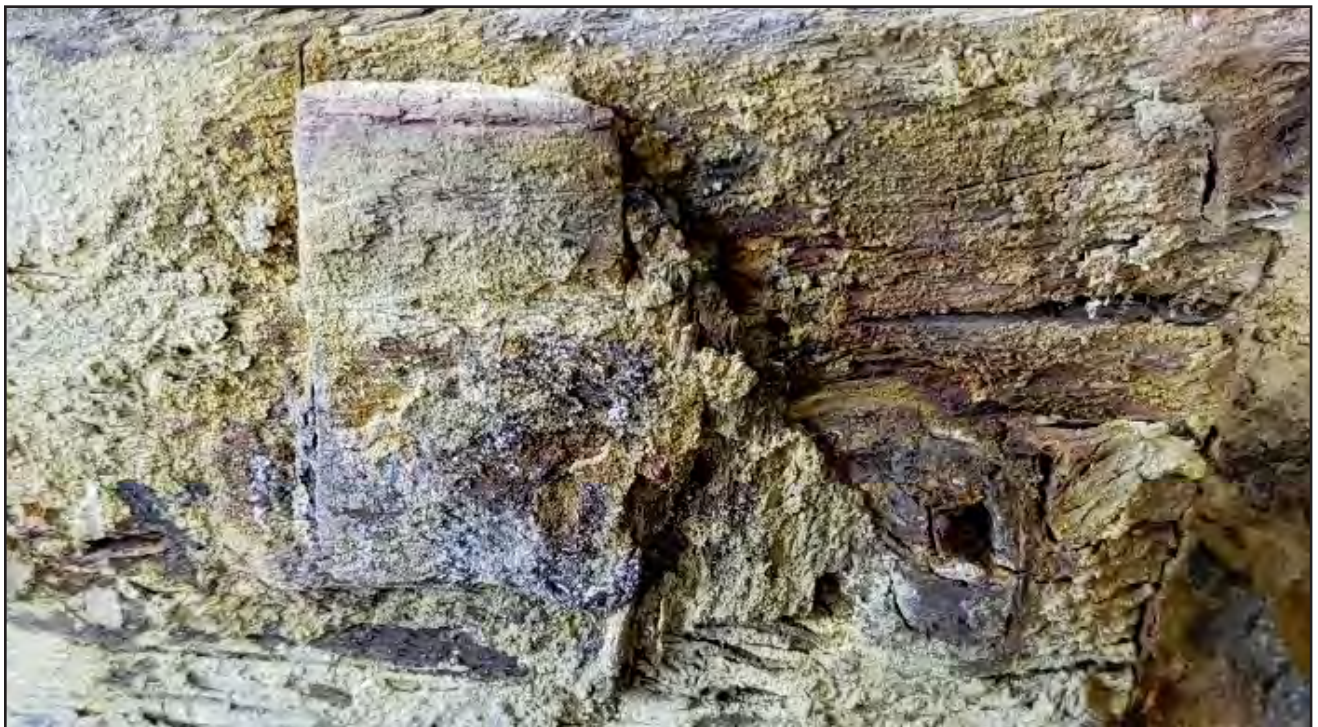
Figure 6.87. Block in the bottom of floor timber FL-12 and plank spike hole.
