RE: Pollution Remediation Obligations FY23

William & Mary FY23 Illicit Discharge Report

July 1, 2022 - June 30, 2023

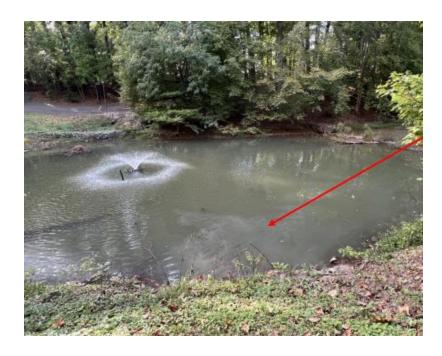
2. Health Center BMP Sewage Spill DEQ #3006800 – Work Order 340111

On October 11, 2022, sewage overflowed from a manhole behind the Campus Living Center, ran down the pathway and entered a storm drain at the Health Center BMP, located at 230 Gooch Drive, Williamsburg, Virginia. It was estimated that the amount that entered the waterway was no more than 50 gallons. A visible sheen was observed where the stormwater drain flow entered the pond. It was determined that the overflow was caused by a grease blockage in the line. The blockage was cleared by jetting the line. Facilities Management is assessing the frequency of a PM to clear this line. An engineering study is being initiated to plan upgrading or replacing the existing sewer line. No insurance claim was filed for this incident.
